**ARCHITECTURAL/HISTORIC INVENTORY FORM**

1. Survey No. SC-AS-012-0001		2. Survey Name: Reconnaissance Level Survey of Historic Downtown Wentzville	
3. County: St. Charles		4. Address (Street No.) 102	Street (name) East Third Street
5. City: Wentzville	Vicinity: <input type="checkbox"/>	6. UTM:	
8. Historic name (if known):		9. Present/other name (if known):	
10. Ownership: <input type="checkbox"/> Private <input type="checkbox"/> Public		11a. Historic use (if known): DOMESTIC/single dwelling	11b. Current use: DOMESTIC/single dwelling
5. City: Wentzville		7. Township/Range/Section:

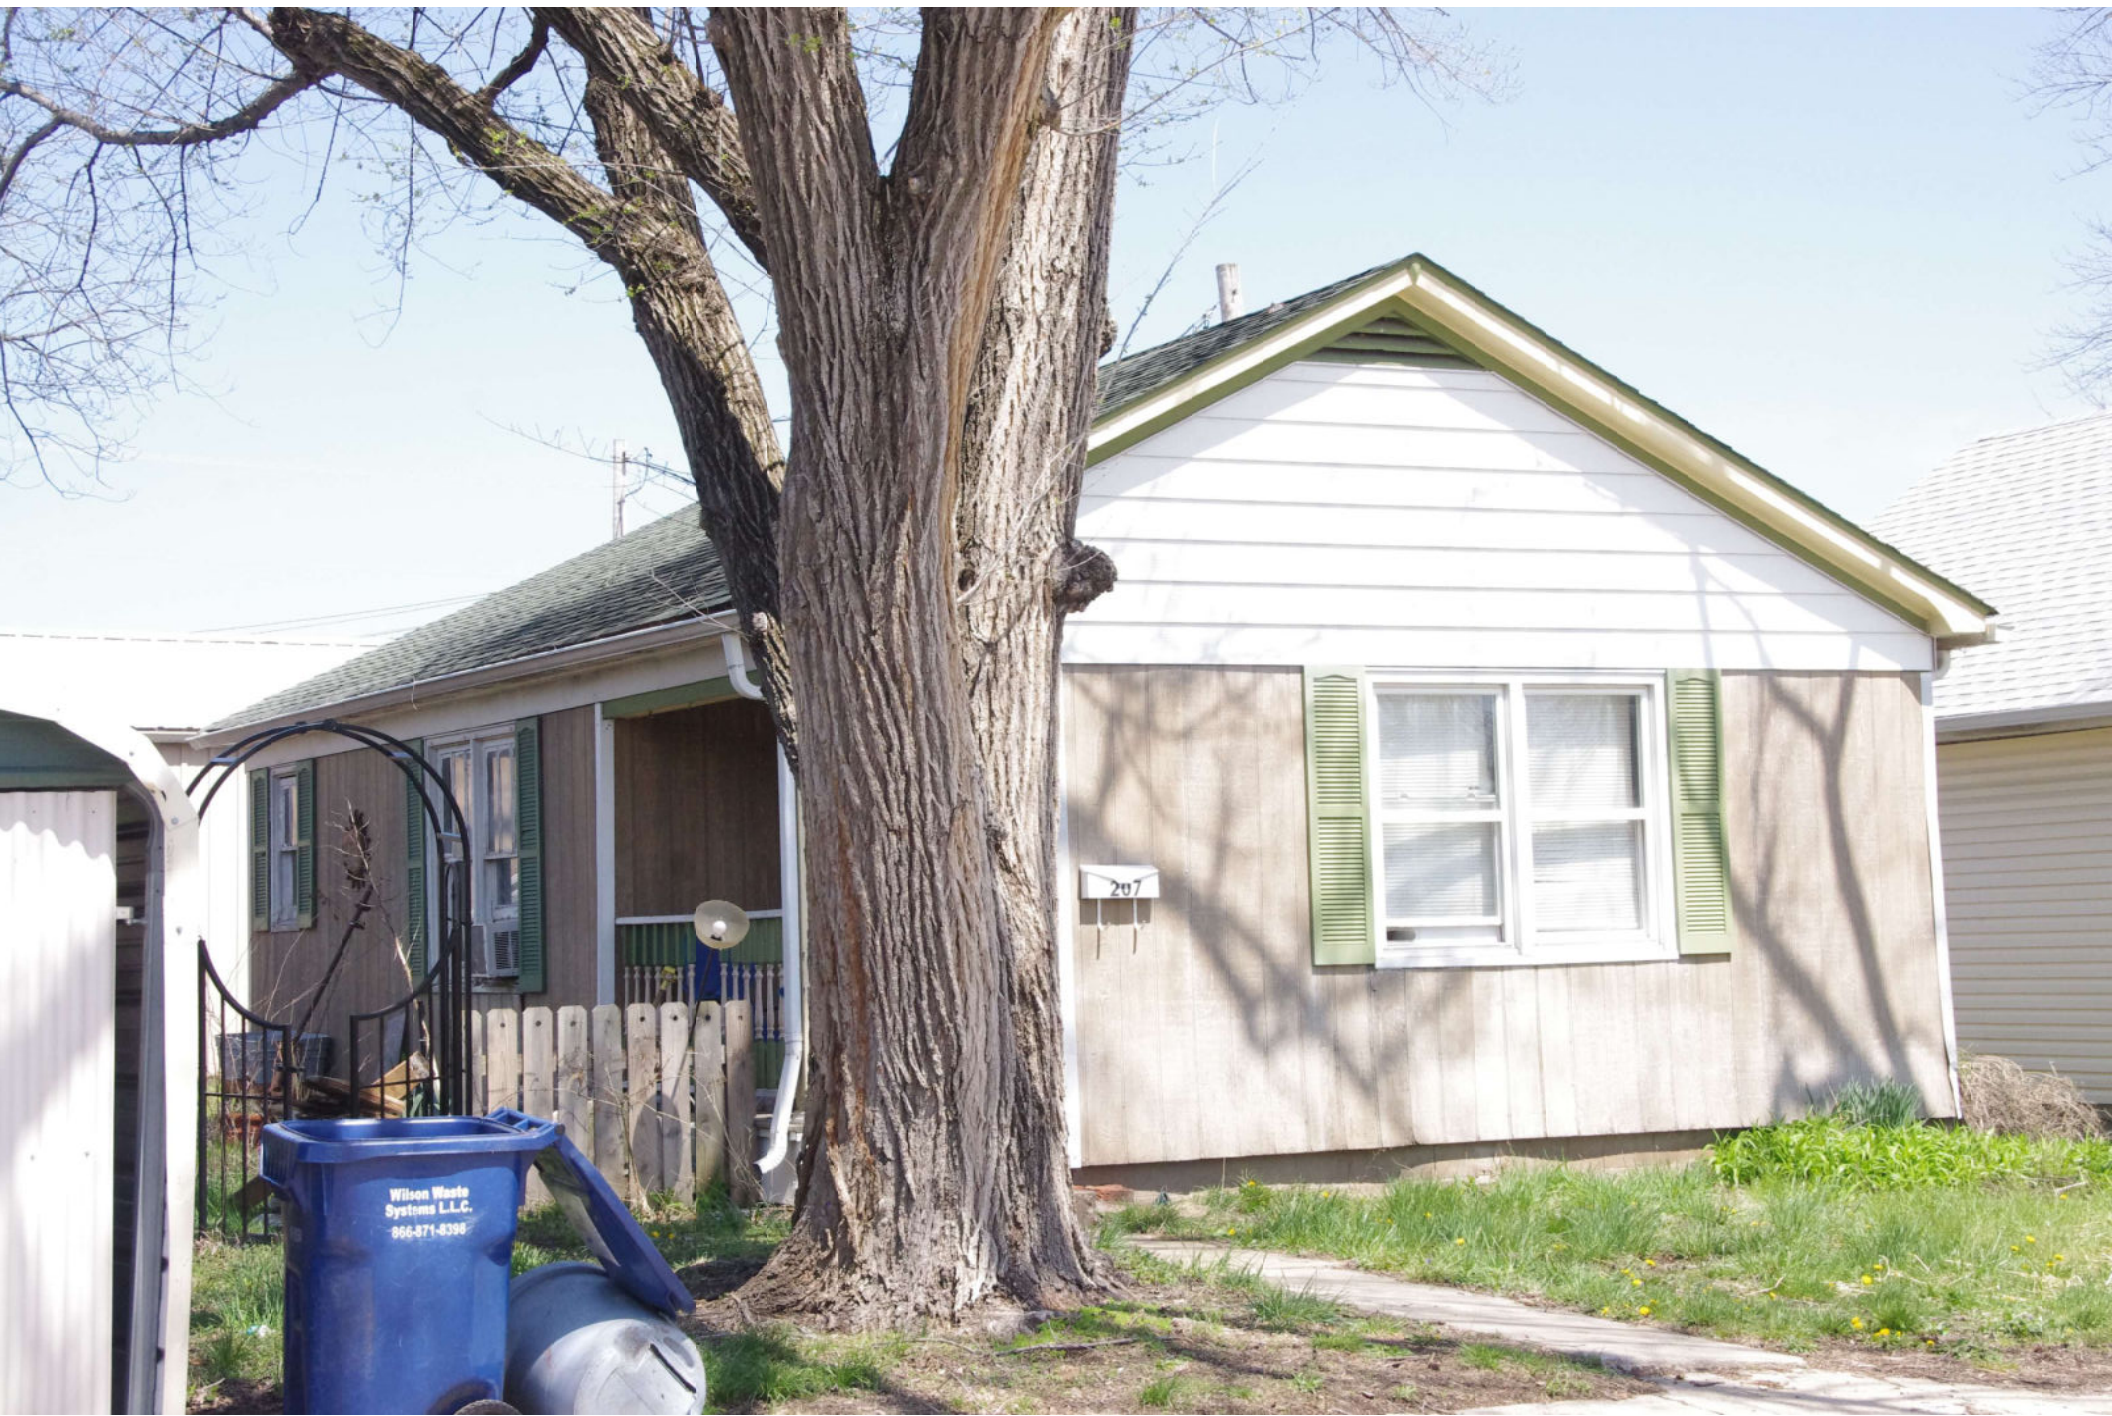
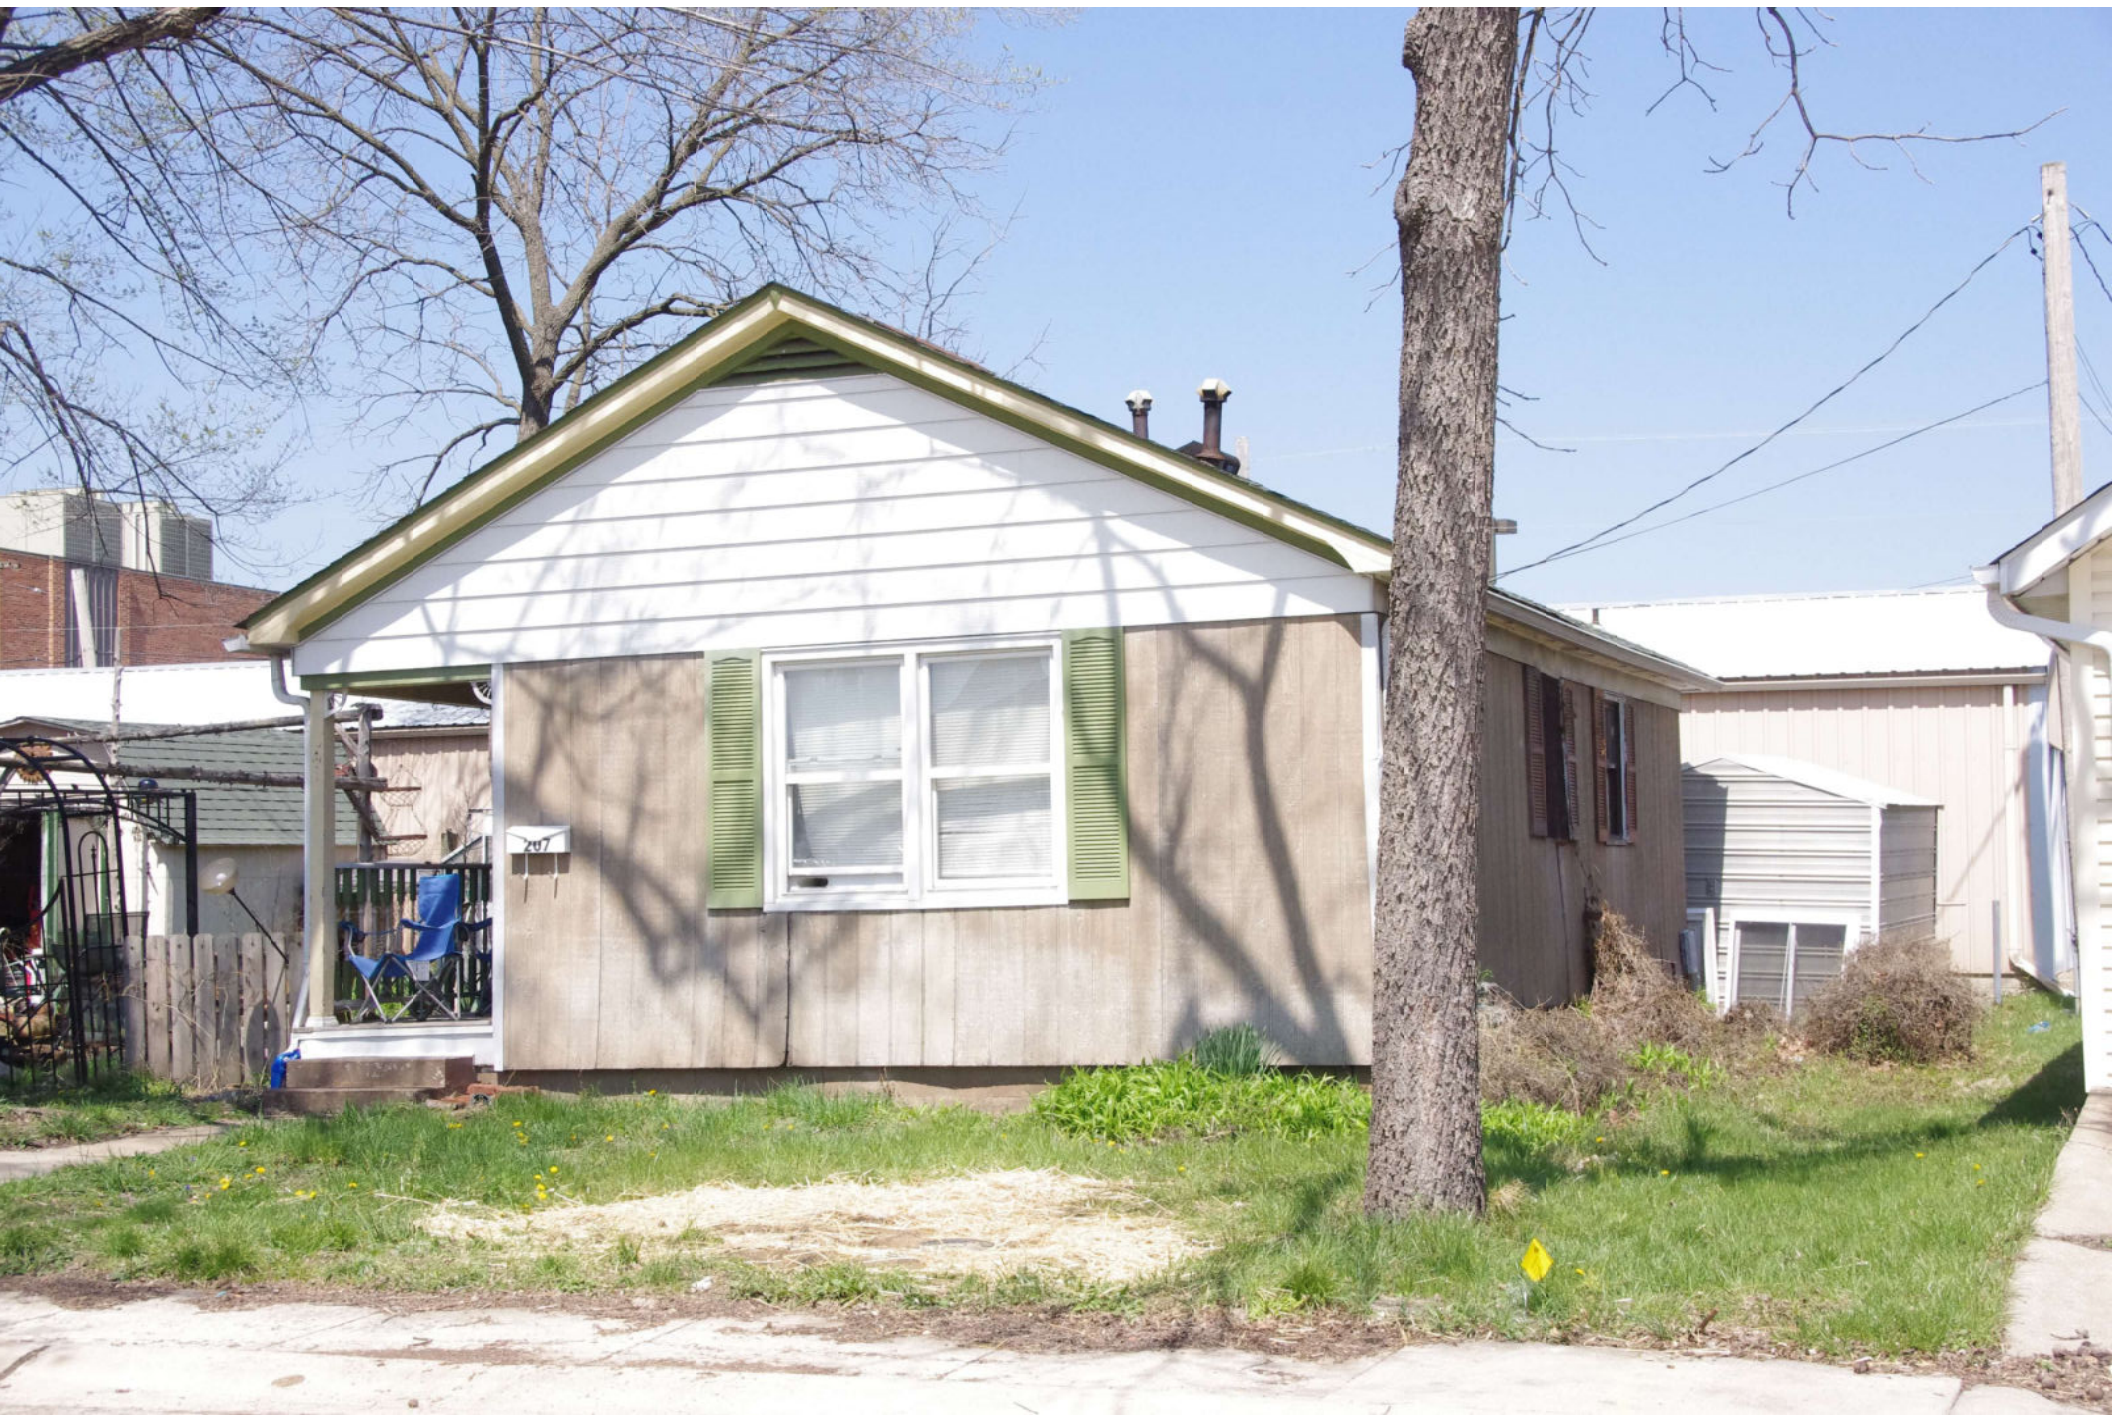
The façade on this simple, side gabled, 1-story house faces west toward the side yard instead of facing the street. On the street side elevation the gable end has replacement vinyl siding with the wall below clad with replacment vertical board siding around paired vinyl 1/1 windows. At the west end of this elevation, with a square corner post supporting the opening into the recessed porch are two concrete steps leading up to the wood porch floor. The façade is is divided into three bays, with the southern bay being the recessed porch. In the middle bay is another pair of windows with a smaller 1/1 window in the north bay.

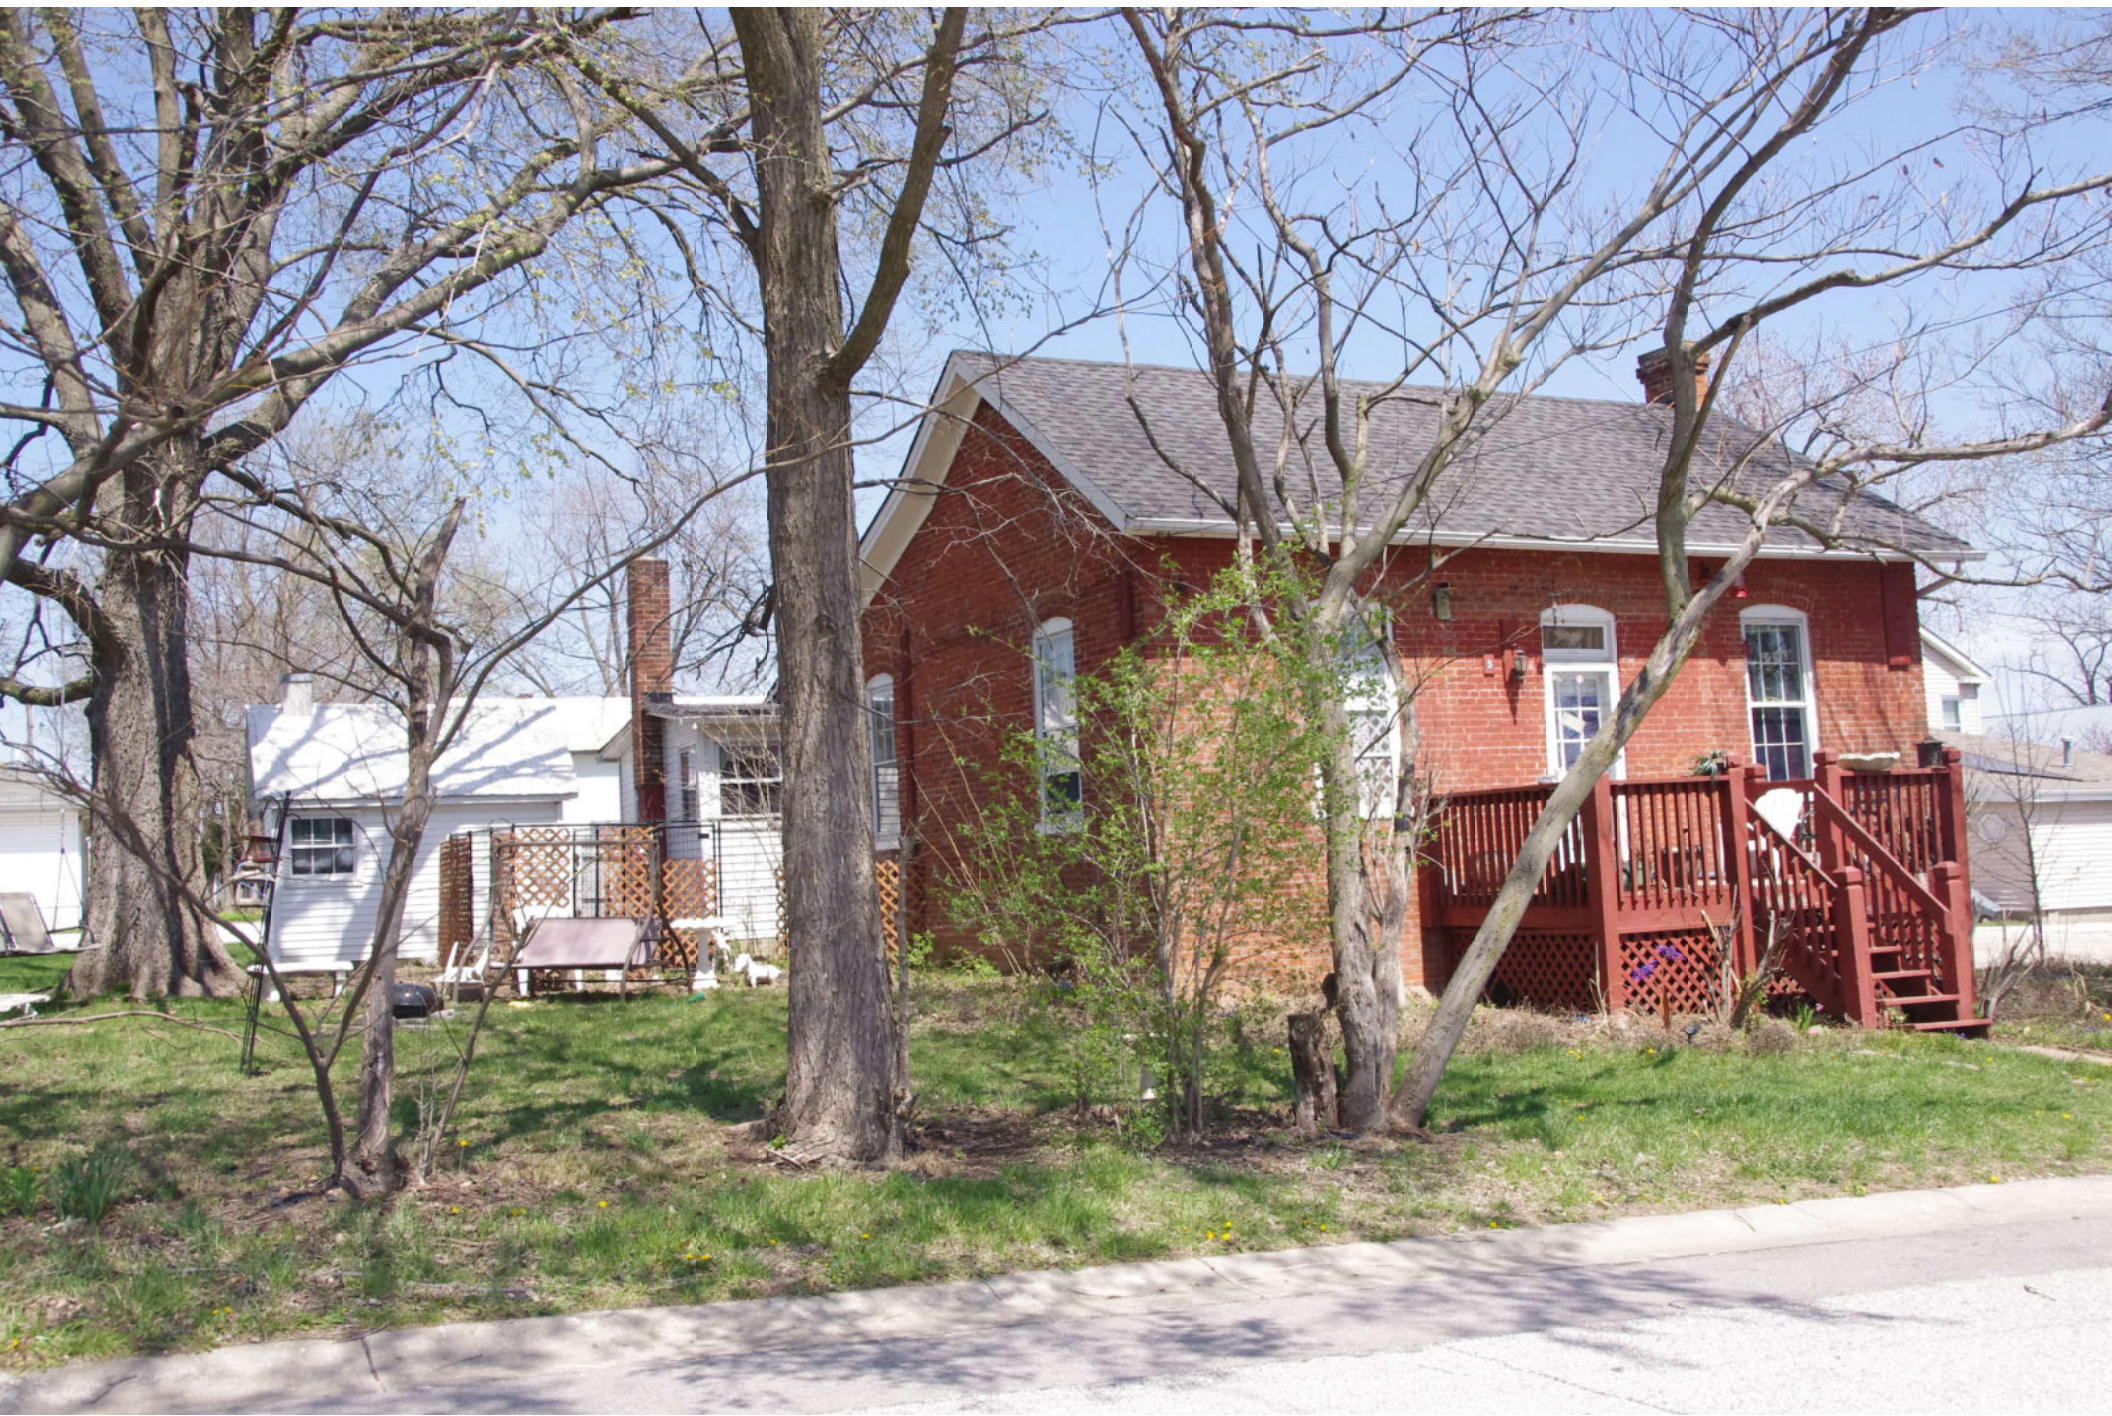
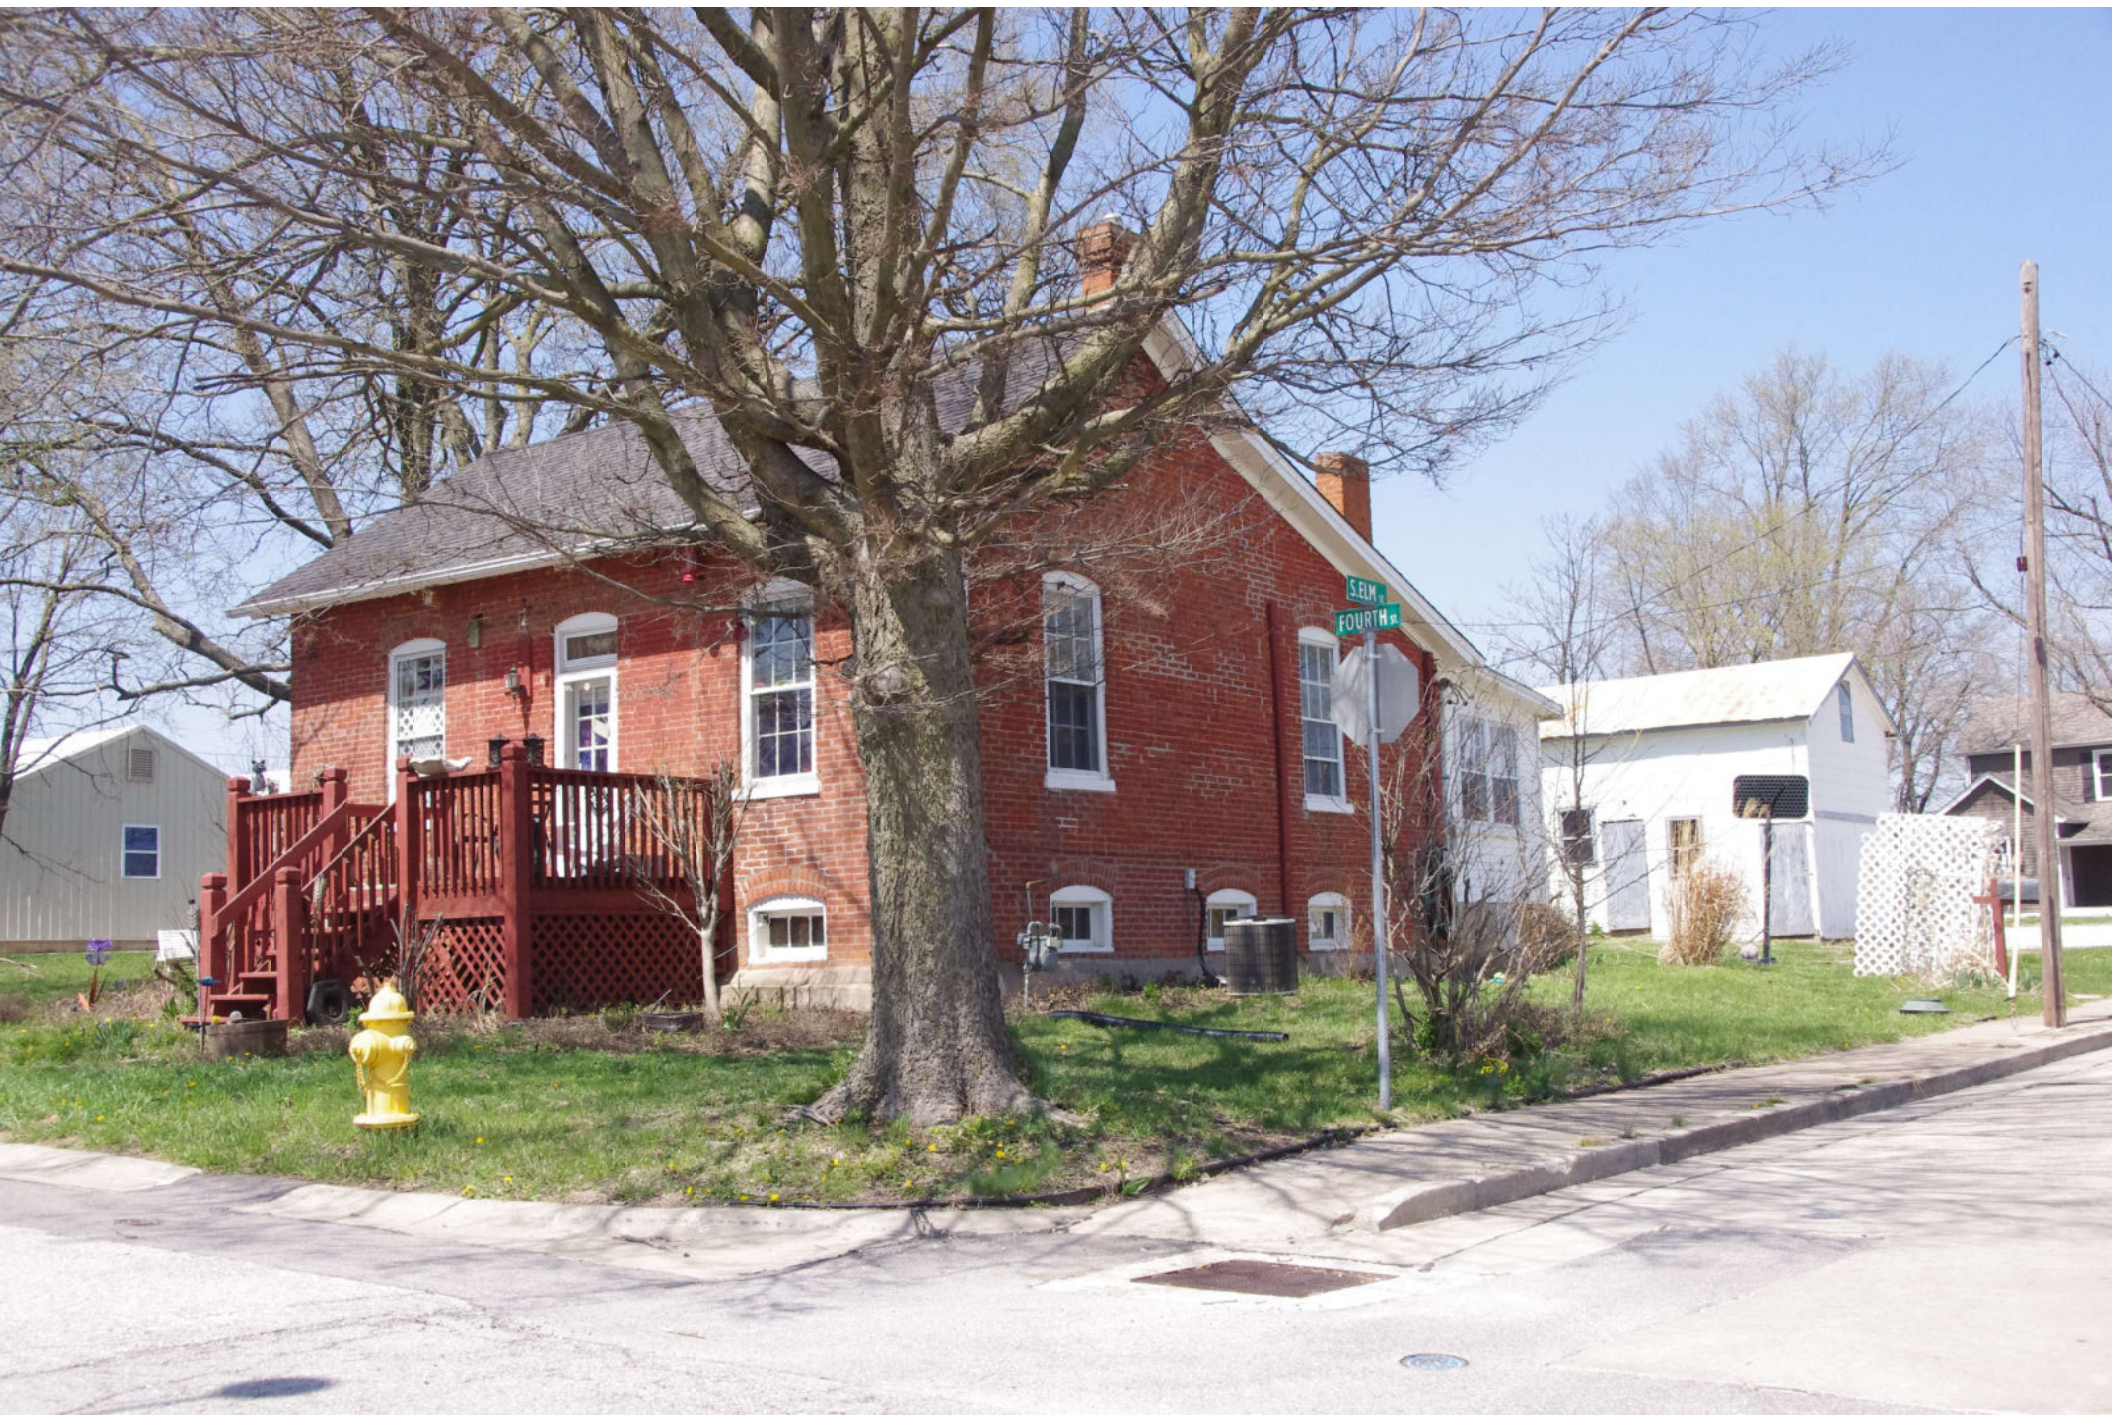
This resource is a one-story brick house with a side gabled roof that sheds lower on the rear where it now connects to a shed roofed addition that spans the rear elevation. The half light (6 lights) wood panel door is centered on the façade with an arched transom and is accessed by the central wood deck, a replacement for what appears to have been a covered porch of the same width (from shadow lines on the brick wall). The outer bays contain six-over-six windows with painted wood sills and segmental arched lintels. The shed roof addition was probably added about 1950 with six-over-six windows. The windows appear to be recent replacements and the siding on the rear is replacement vinyl siding. There is another wood deck on the rear, similar to the front, both of which appear to have been replaced in recent years.

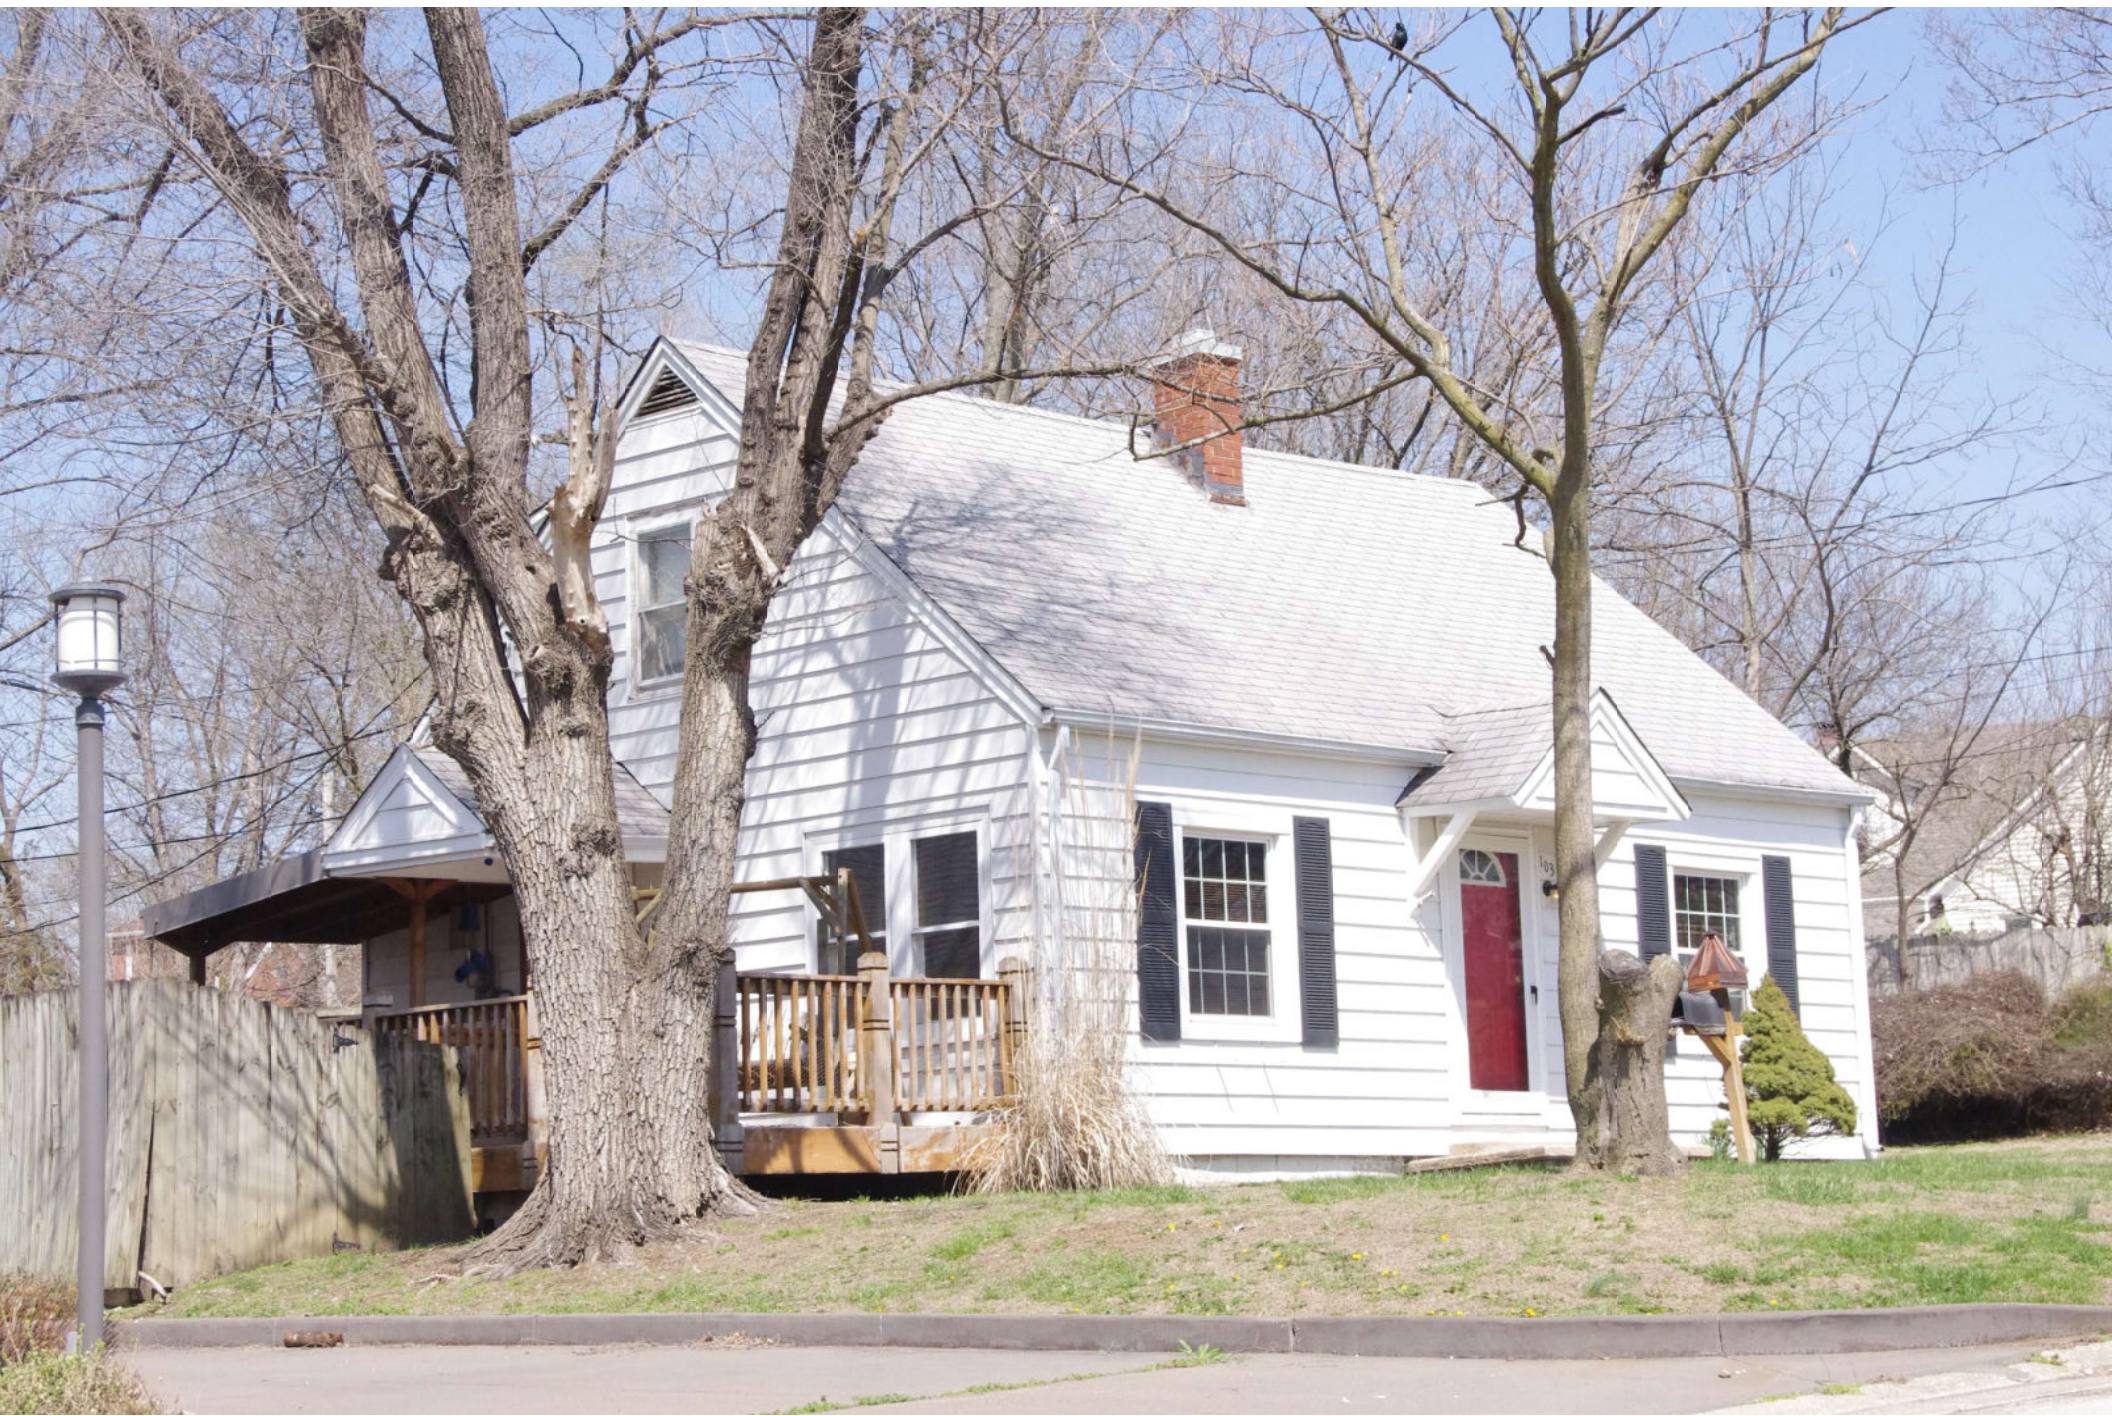
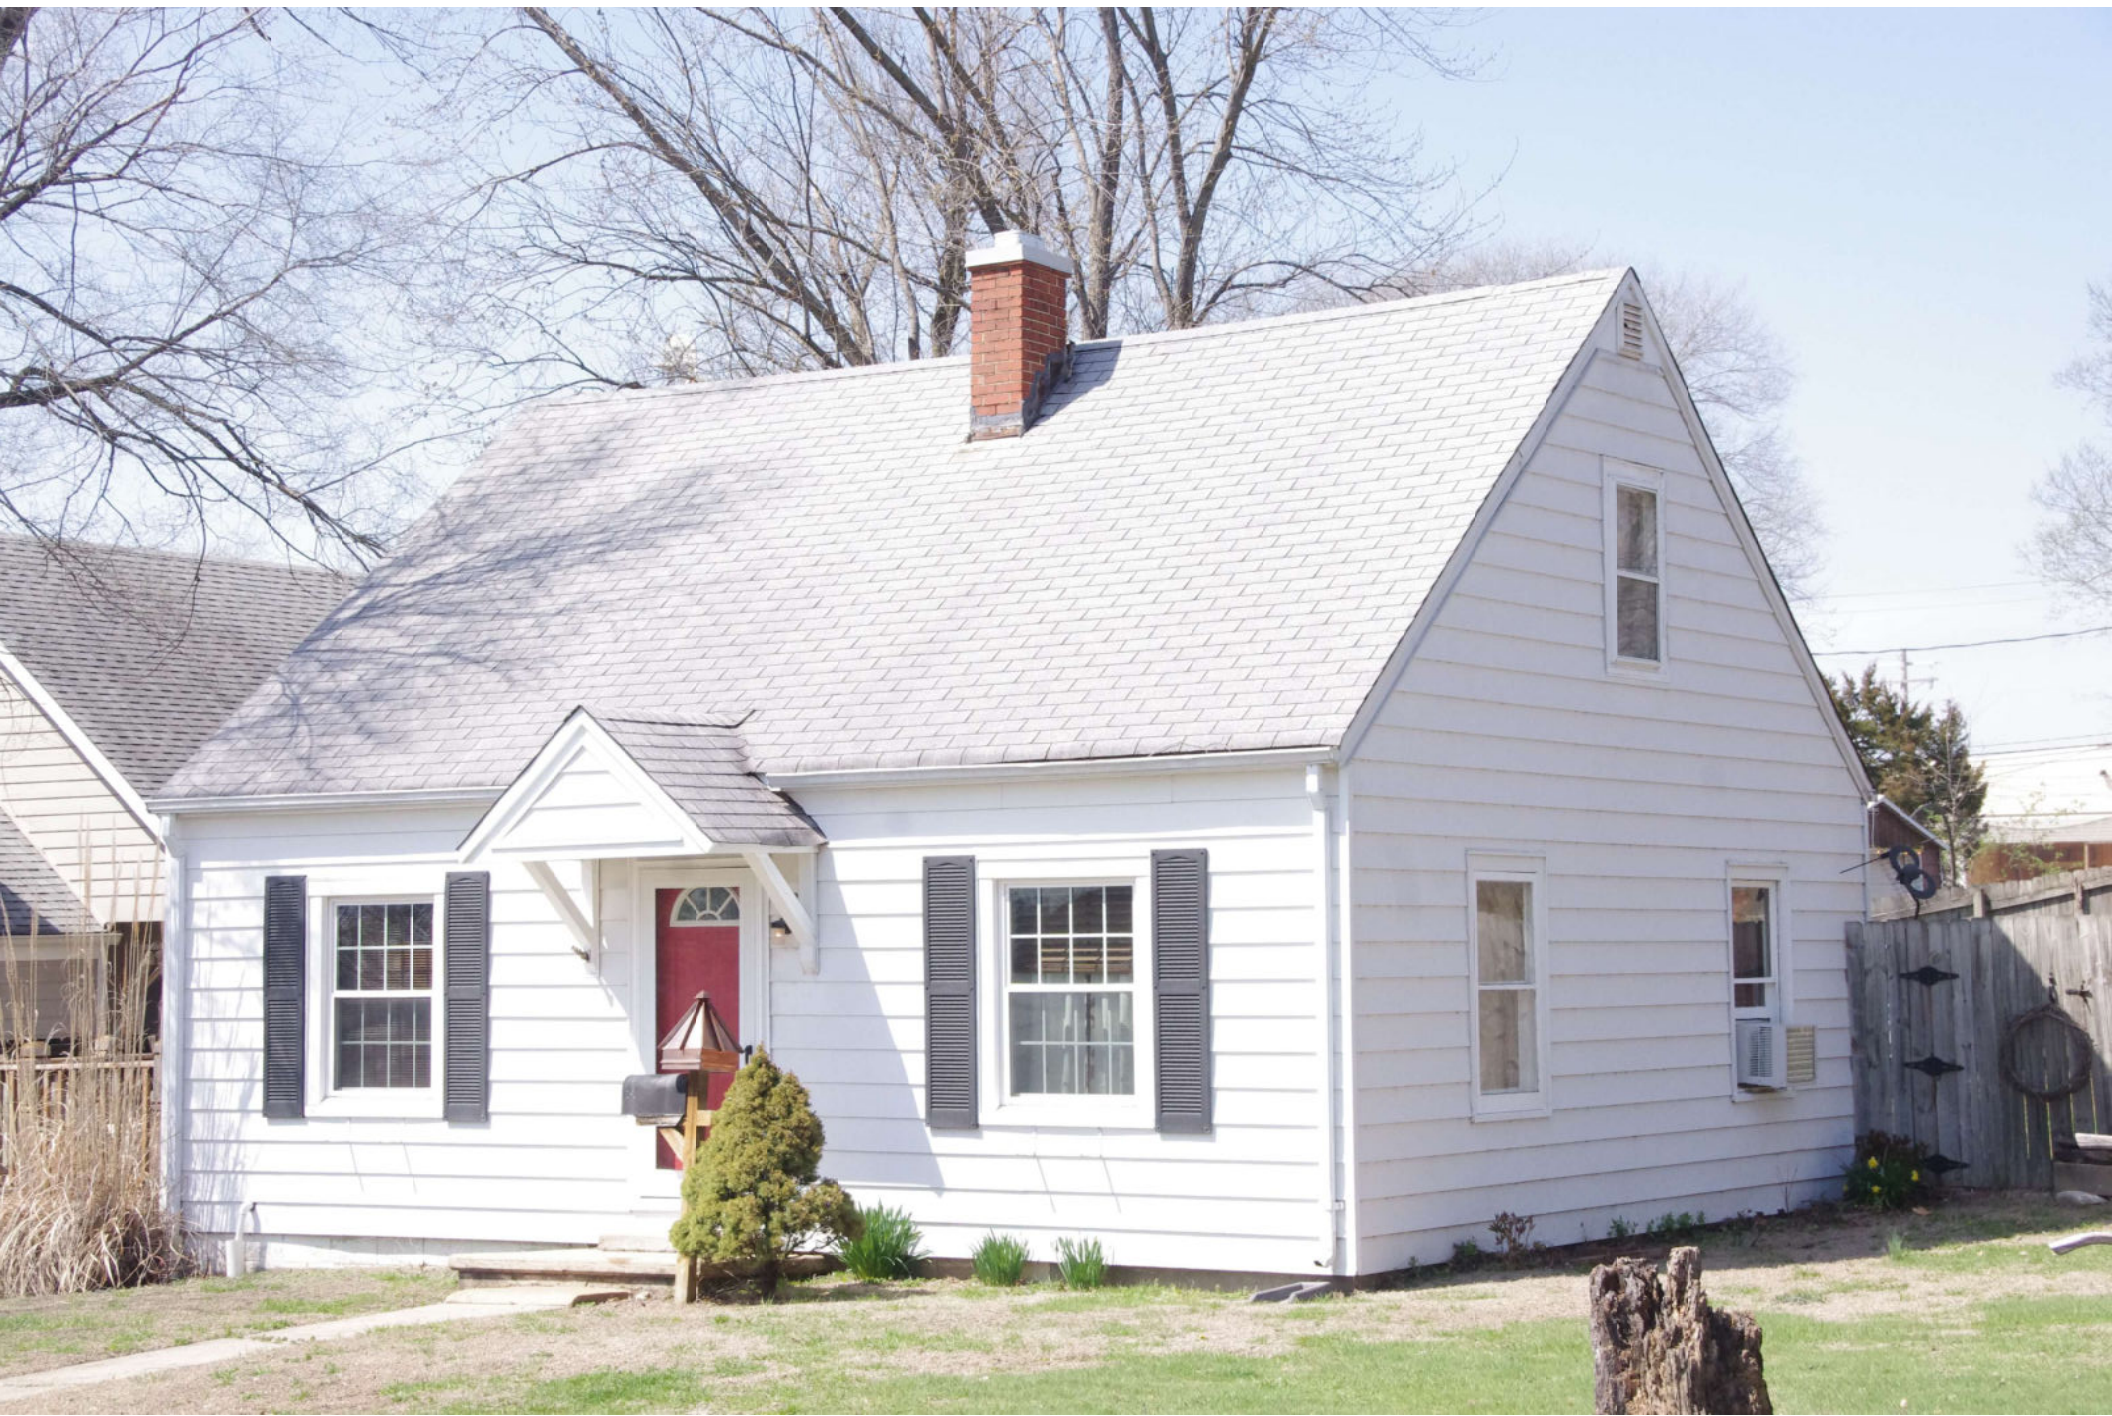
This Cape Cod is a 1.5 story side gabled house with vinyl siding. The central fanlight/wood paneled wood door is located below a gable supported by knee braces. There is a simple concrete pad just above grade in front of the door. The outer bays are filled by eight-over-eight vinyl sash windows. Windows on the side elevations are six-over-six replacement sashes with vinyl faux shutters. There is another gable over the side entry on the west elevation that is now supported by simple wood posts within the wood deck added to that side. There is a central brick chimney at the ridge.
