**ARCHITECTURAL/HISTORIC INVENTORY FORM**

1. Survey No. SC-AS-012-0001		2. Survey Name: Reconnaissance Level Survey of Historic Downtown Wentzville	
3. County: St. Charles		4. Address (Street No.) 102	Street (name) East Third Street
5. City: Wentzville	Vicinity: <input type="checkbox"/>	6. UTM:	
8. Historic name (if known):		9. Present/other name (if known):	
10. Ownership: <input type="checkbox"/> Private <input type="checkbox"/> Public		11a. Historic use (if known): DOMESTIC/single dwelling	11b. Current use: DOMESTIC/single dwelling
5. City: Wentzville		7. Township/Range/Section:

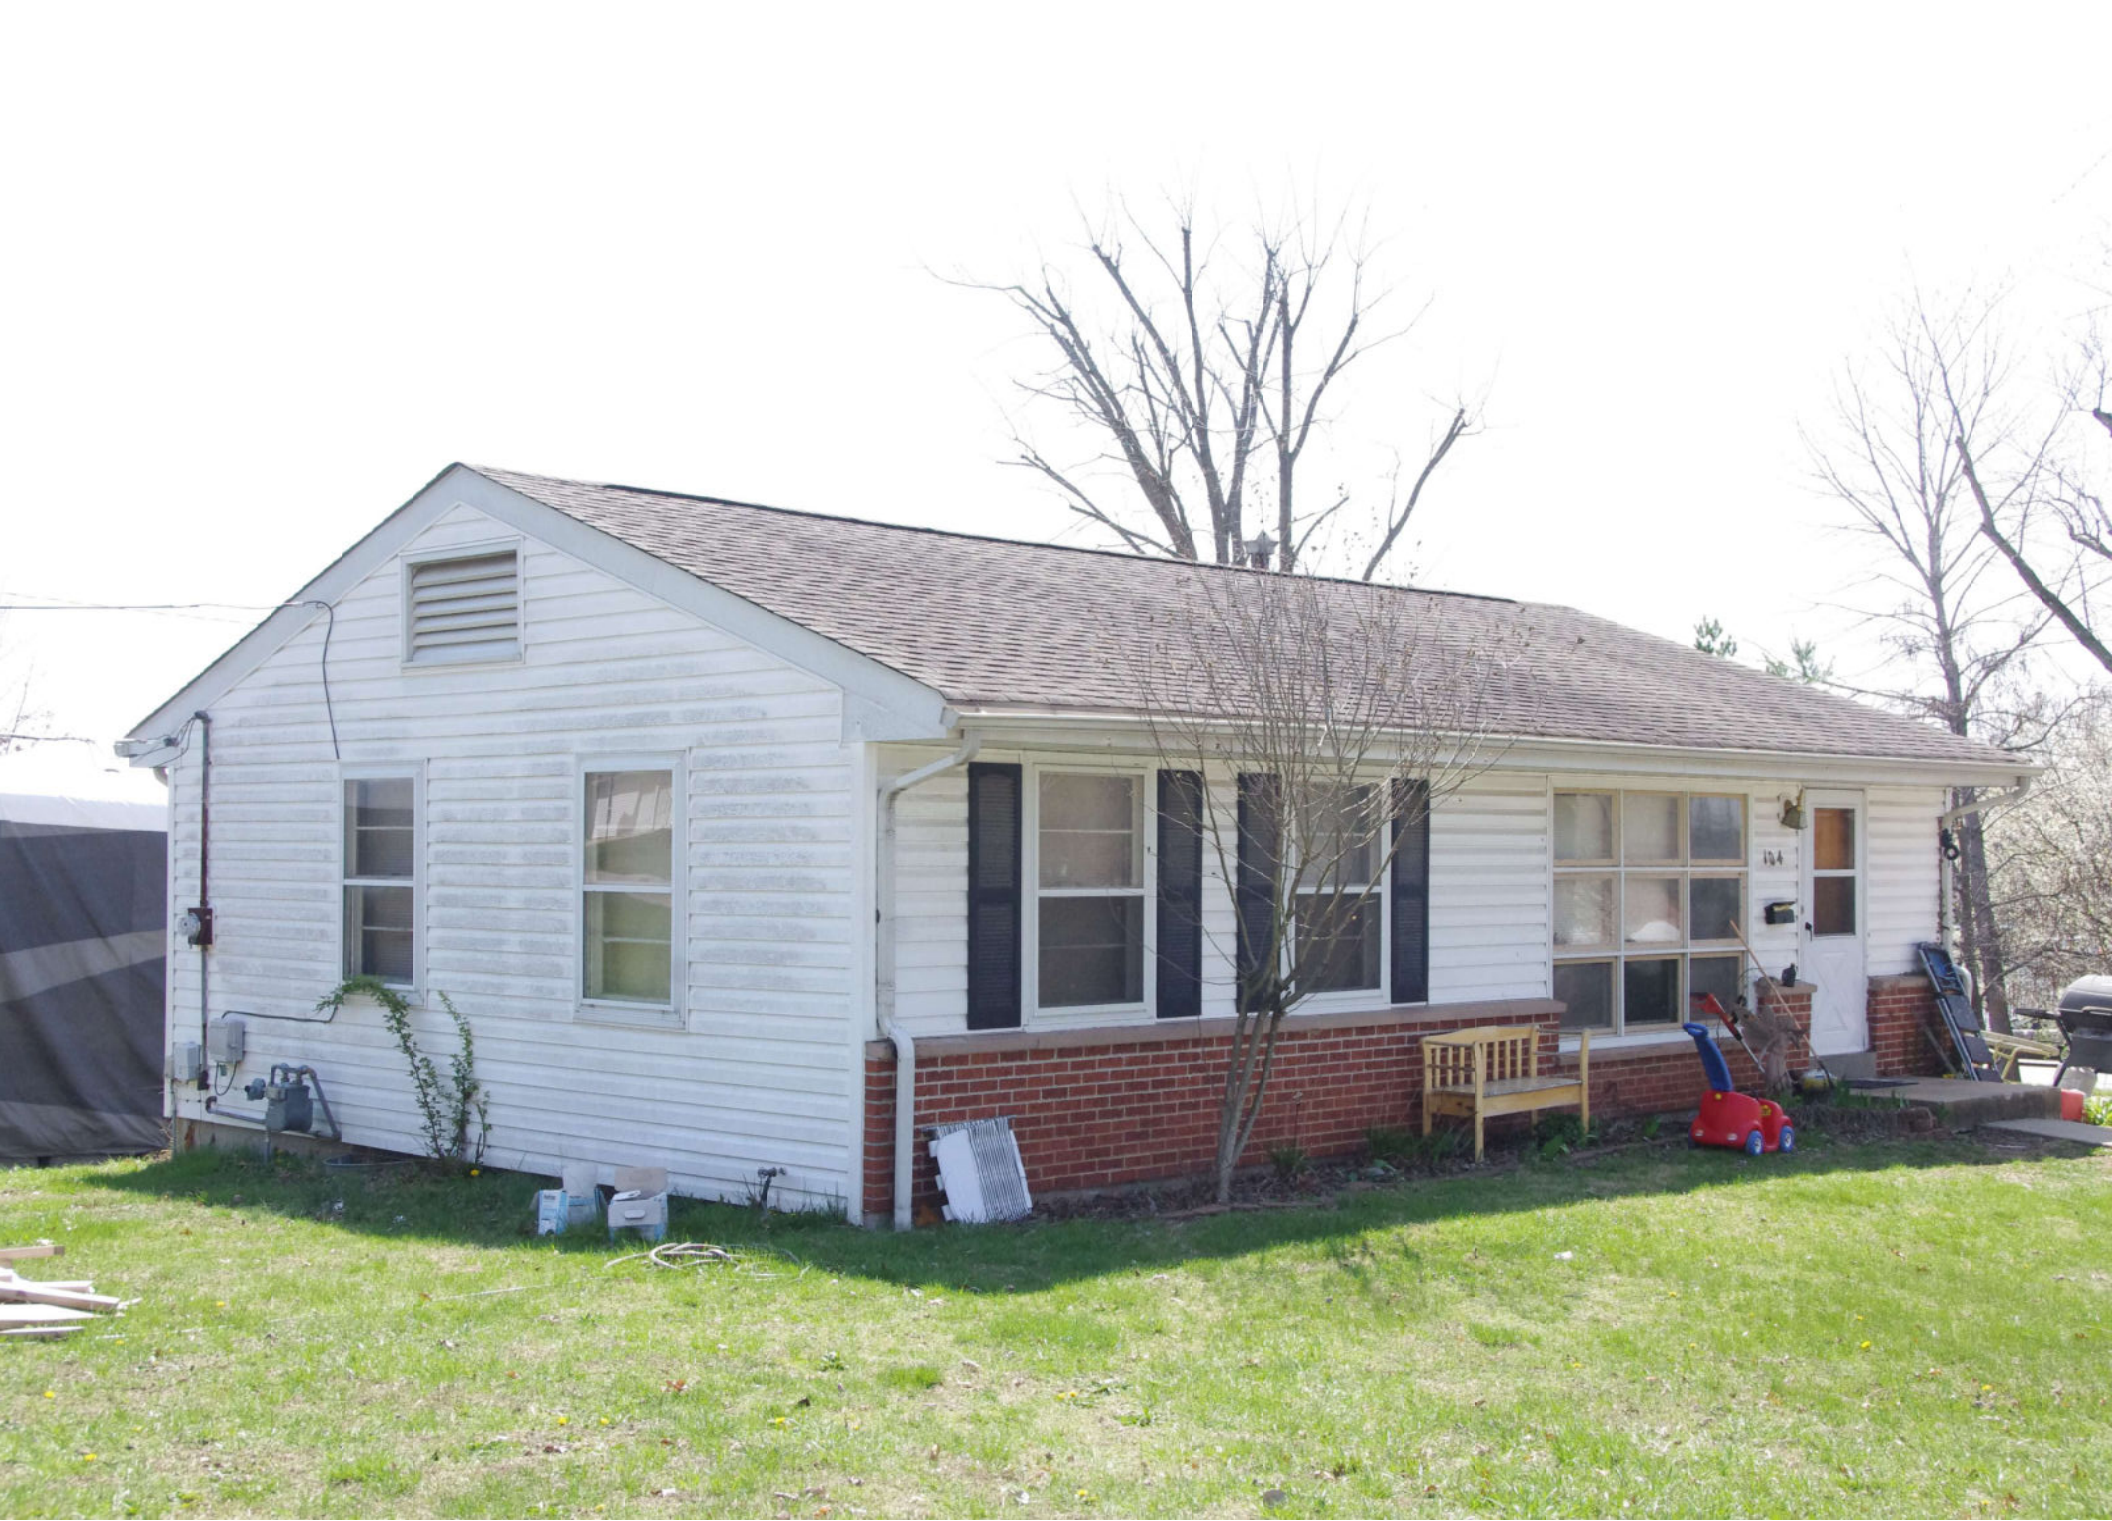
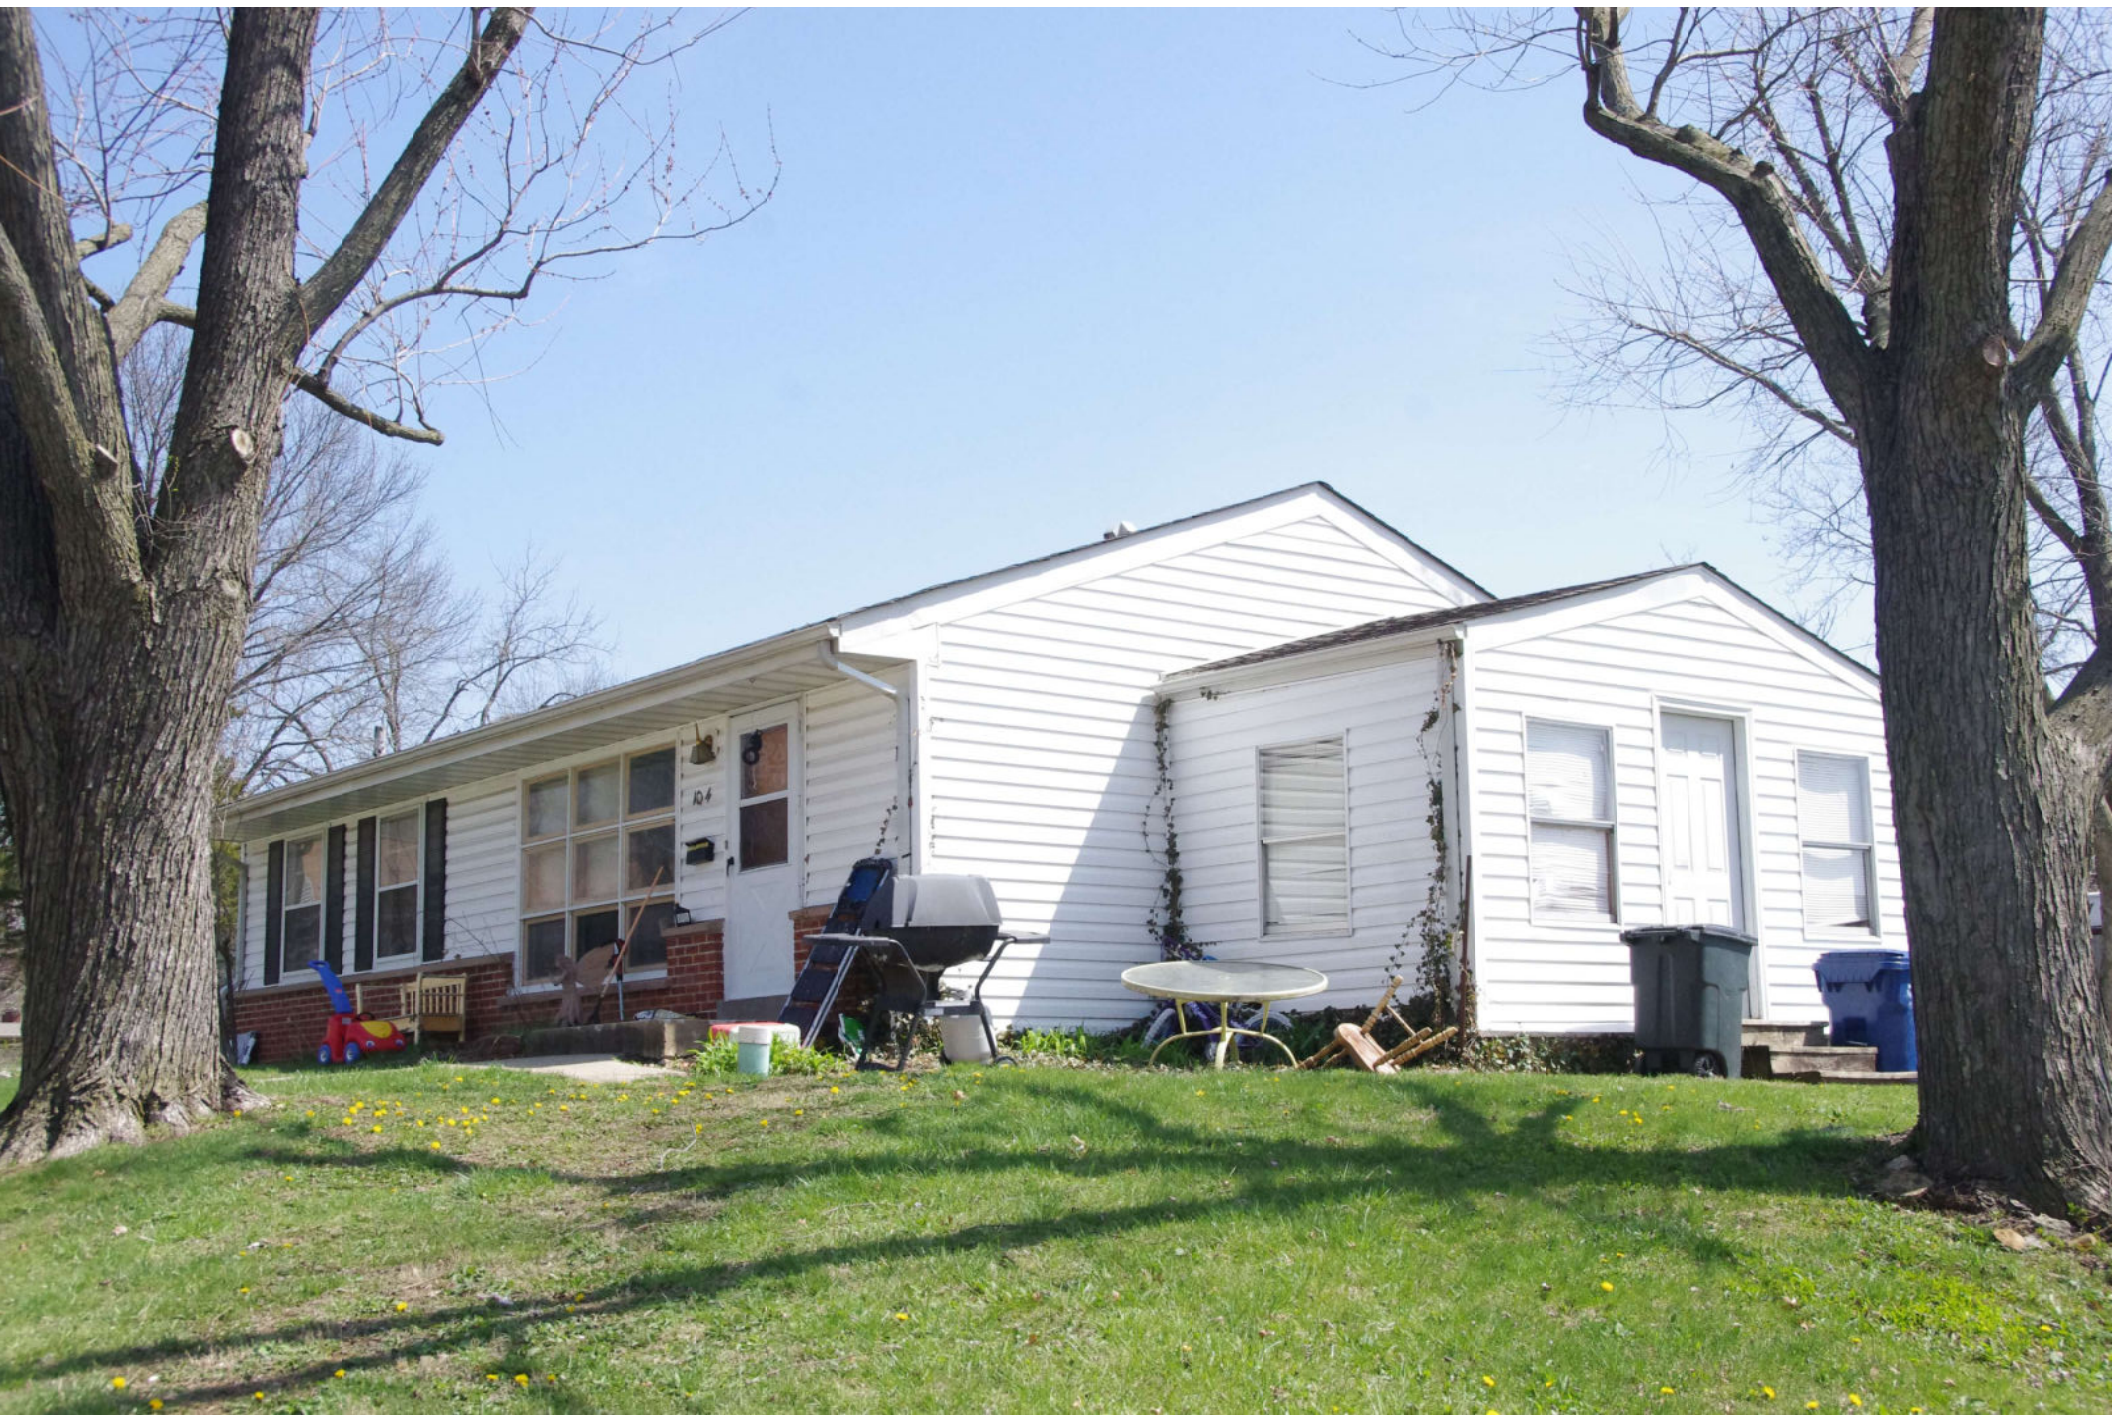
This modest Ranch style house is one-story, side gabled, with wide eaves and has replacement vinyl siding but retains the original brick knee wall across the facade. The wood door with aluminum storm door is located in the western bay of the three bay facade. A nine light historic picture window fills the center bay and two 2/2 horizontal light sash windows are found in the eastern bay of the façade. A side addition, which appears to be the enclosure of a porch, extends one bay to the west, and its 1/1 vinyl sashed window is visible from the street. On the west gable end is a six panel door flanked by additional 1/1 vinyl sashed windows.

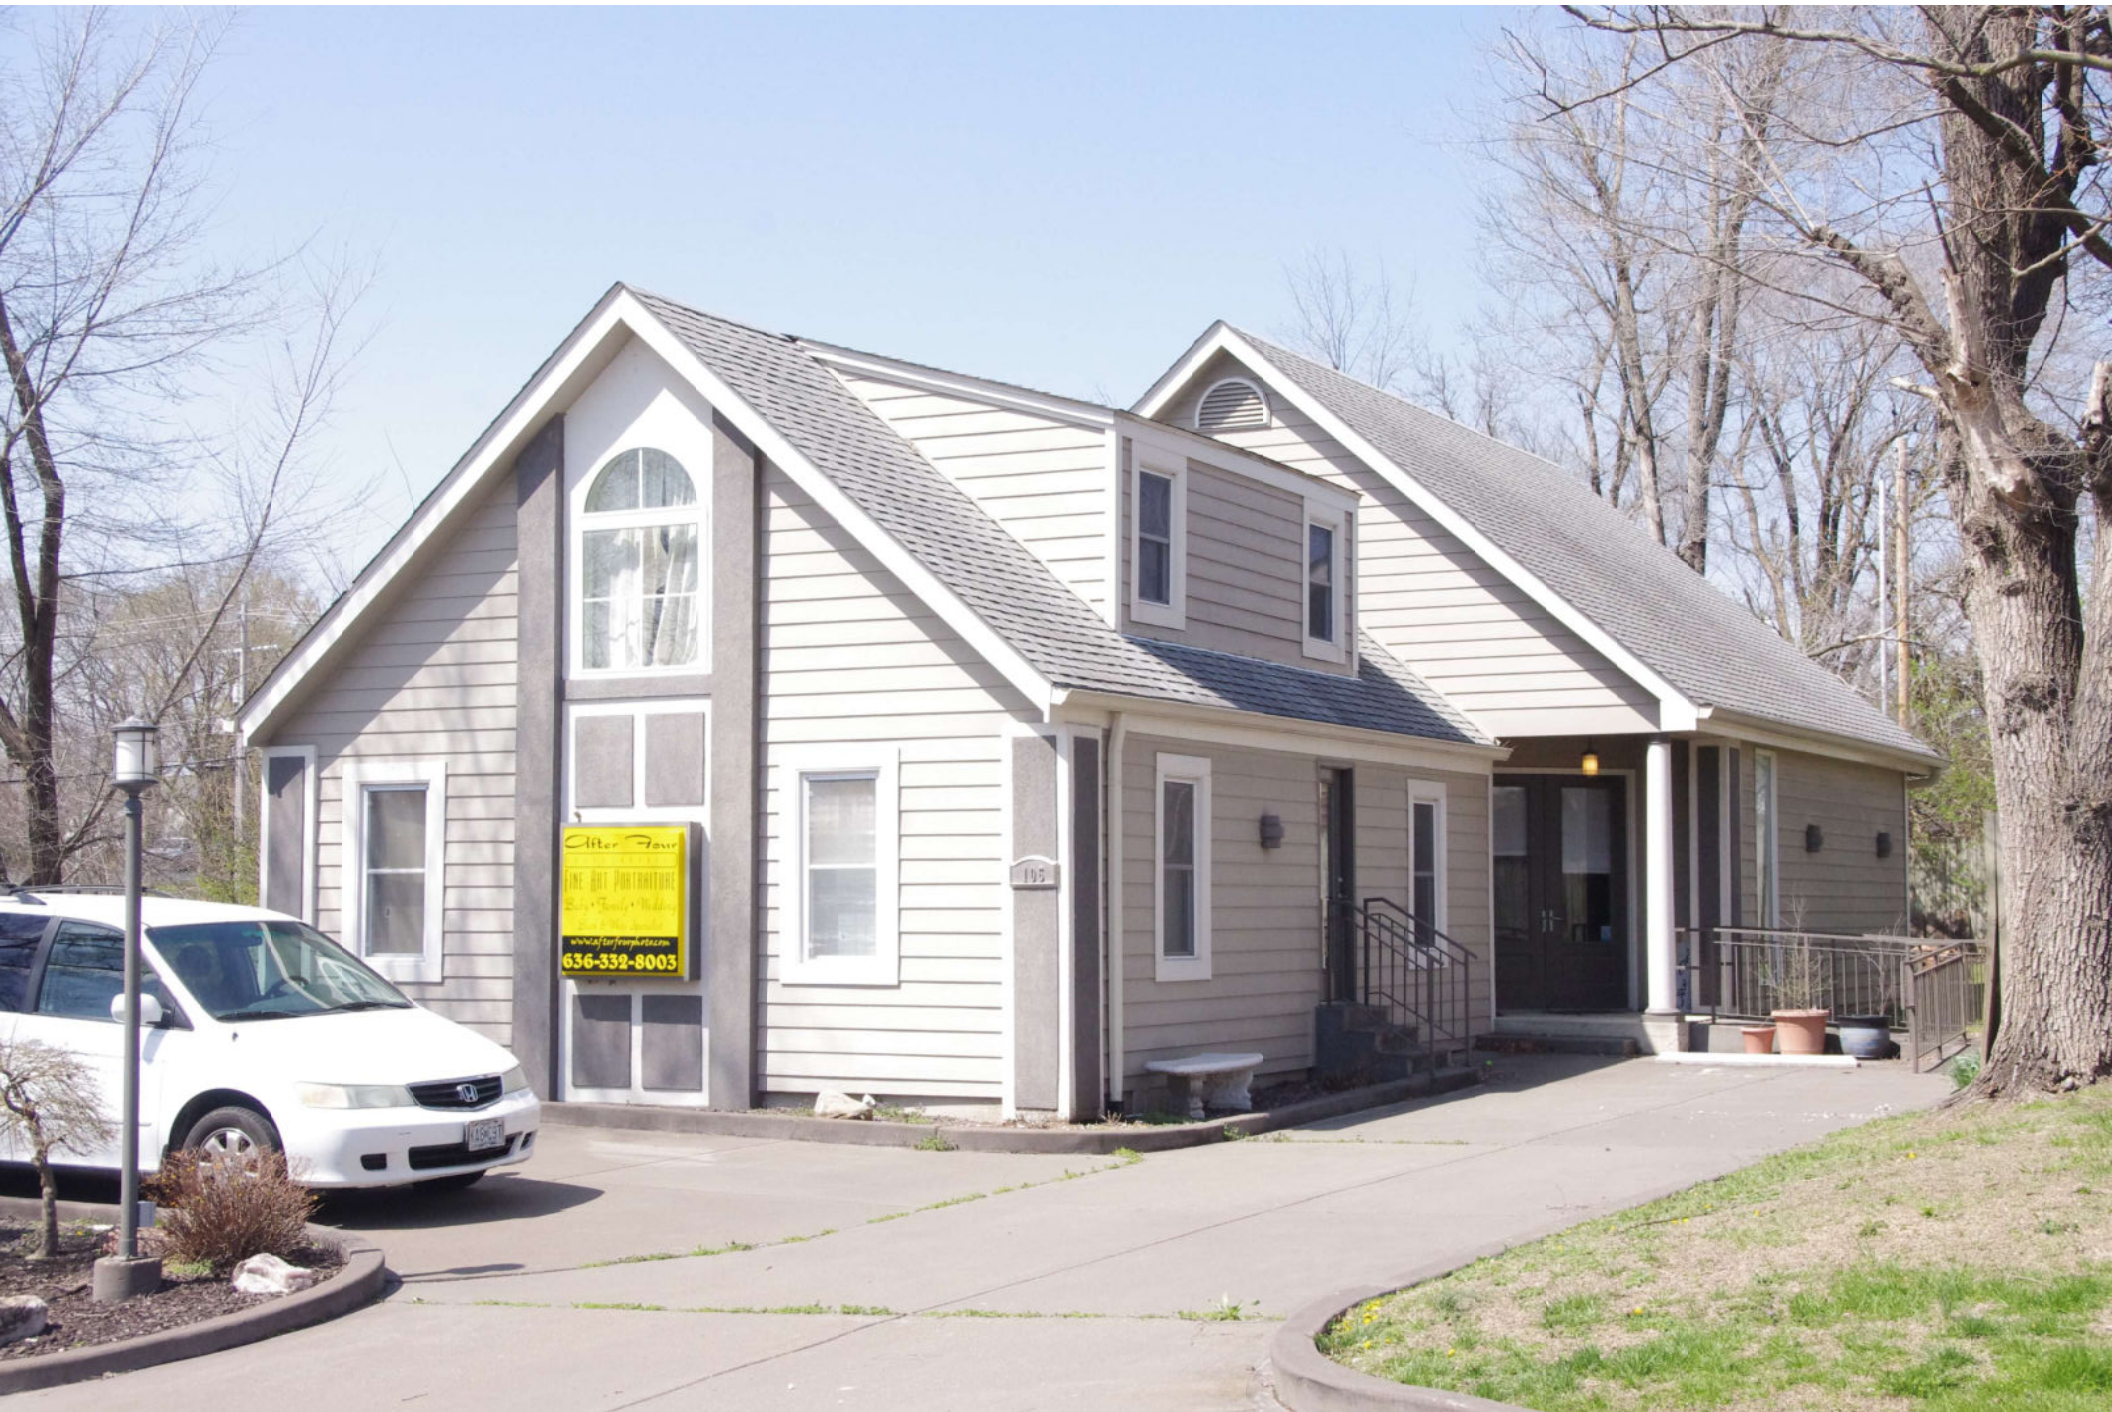
This was originally a Cape Cod, 1.5 story gabled house with vinyl siding and replacement windows that faces east. The full light door is a replacement probably added as this is now used as a commercial business, but it still has the simple concrete steps with iron railings. On either side is a sashed window and there is a shed roofed dormer with two sashed windows. The rear, facing west, has two gabled dormers with sashed windows. The south gable end, side elevation faces the street and has been modified with a stucco projection with a palladian-like window in the gable between flat pilaster strips that divide the wall into three bays. Below the window are flat panels and a sign for the business. The outer bays include one-over-one sash windows. Behind the original house is a 1.5 story gabled addition with a simple column supporting the corner of the gabled roof over the recessed corner porch where there are paired 3/4 light wood doors.

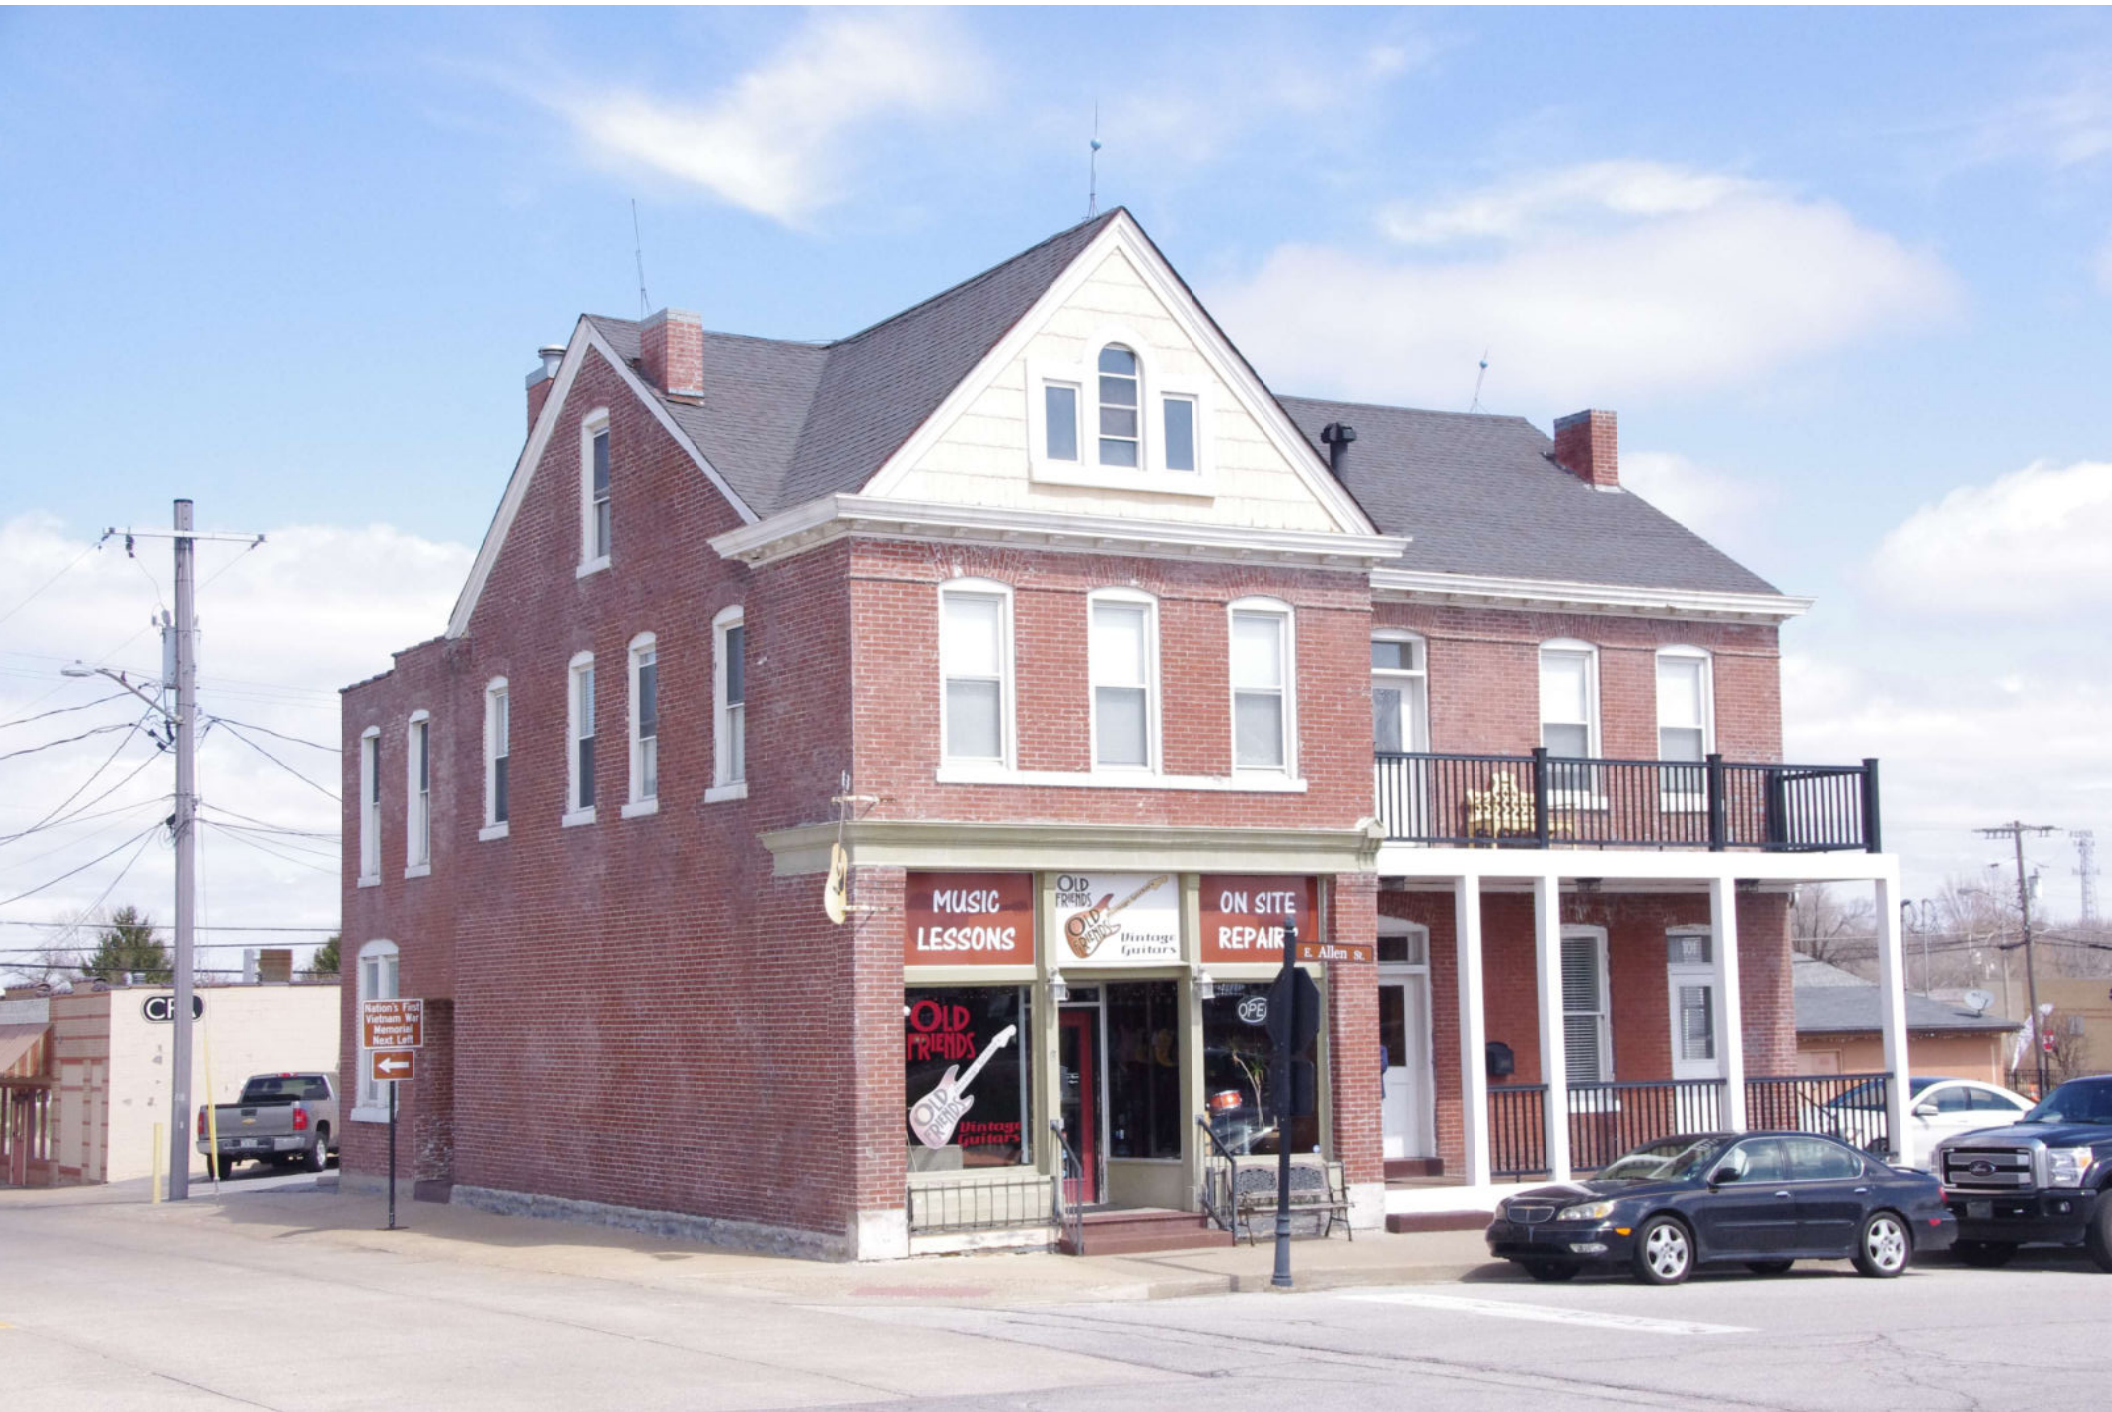
This resource is a two-and-a-half story, brick, gable and wing building with a stone foundation. The projecting gable western bay is comprised of a central recessed entry, wood framed storefront and display windows with cast iron columns. The second level includes three one-over-one sash windows. A Palladian round arch window with rectangular sidelights is located in what appears to be replacement simulated slate gable end. The east half has two half light, two panel wood doors with transoms under the segmental arch lintels on the first floor. The second floor of the east wing includes a similar door, and two one-over-one sash windows. All of the second level openings have segmental arched lintels. The two-story gallery porch originally had turned posts and Victorian cutwork detailing as well as wood railings on both levels, but these have been replaced with simple posts and iron railings. But, the building still retains its distinctive form, central storefront entry and the two-story gallery as well as the fenestration pattern.

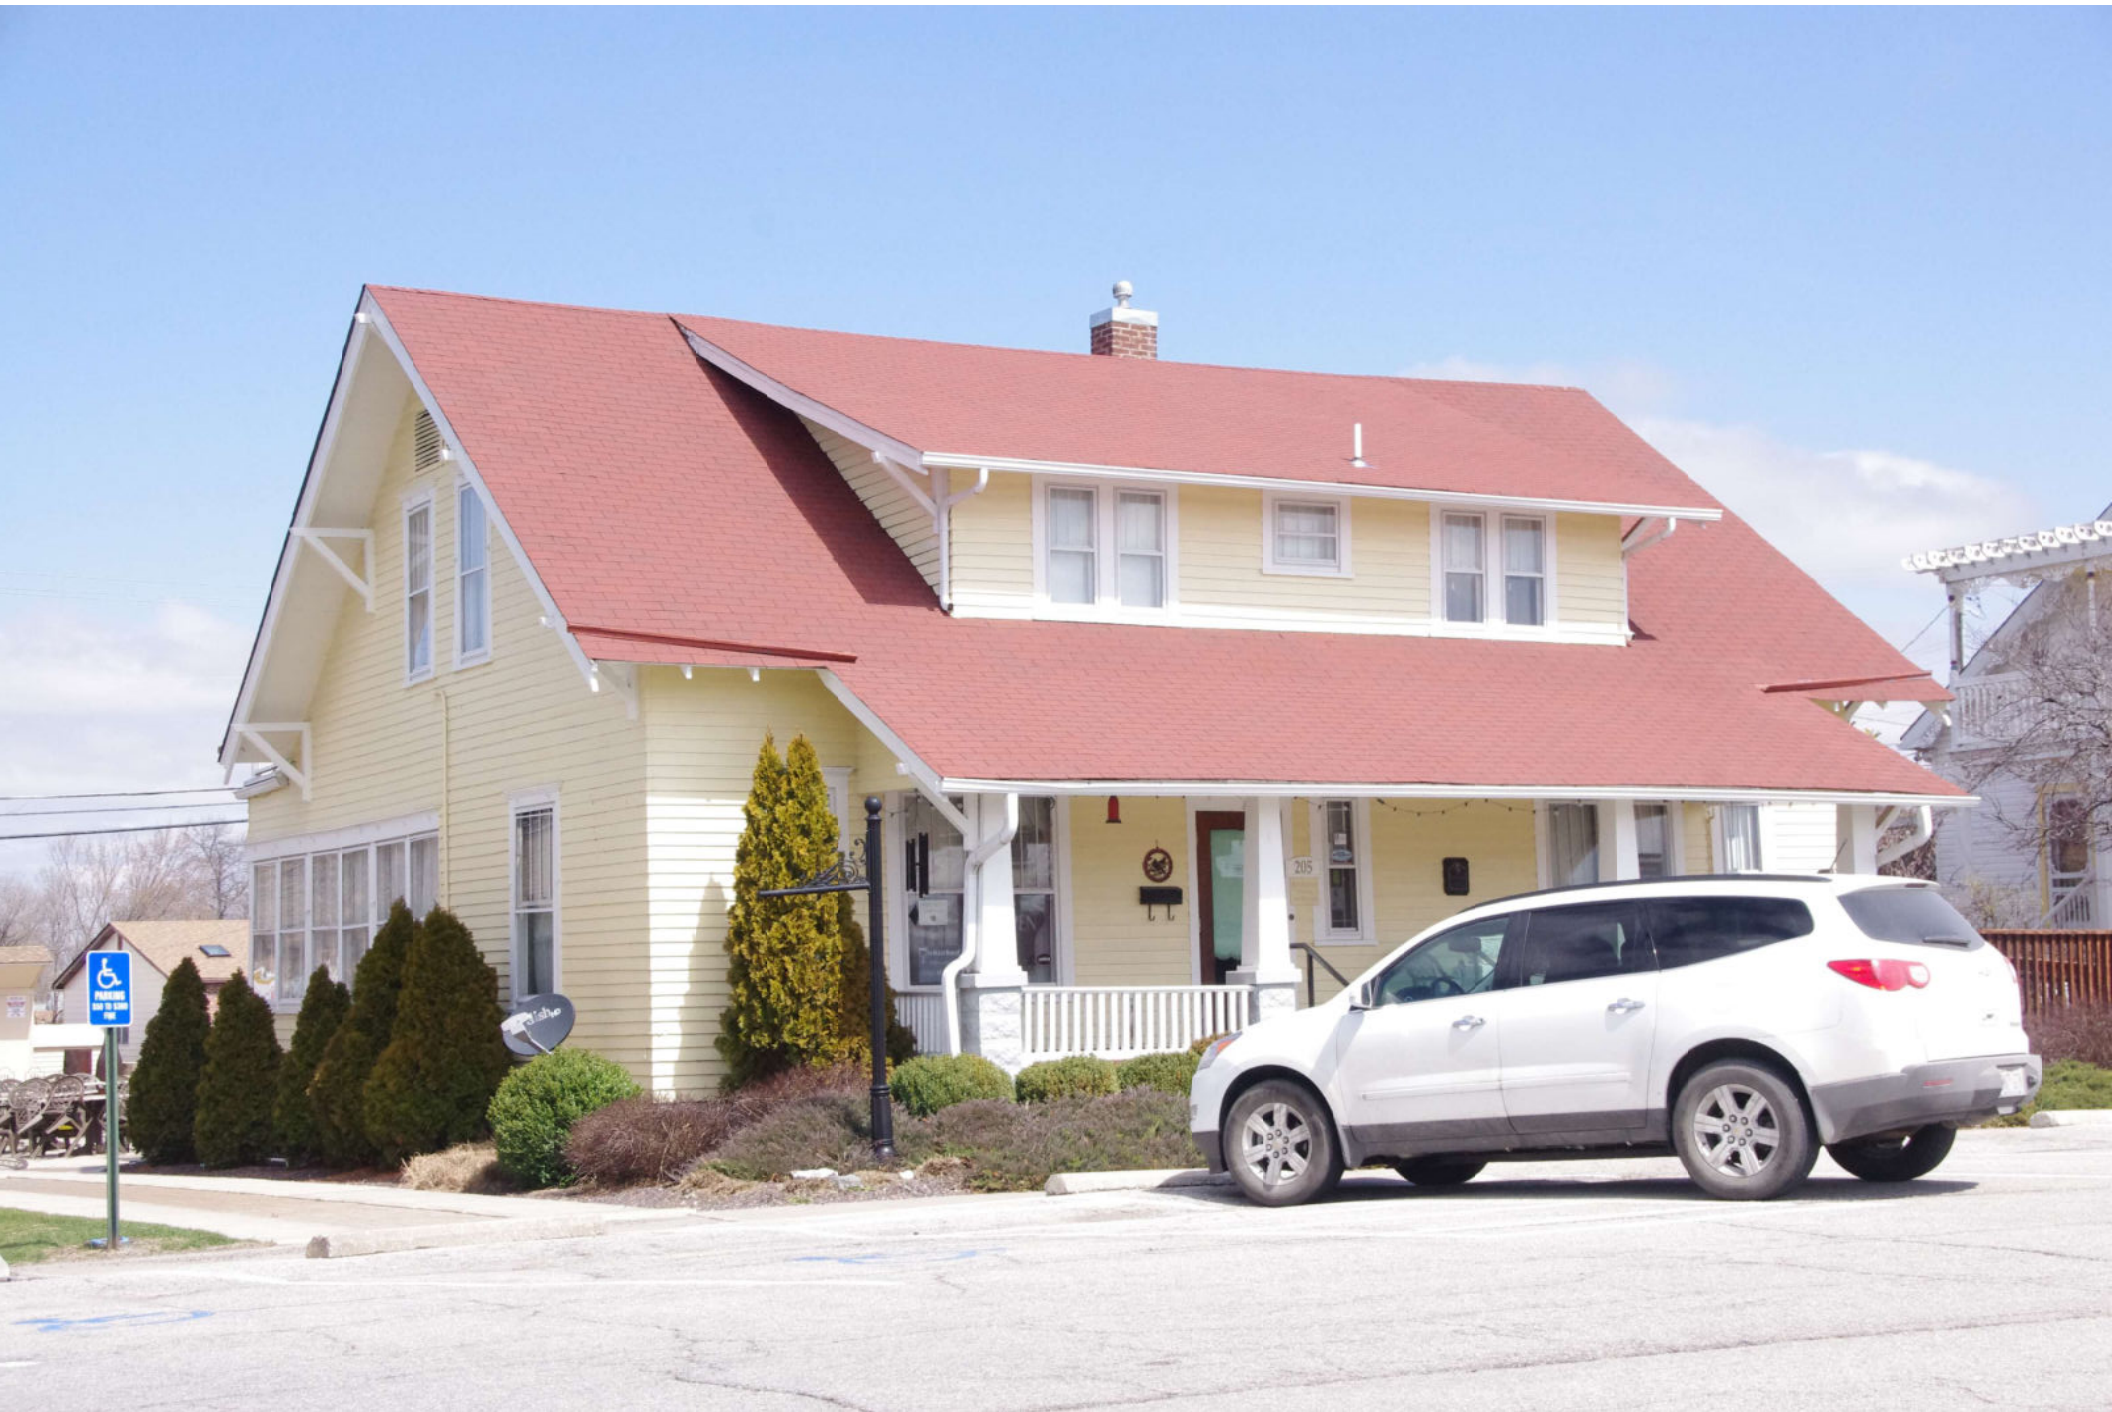
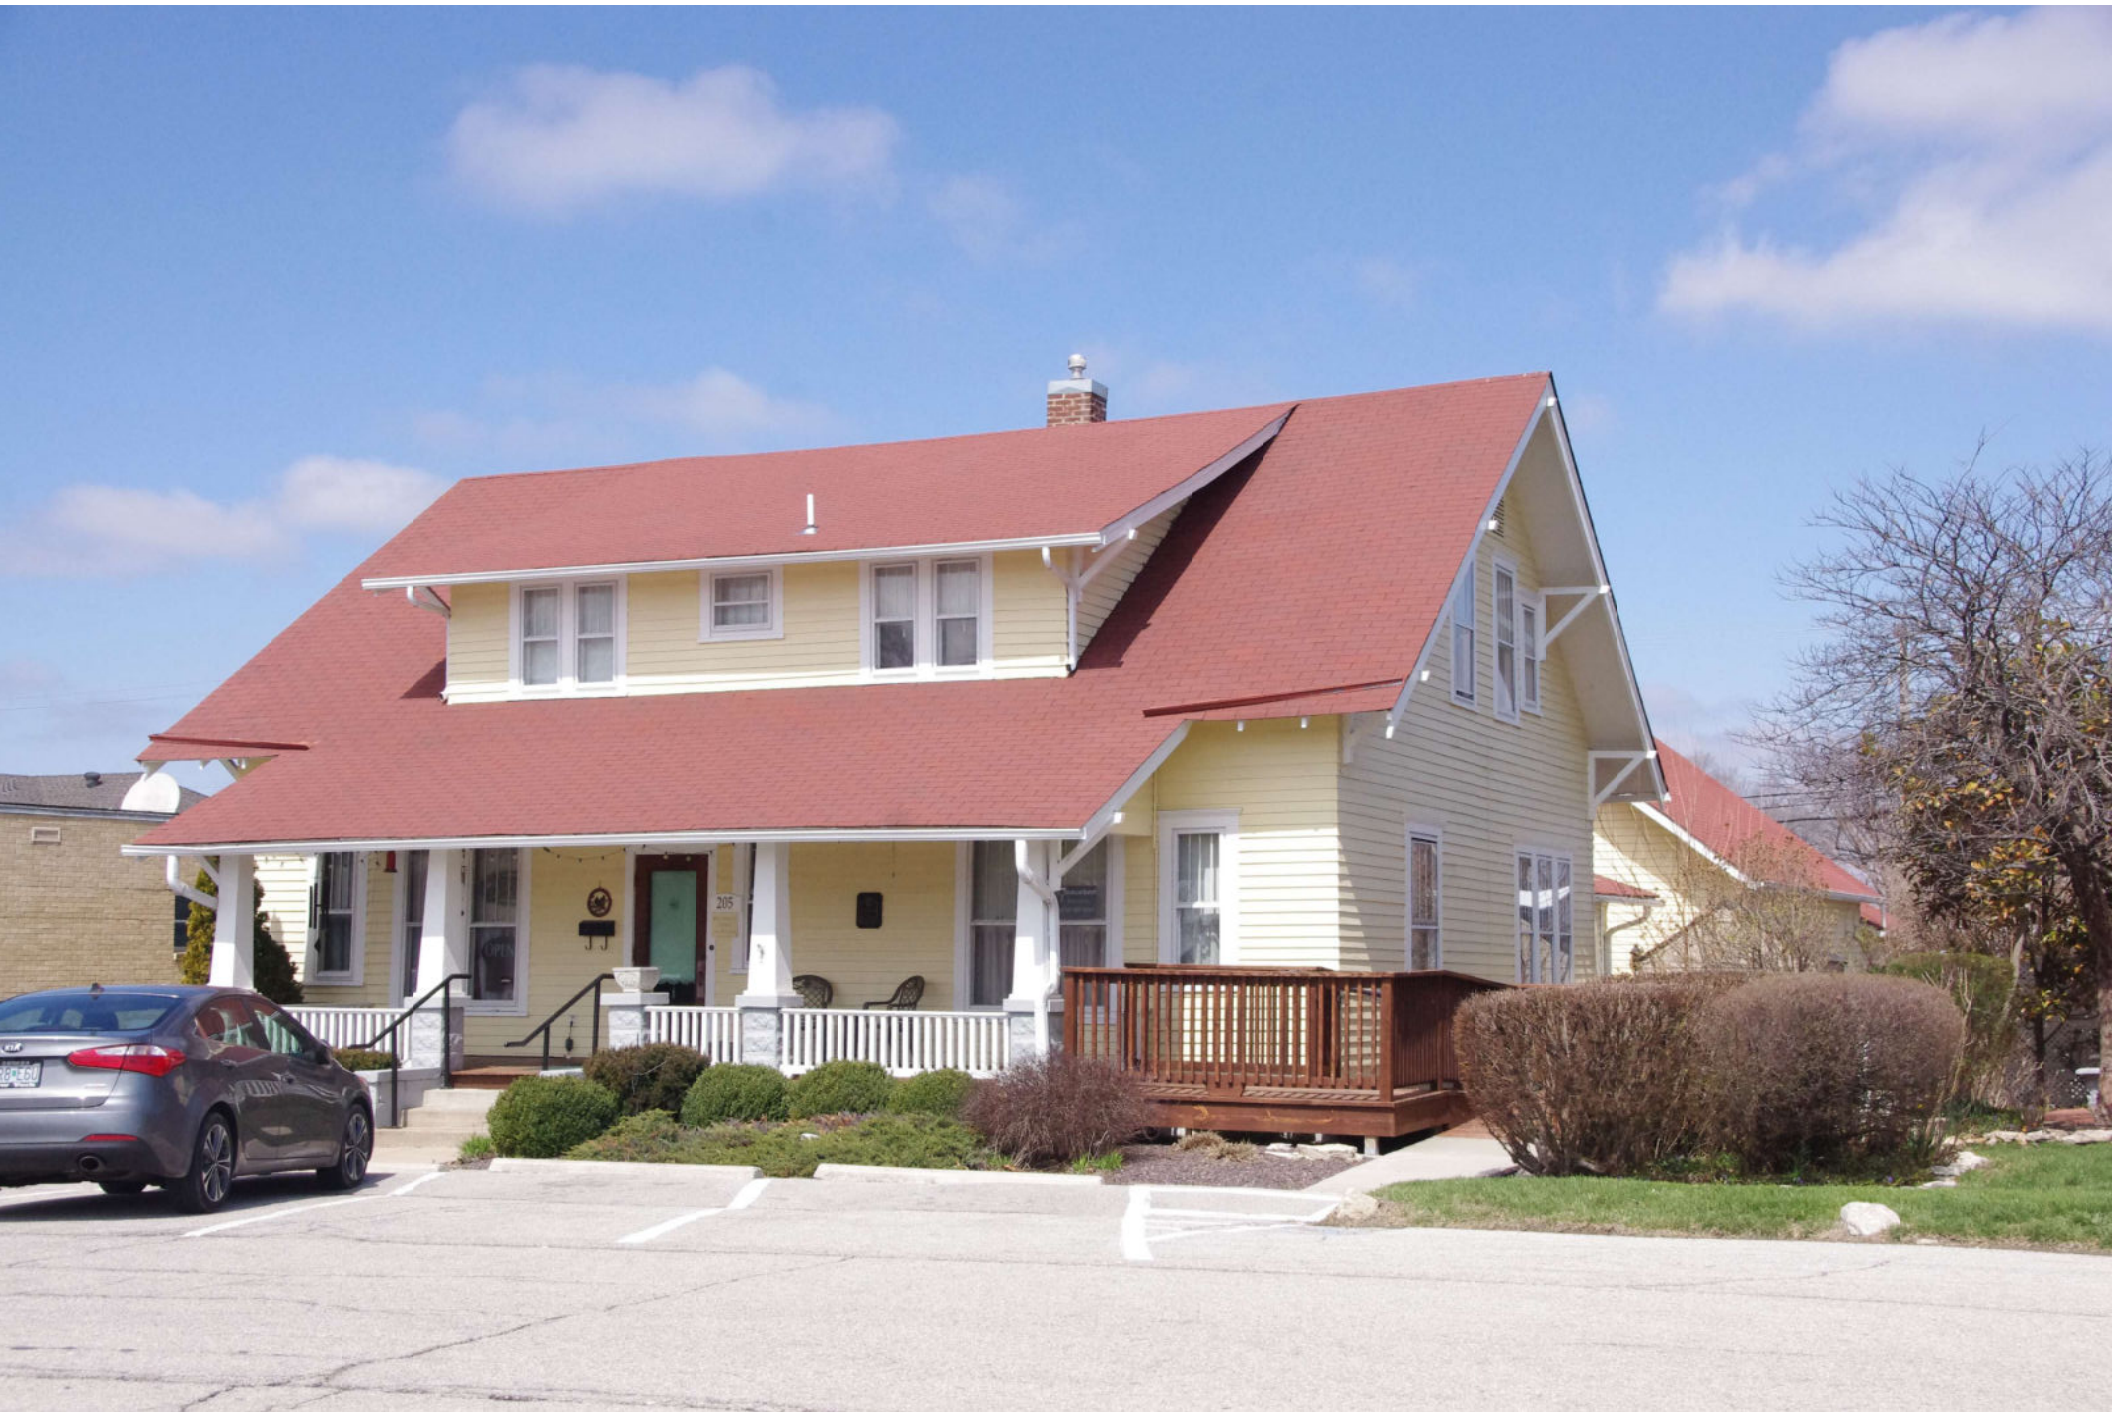
This resource is a one-and-a-half story Craftsman bungalow with a stone foundation and a side gabled roof. The house retains its original wood lap siding and wide eaves. The roof overhang is supported by knee braces and the vergeboards have birds-eye rafter tails. The wood and glass door is located just west of center, with a one-over-one fixed window to the east. Paired four-over-one wood windows flank the entrance below the shed roof of the open porch, which is supported by four tapered square columns resting on raised faux stone piers connected by simple wood railings. One-over-one sash windows are found recessed in the bays on either side of the porch. A broad shed roof dormer centered above has two sets of paired 4/1 sashed windows and a central, fixed, horizontal, 4-vertical light window in the middle.
