**ARCHITECTURAL/HISTORIC INVENTORY FORM**

1. Survey No. SC-AS-012-0001		2. Survey Name: Reconnaissance Level Survey of Historic Downtown Wentzville	
3. County: St. Charles		4. Address (Street No.) 102	Street (name) East Third Street
5. City: Wentzville	Vicinity: <input type="checkbox"/>	6. UTM:	
8. Historic name (if known):		9. Present/other name (if known):	
10. Ownership: <input type="checkbox"/> Private <input type="checkbox"/> Public		11a. Historic use (if known): DOMESTIC/single dwelling	11b. Current use: DOMESTIC/single dwelling
5. City: Wentzville		7. Township/Range/Section:

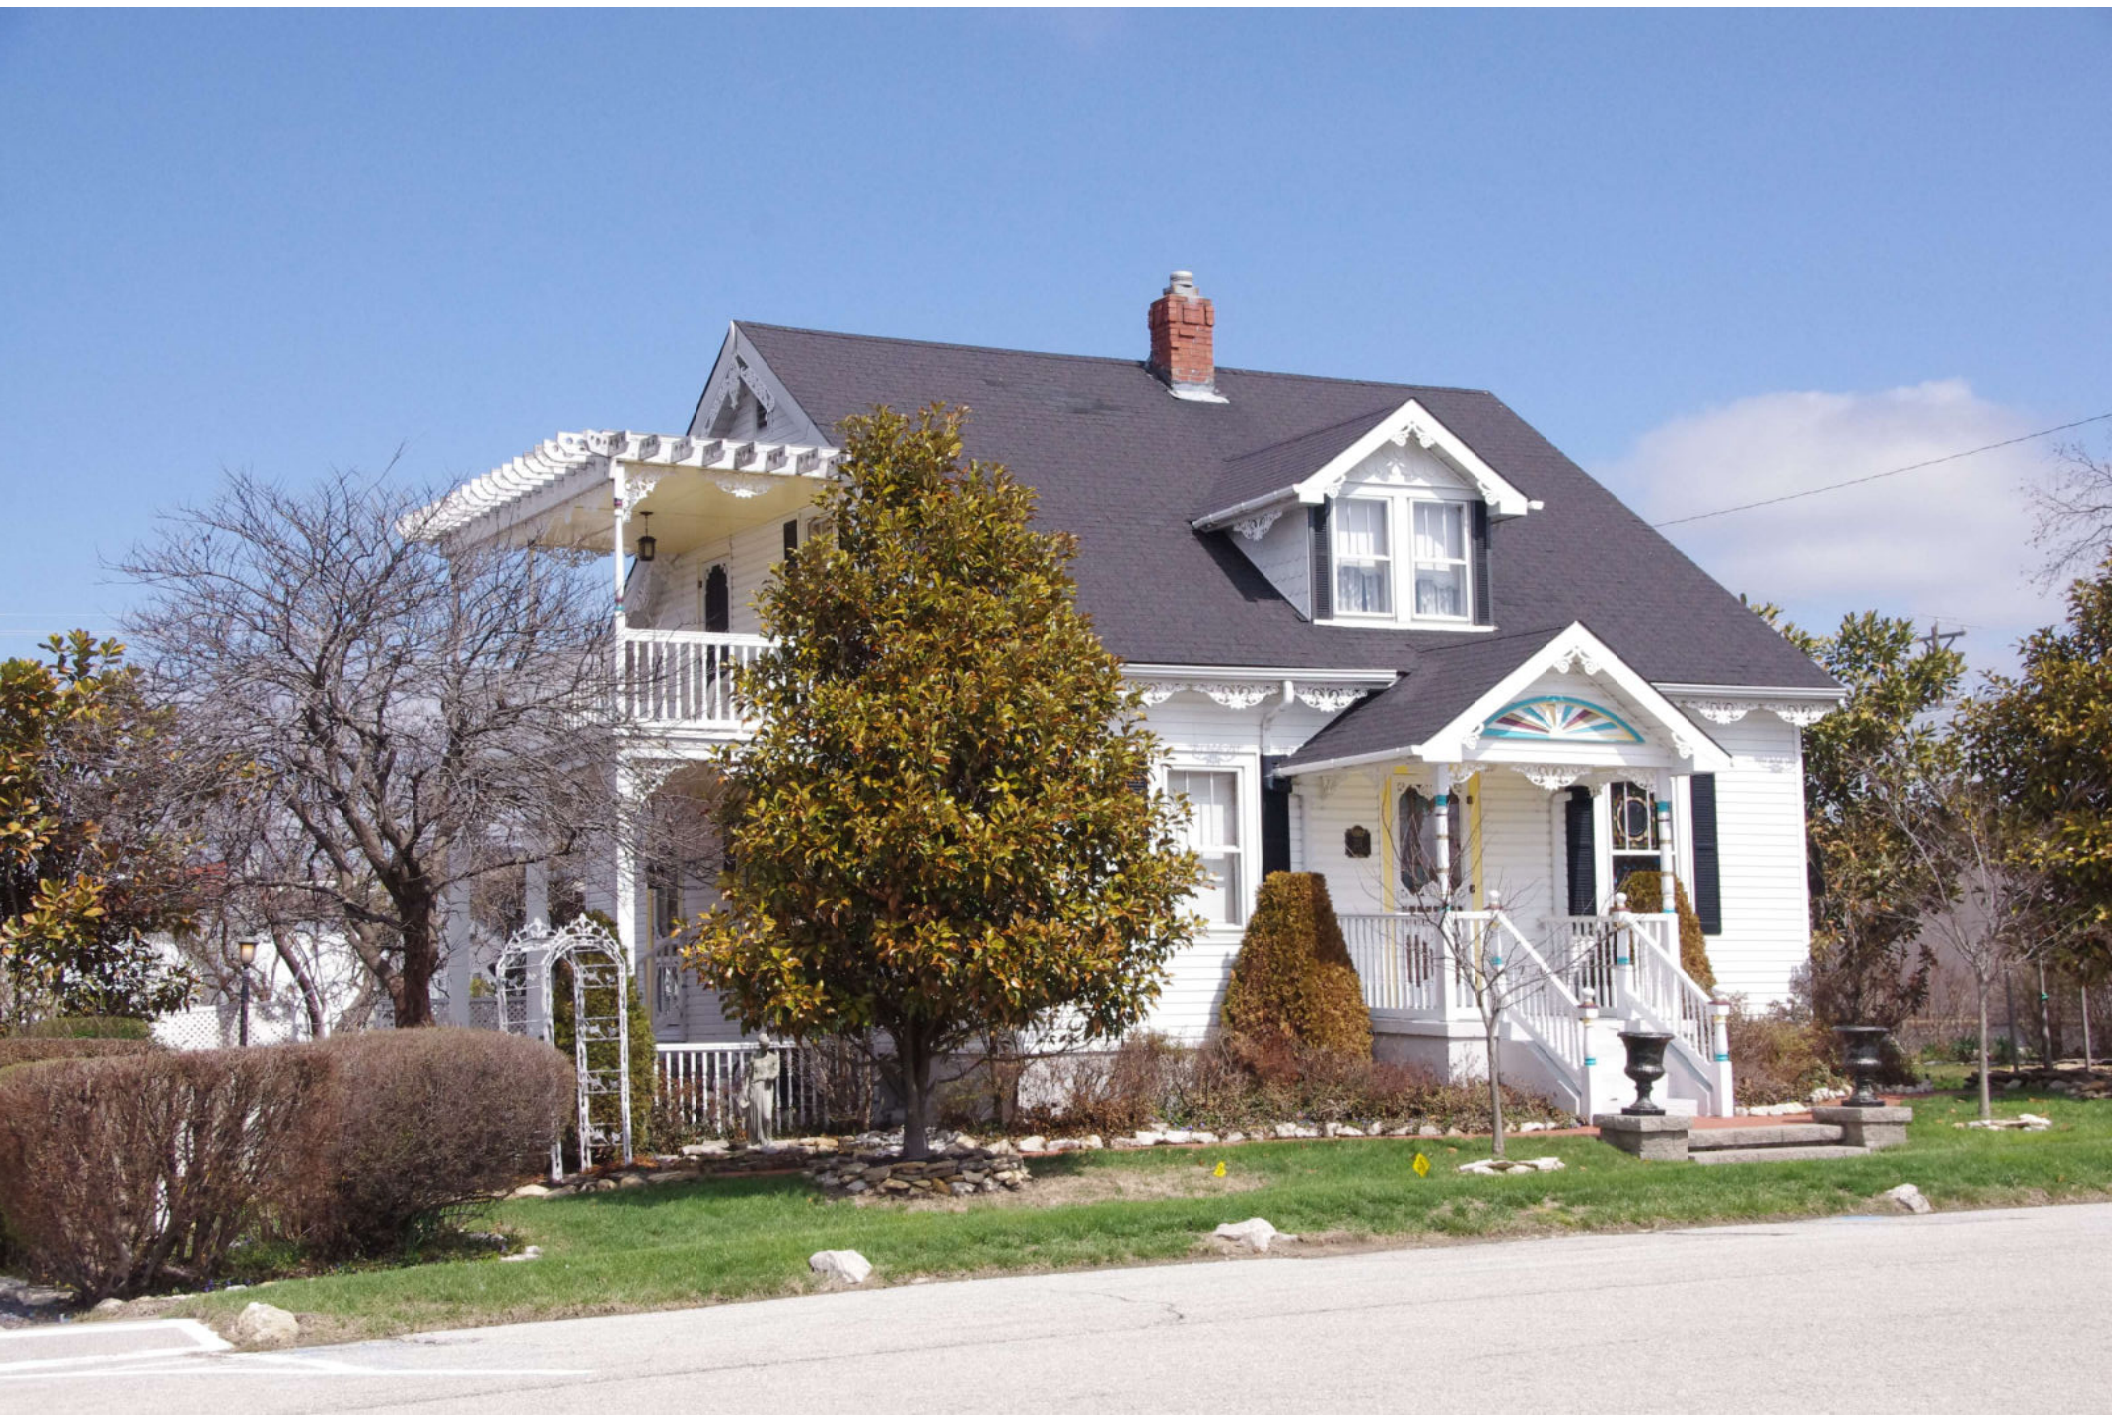
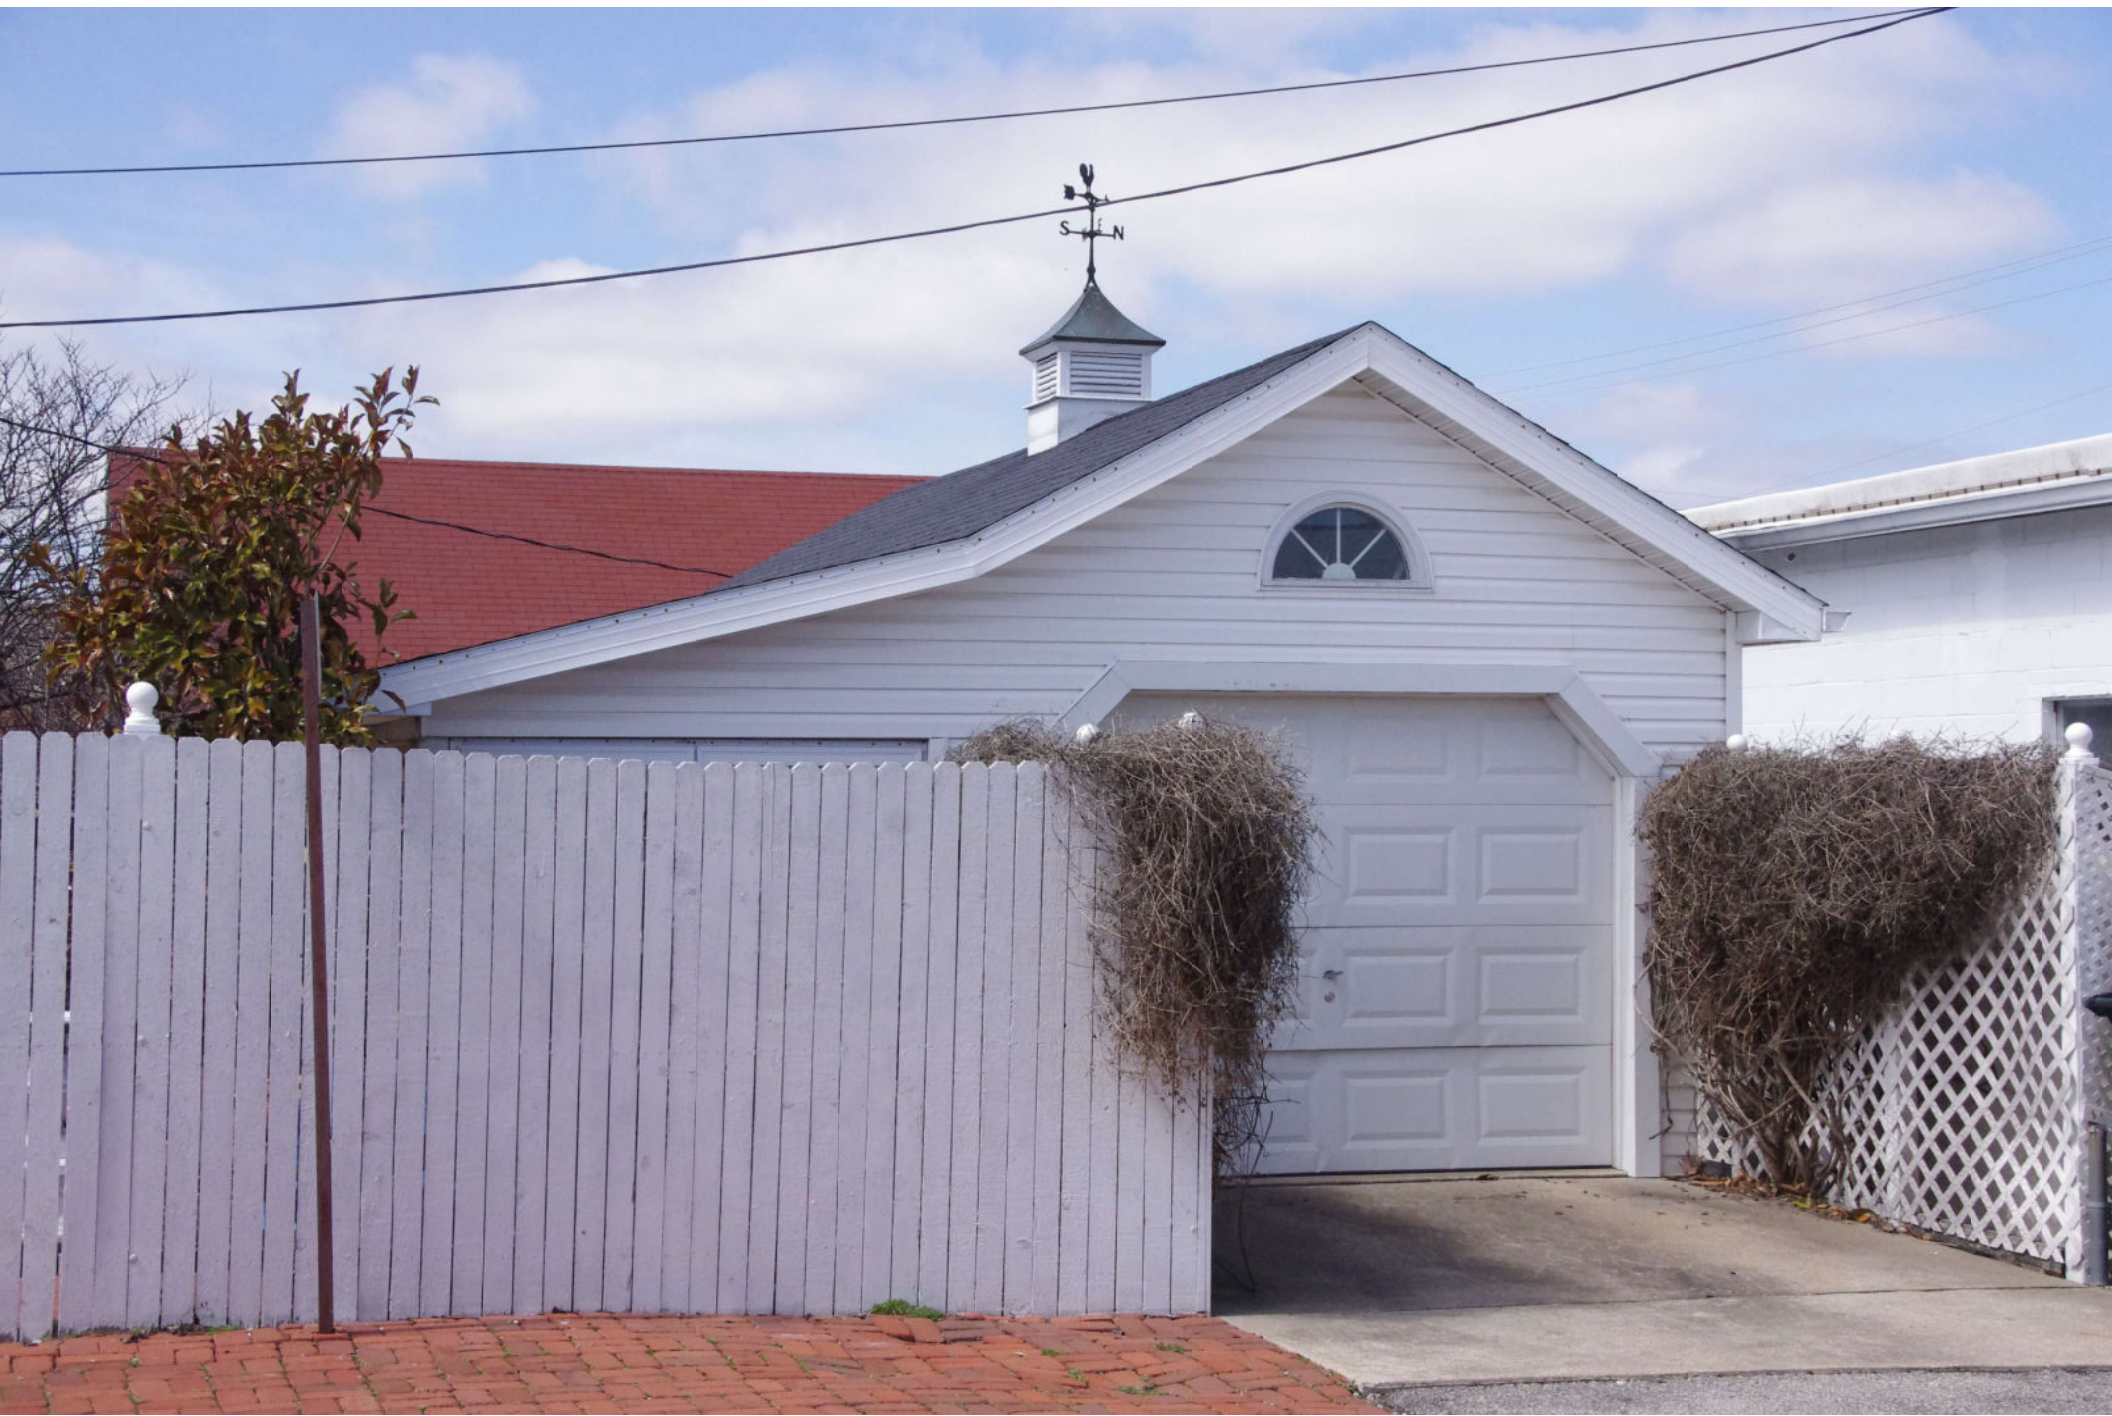
This resource is a one-and-a-half story house with a gabled central open porch. The wood door is accessed beyond the porch. The outer bays are comprised of three-over-one sash windows. Center on the facade is a gabled dormer that includes paired three-over-one wood windows. The building seems to have originally had more Craftsman detailing, as noted by the 3/1 wood windows, but Victorian style "gingerbread" molding has been added to the gable ends and along the roofline along with turned posts. Vinyl shutters and an applied fanlight in the gable end of the rebuilt front porch are also recent alterations. A two-story gallery porch with turned posts and a pergola style roof on the second floor is located on the west side of the building. None of these Victorian details are original to the building.

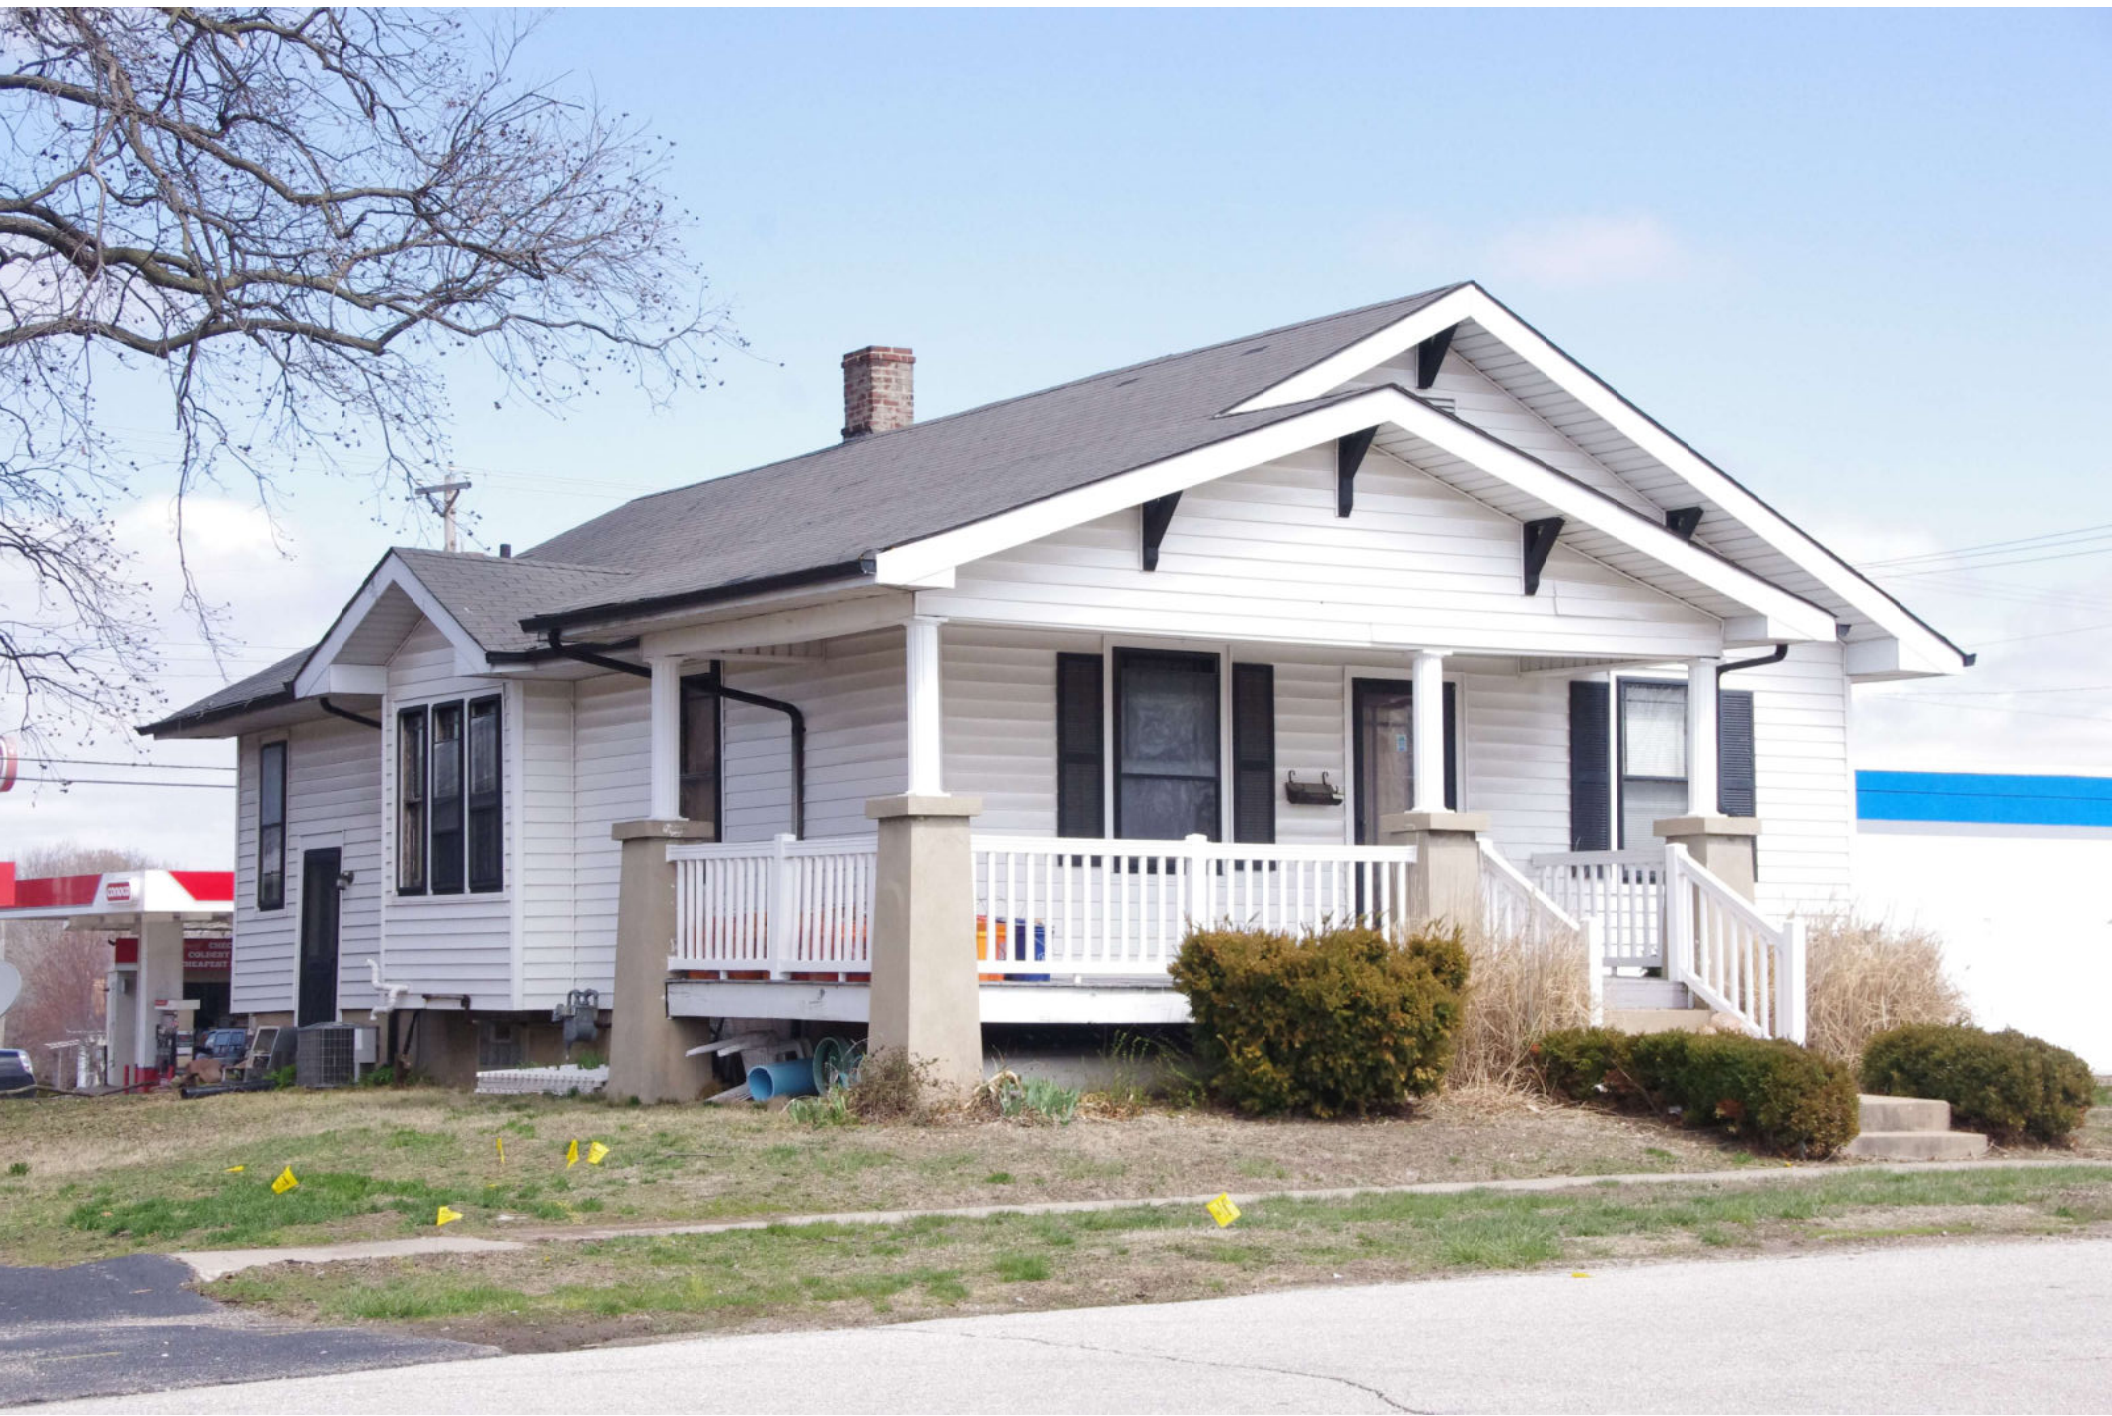
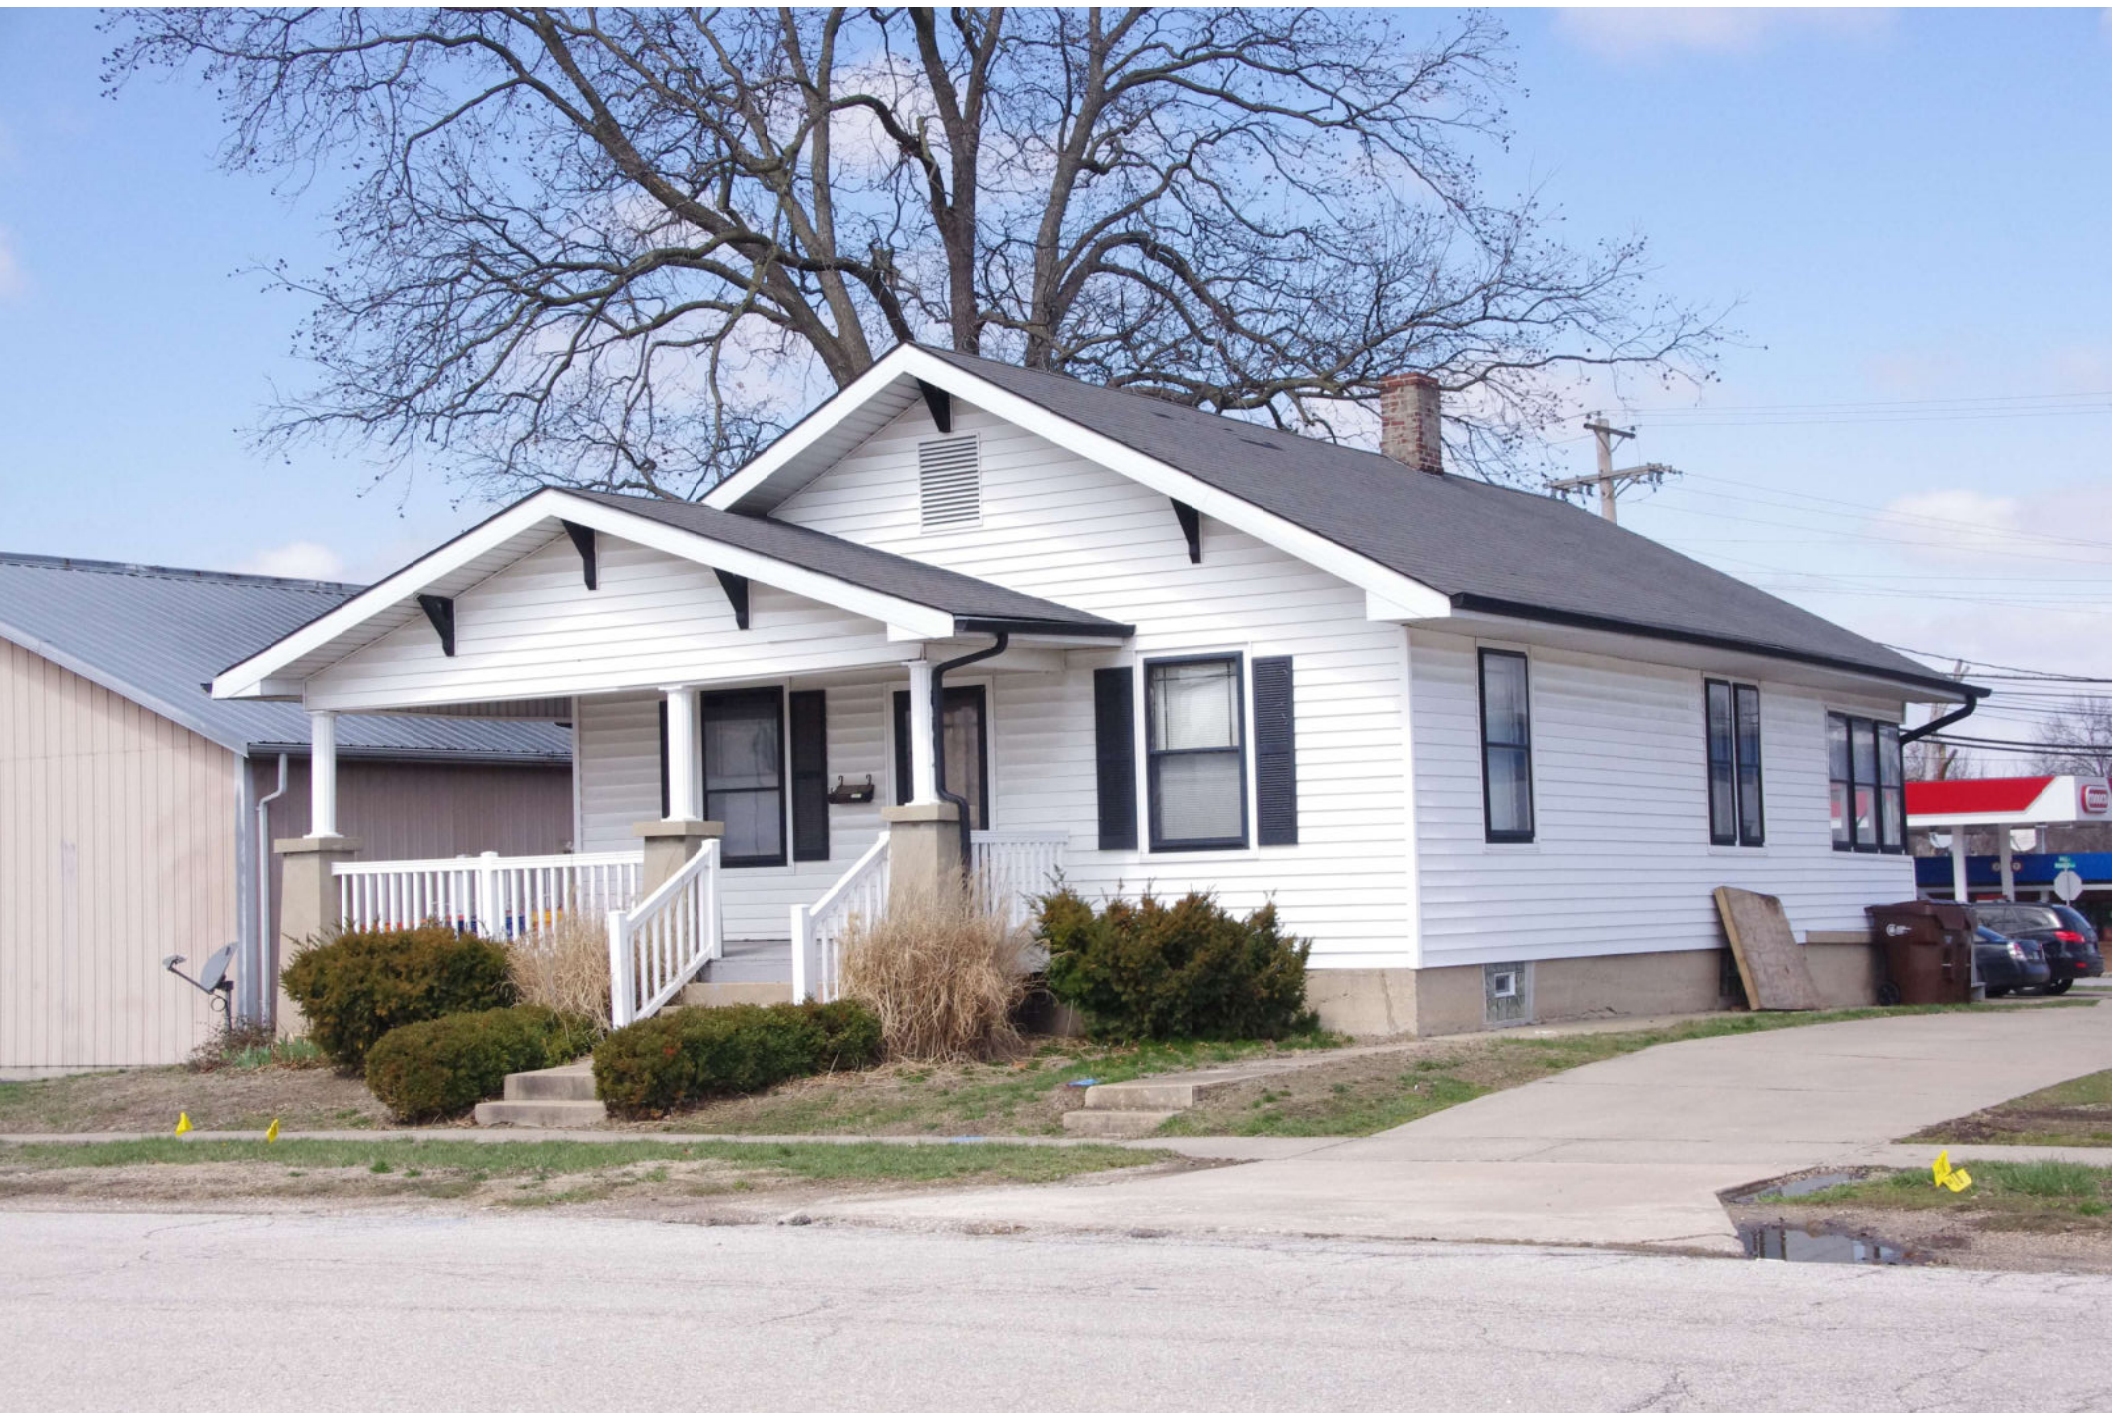
This resource is a one-story, Craftsman bungalow with a end gabled roof with wide eaves. Wood knee brace brackets decorate the gables. The rectangular light wood door has muntins paralleling the top and sides of the light (similar to those on the upper sashes of the windows). It is centered on the façade, with wood sashed windows in the outer bays. The gabled porch covers the western two bays and wraps around to the west side of the building. Tall, tapered, square, concrete piers are spanned by replacement vinyl railings with square balusters (probably similar to the originals) but the round fluted columns on top of the piers are replacements supporting the roof of the porch. There is a gabled projecting bay on the west side with a triple window.

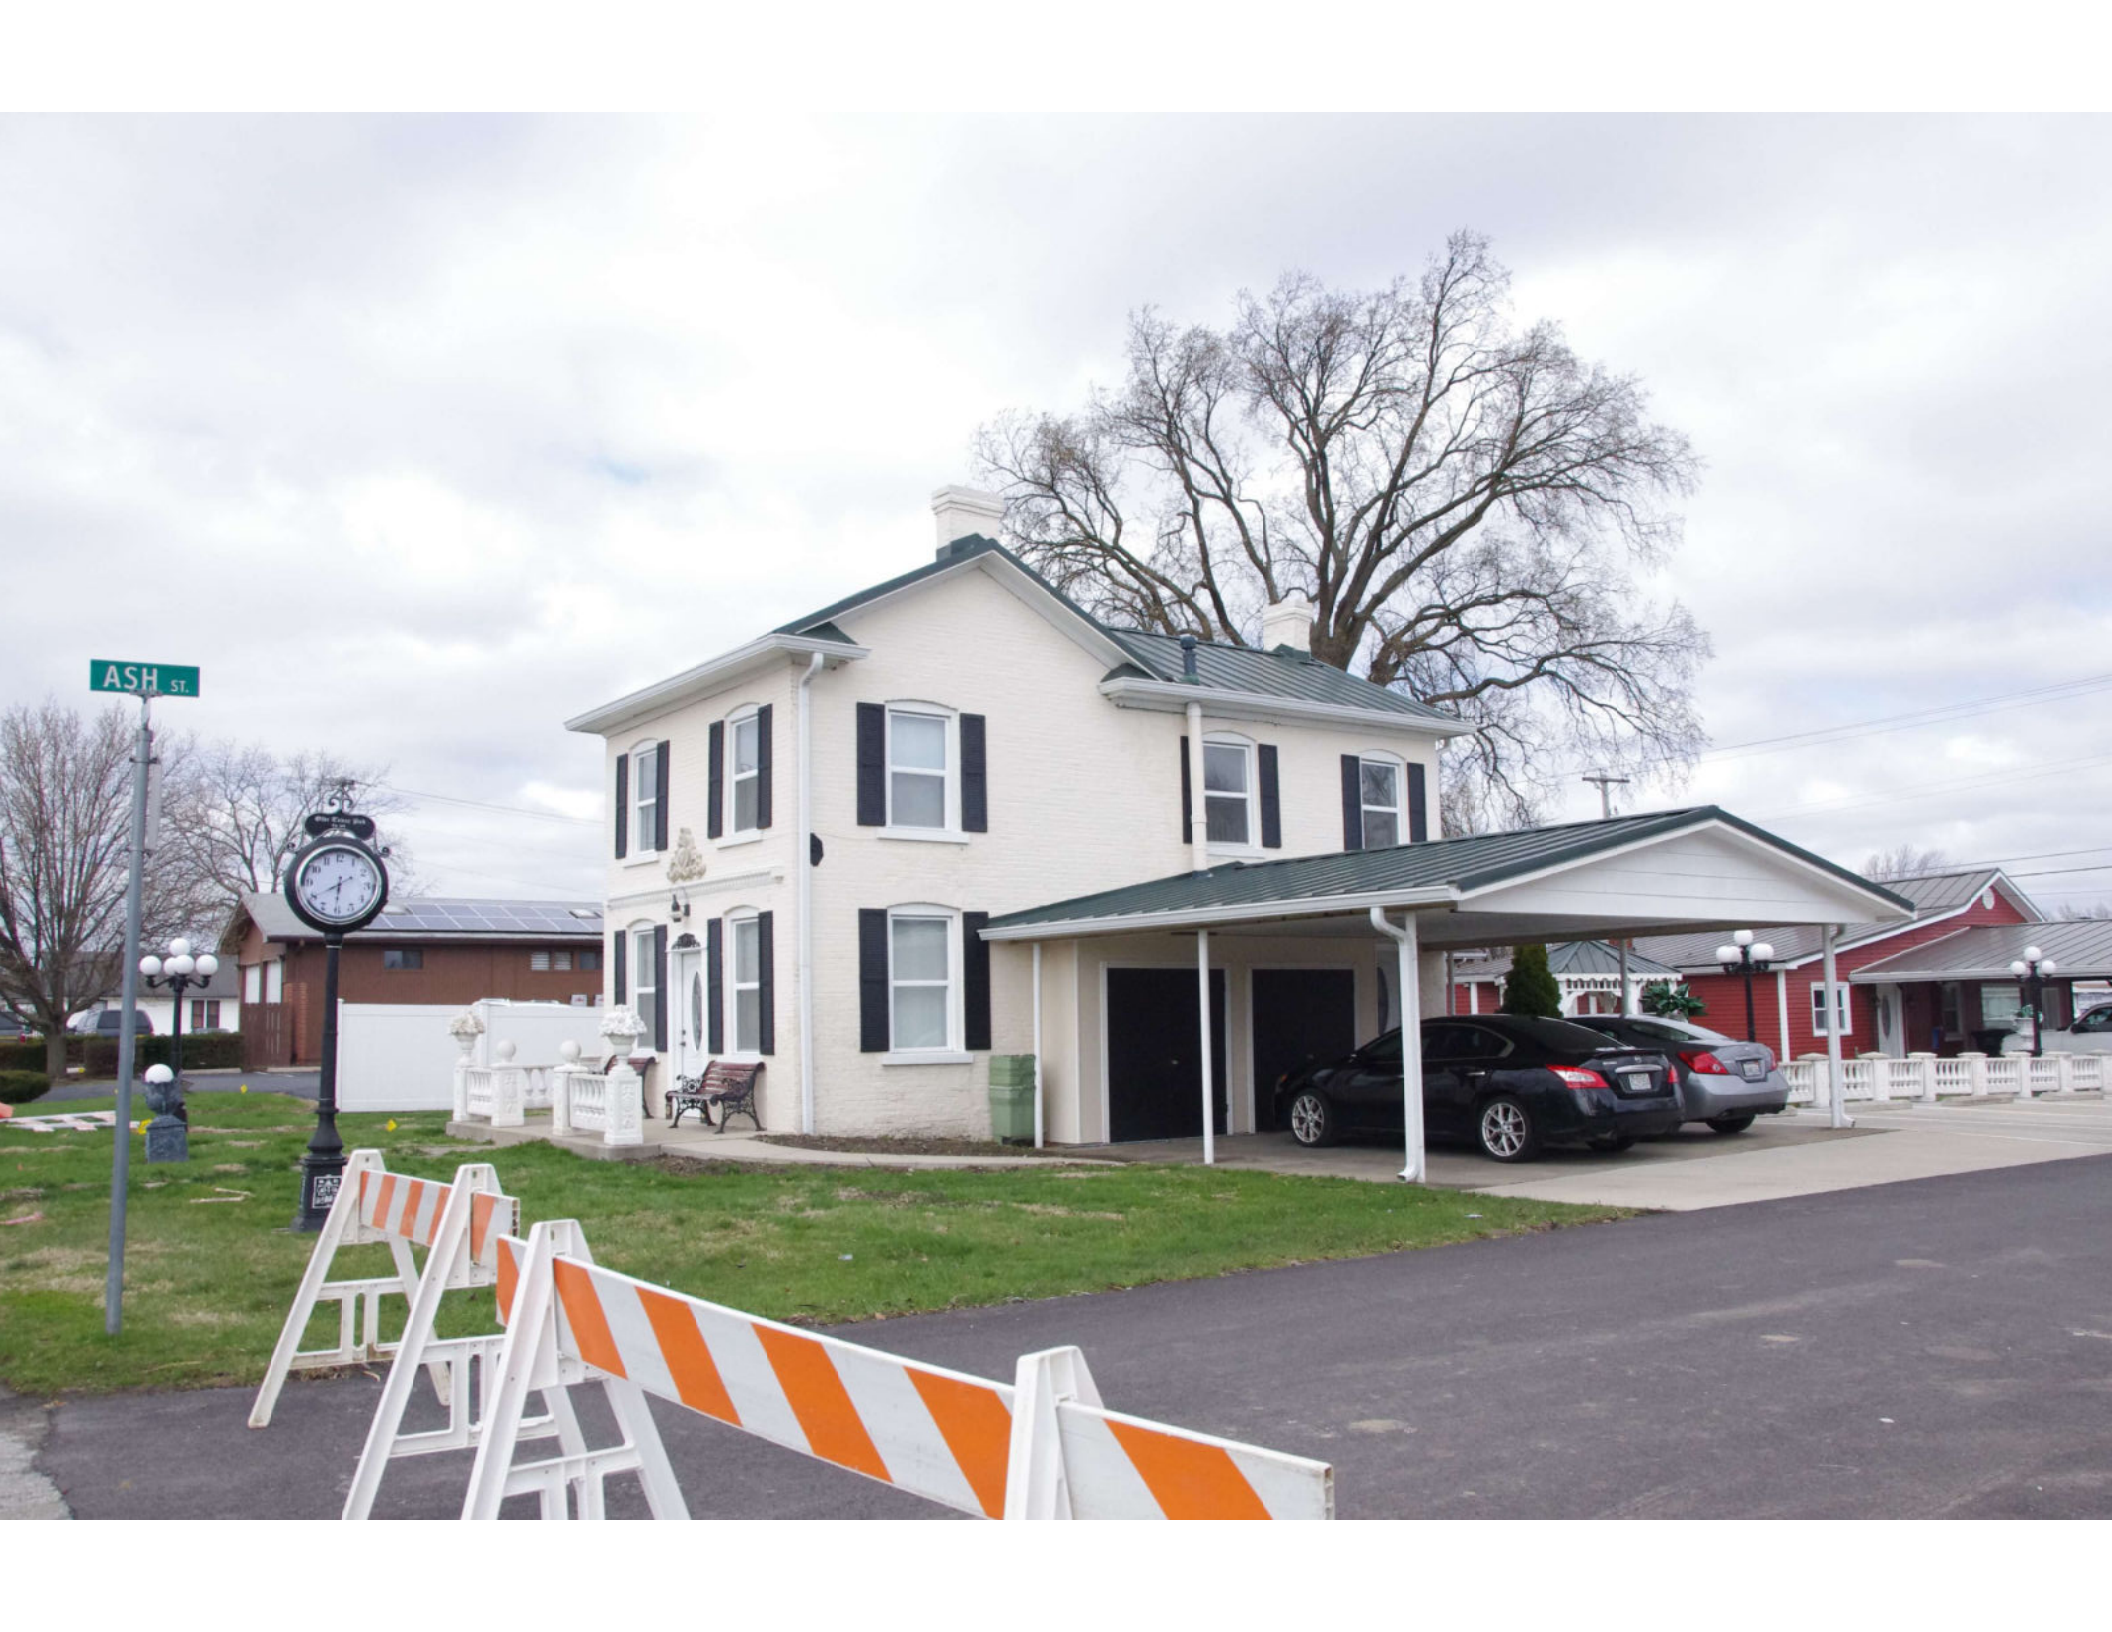
This resource is a two-story brick house with a side gabled metal roof. The form of the house is that of a I-house, being one room deep under the side gable, with an intersecting cross gable wing that spans across the rear. A painted brick chimney with its corbelled top is located at the ridge on the east side and another is located at the north end of the house. The central wood door with oval light is a recent replacement as are the pilaster stirps and entablature surround although it is positioned within the original segmental arched masonry door opening. The remaining outer bays on the first level and two on the second level are filled with one-over-one replacement sashed windows with segmental arched lintels and stone sills. The dentil strip and cartouche are recently applied details above the entry. The concrete slab terrace across the façade with its elaborate cast stone balustrade is also a recent alteration. A two-bay carport with a metal roof is also located on the east side of the building with two overhead garage doors into what was originally part of the interior of the rear wing of the house.

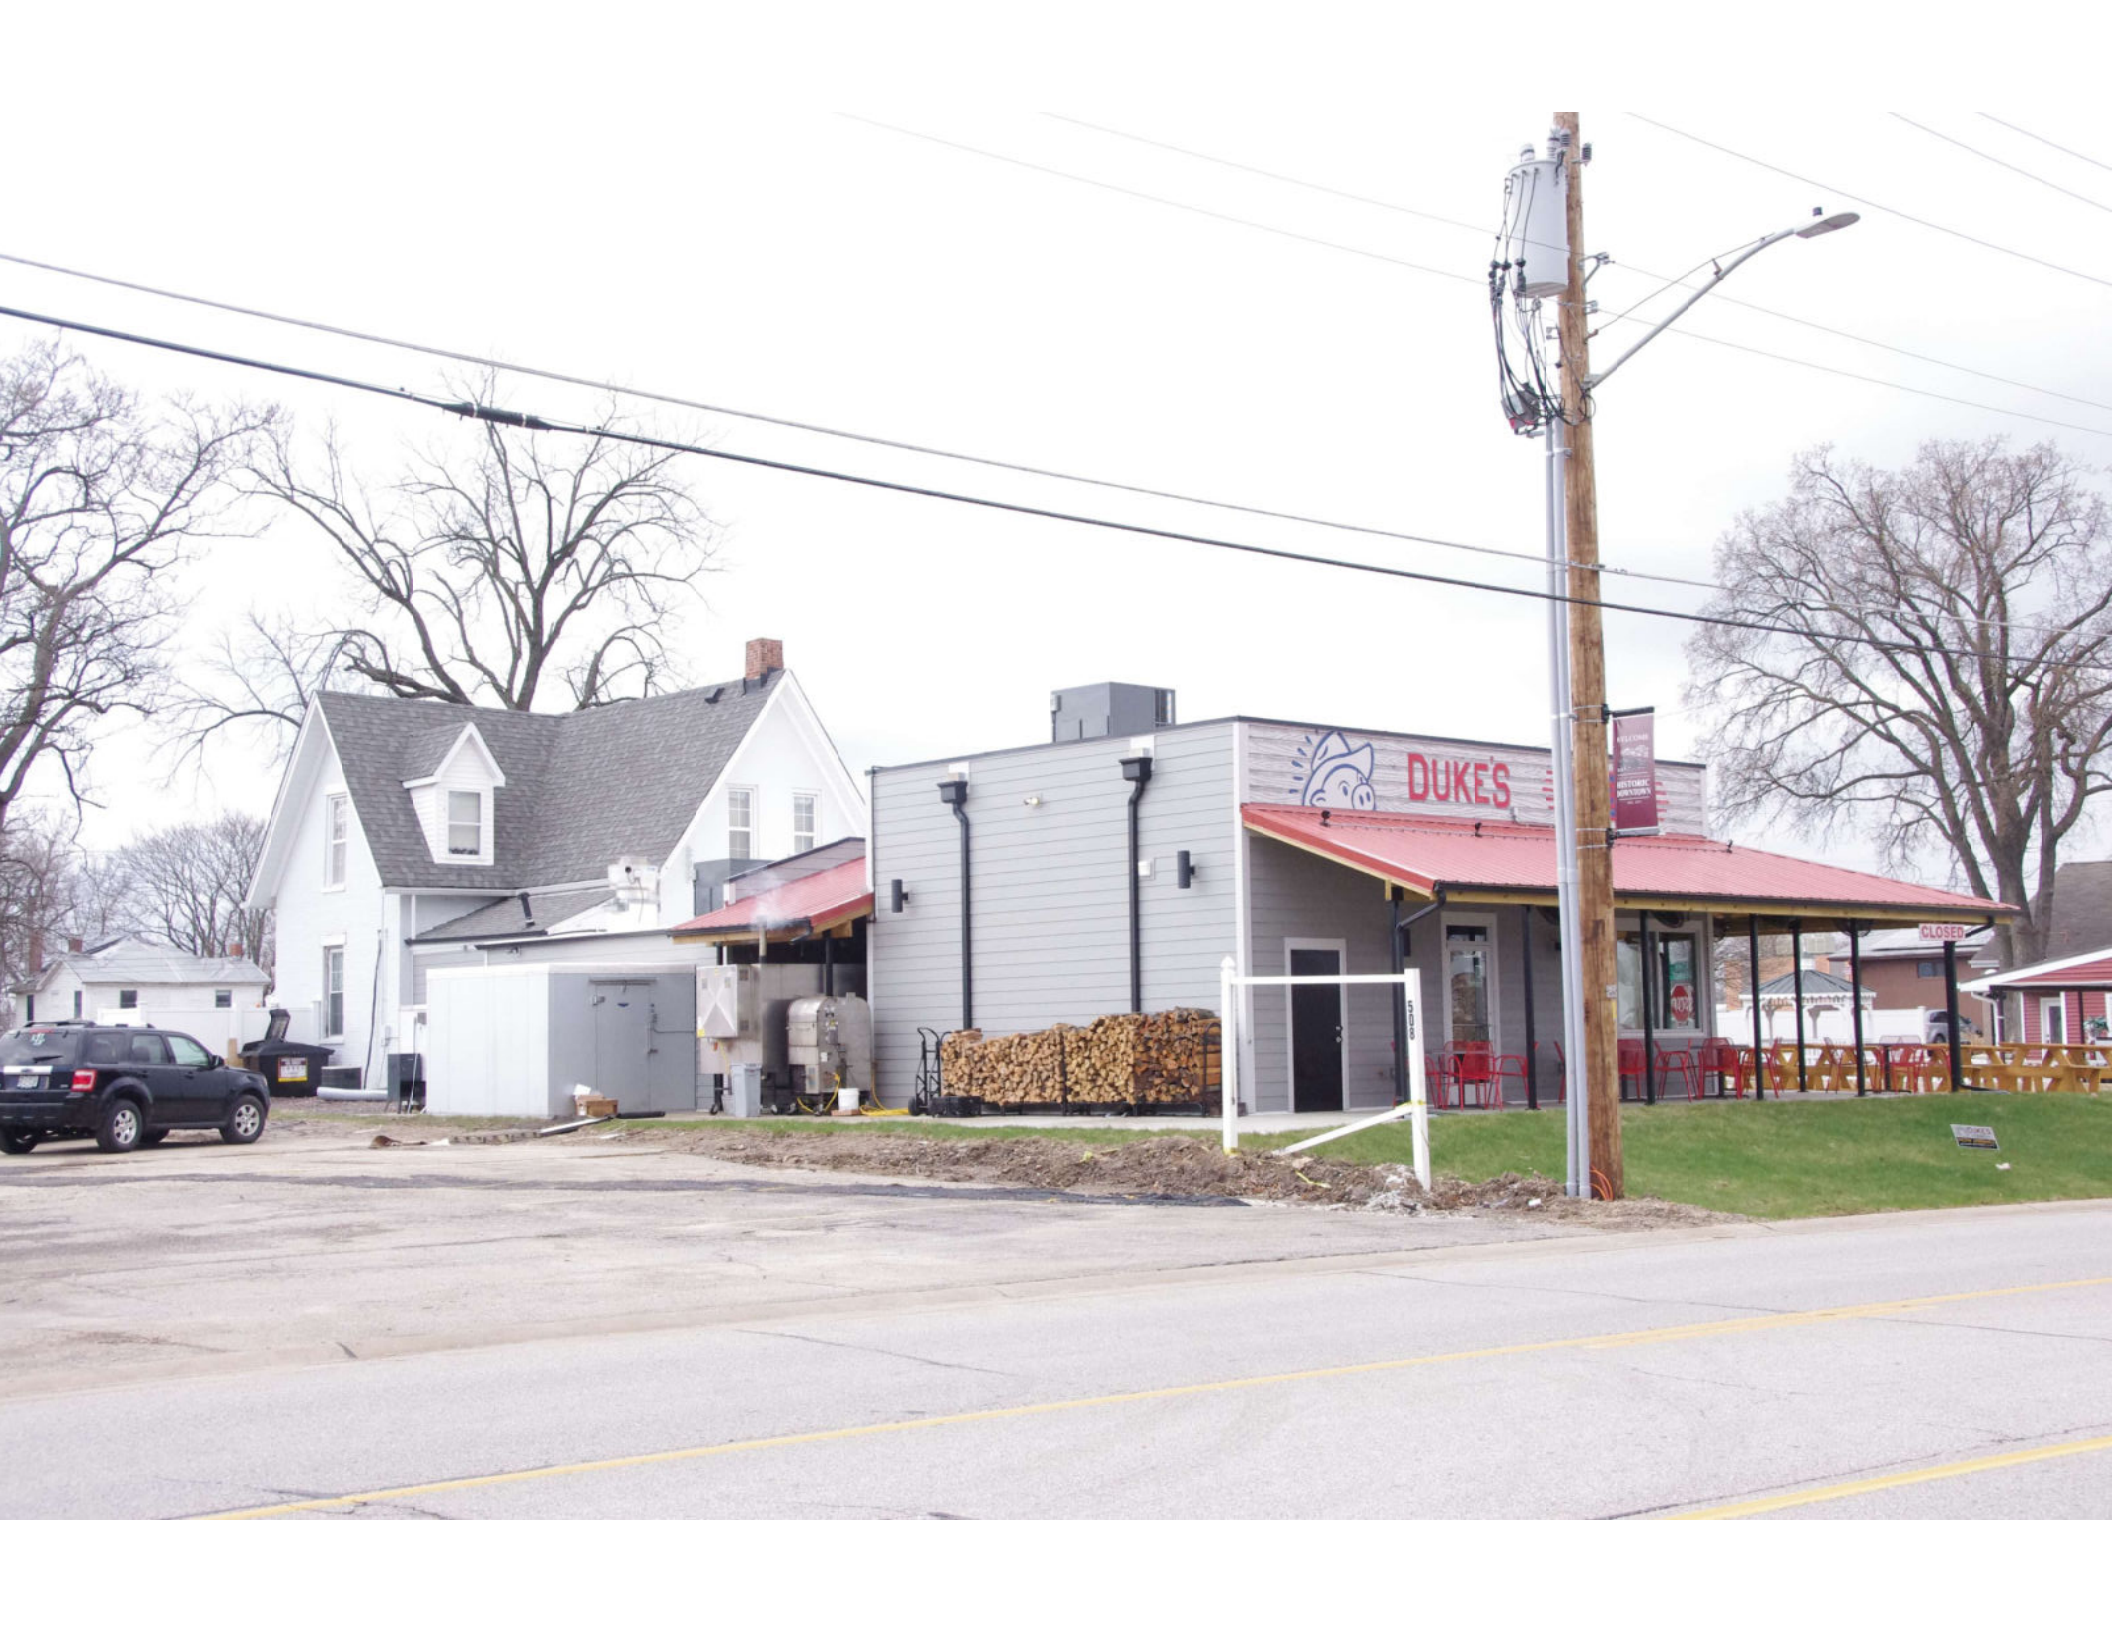
This 1.5-story brick house has a steeply pitched cross gabled roof. The six light door with sidelights is centered below a gabled portico with fluted pillars resting on a concrete base. The central bay projects, and paired one-over-one sash windows with stone lintels and sills are located in the gable. The outer recessed bays contain vinyl six-over-six sash windows with stone sills and lintels on the first level. Gabled dormers with one-over-one vinyl sash windows flank the central gable. The portico and doorway and the 6/6 windows are Colonial Revival details but they are not original to this house and it is not known what style the original porch or entry door were. Attached to the rear gabled wing of the house is a one story addition, built in three major components with flat roofs, vinyl siding wrapped by broad metal verandas for the newly created barbeque restaurant that faces onto Pearce.
