**ARCHITECTURAL/HISTORIC INVENTORY FORM**

1. Survey No. SC-AS-012-0001		2. Survey Name: Reconnaissance Level Survey of Historic Downtown Wentzville	
3. County: St. Charles		4. Address (Street No.) 102	Street (name) East Third Street
5. City: Wentzville	Vicinity: <input type="checkbox"/>	6. UTM:	
8. Historic name (if known):		9. Present/other name (if known):	
10. Ownership: <input type="checkbox"/> Private <input type="checkbox"/> Public		11a. Historic use (if known): DOMESTIC/single dwelling	11b. Current use: DOMESTIC/single dwelling
5. City: Wentzville		7. Township/Range/Section:

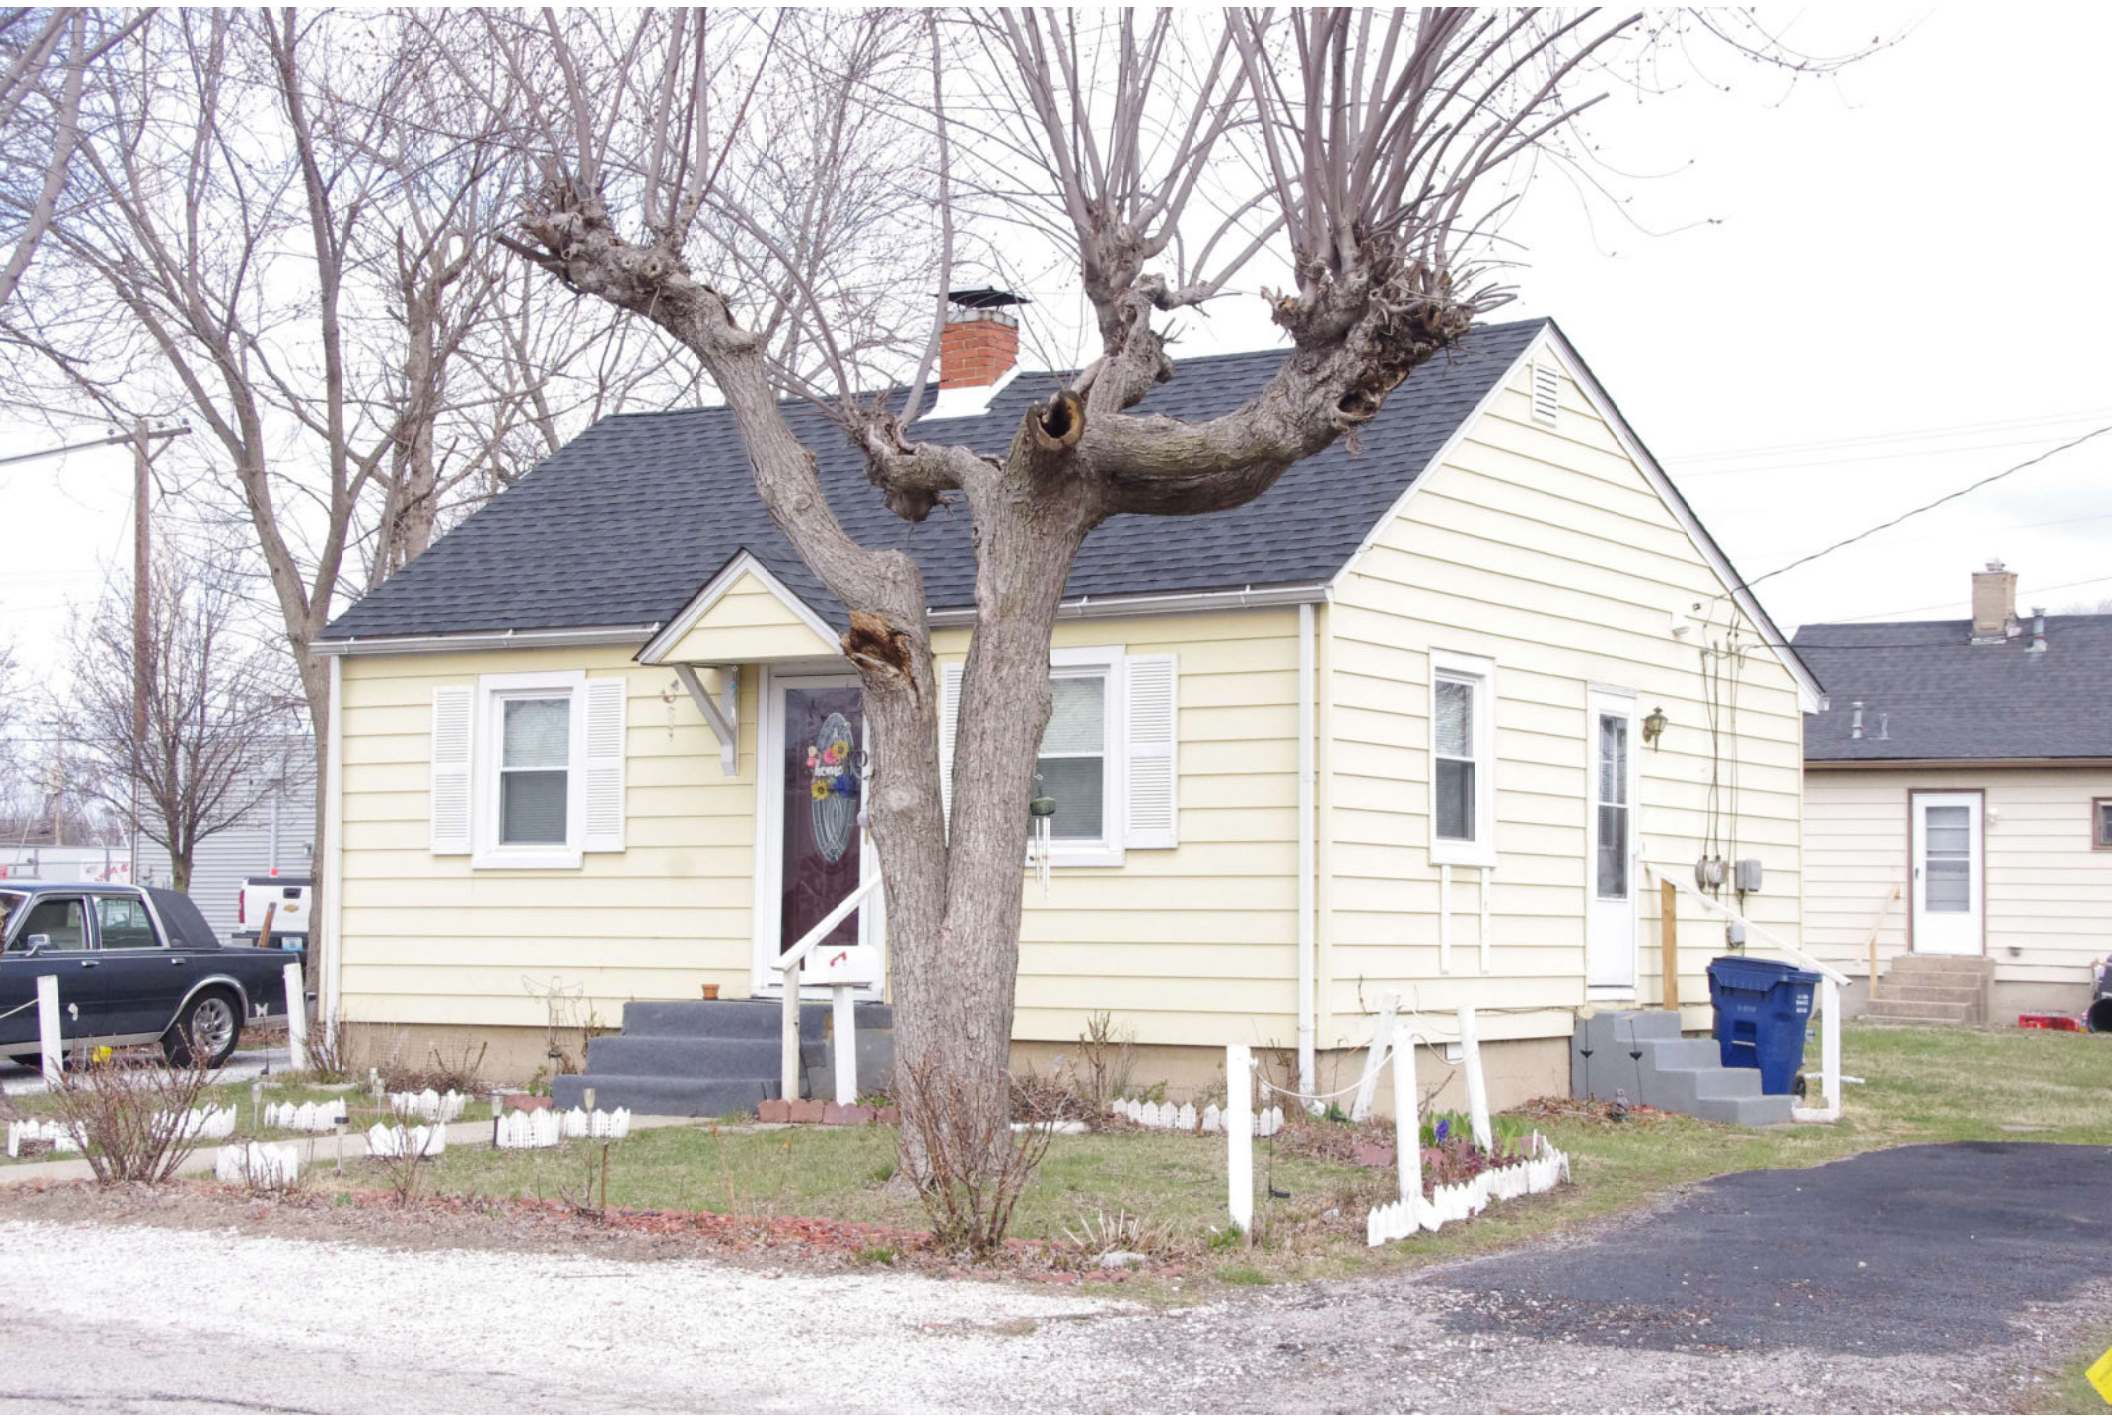
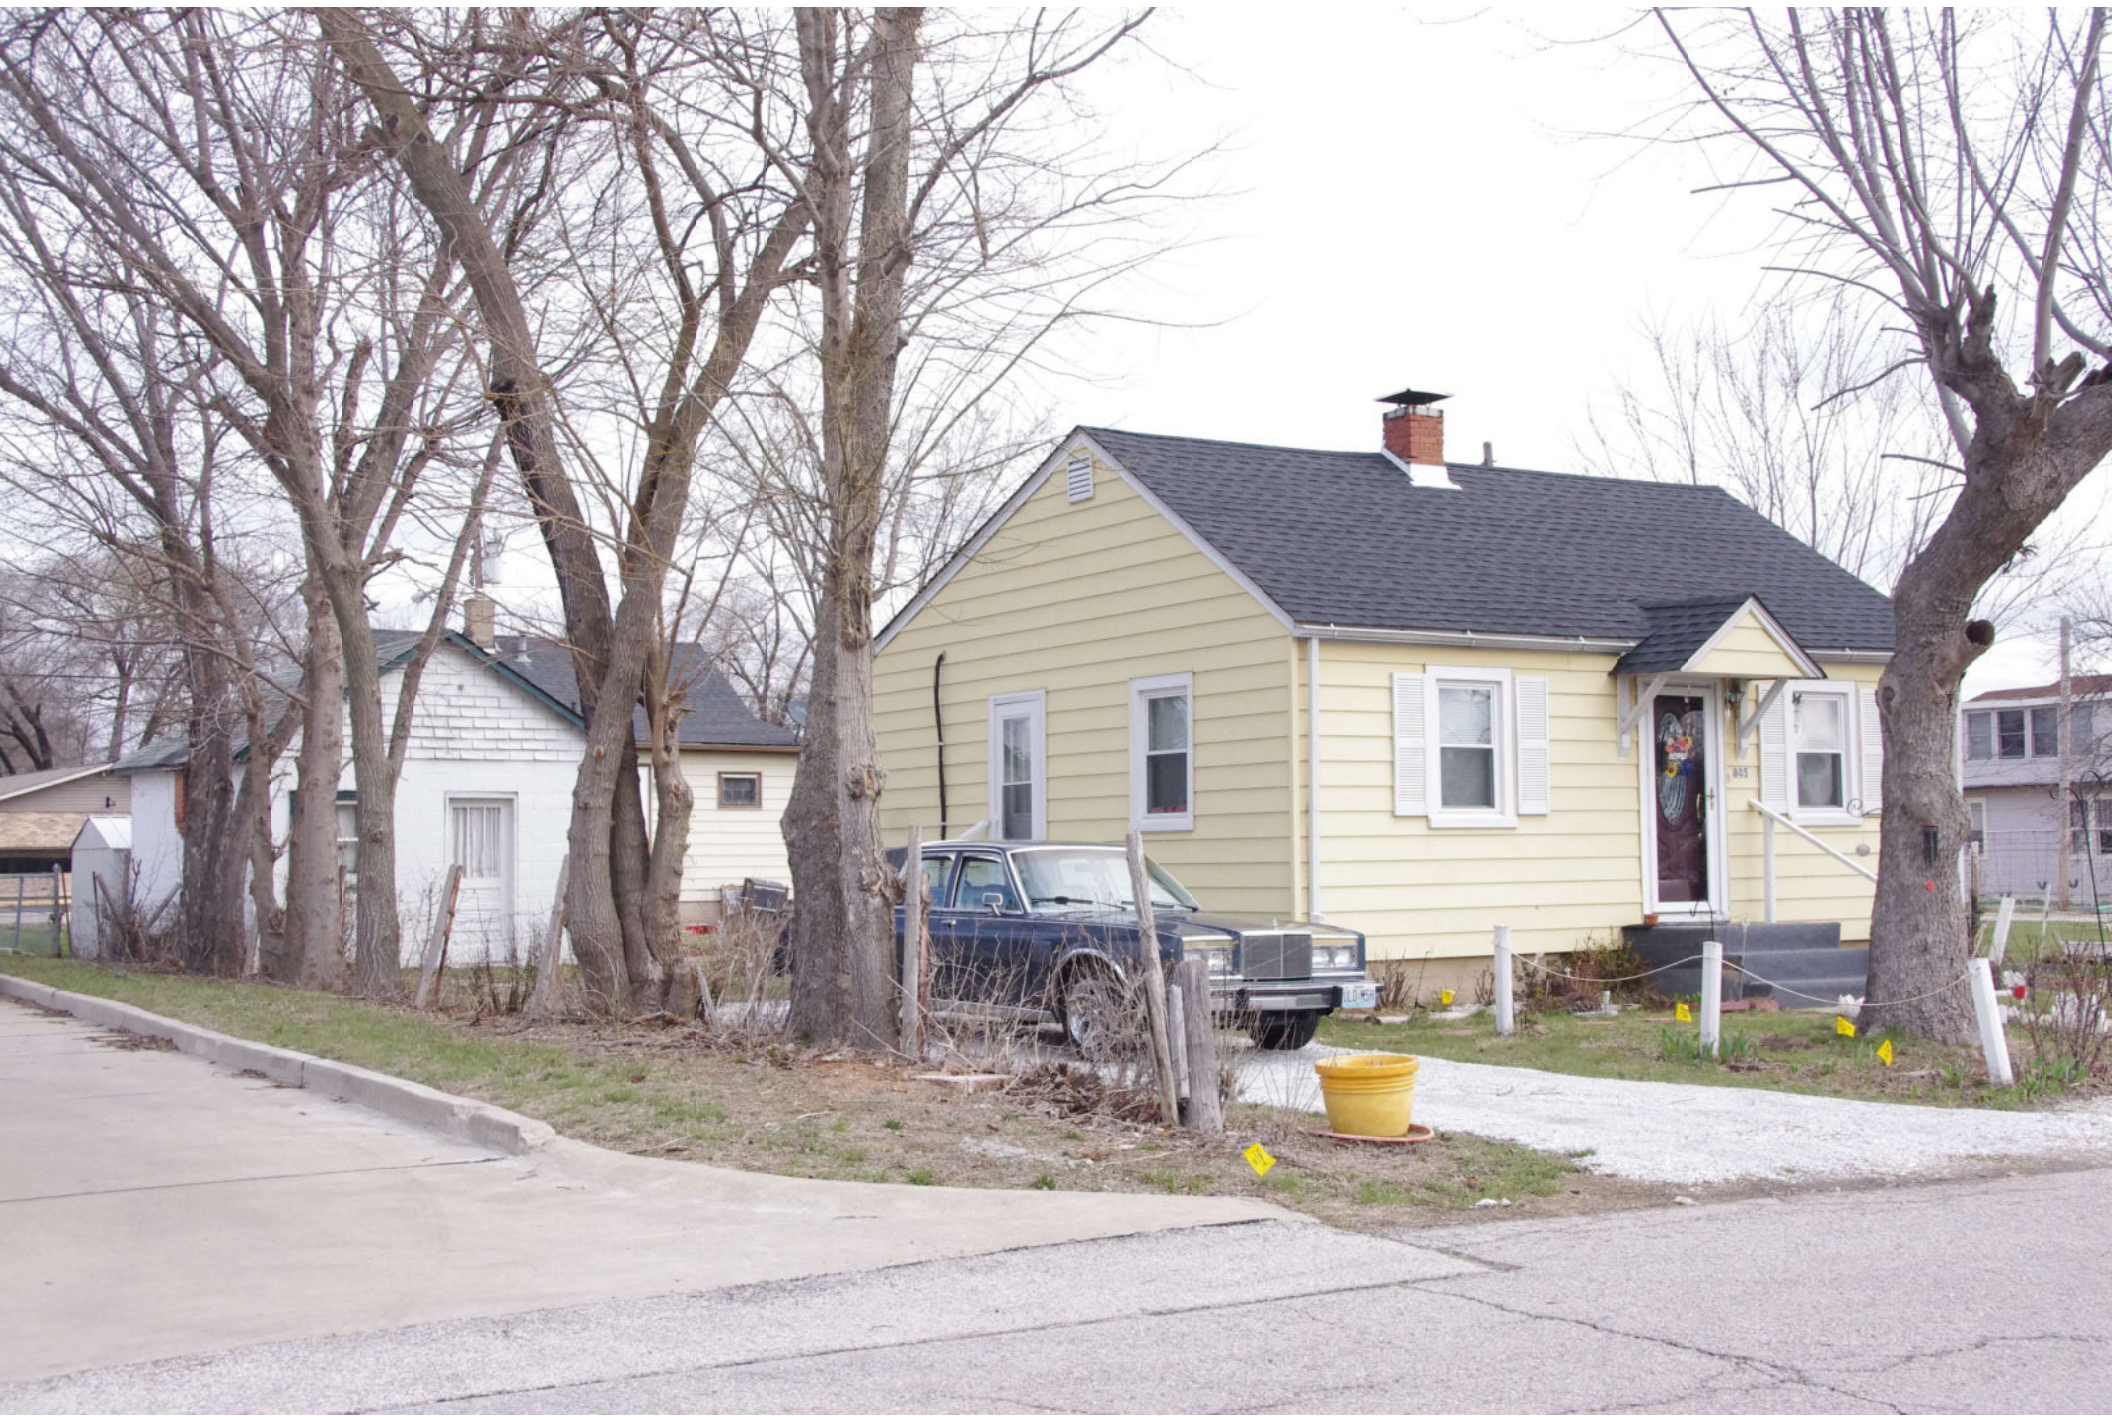
This resource is a one-story, Cape Cod style house with a concrete foundation and a side gabled roof. The central wood door with oval light is a recent replacement. It is located below a gabled, shingled awning supported by knee braces with a concrete stoop below. One-over-one replacement windows with wood shutters flank the entrance. A red brick chimney rises at the center of the roof. The windows, front door, and vinyl siding seem to all be part of a recent renovation.

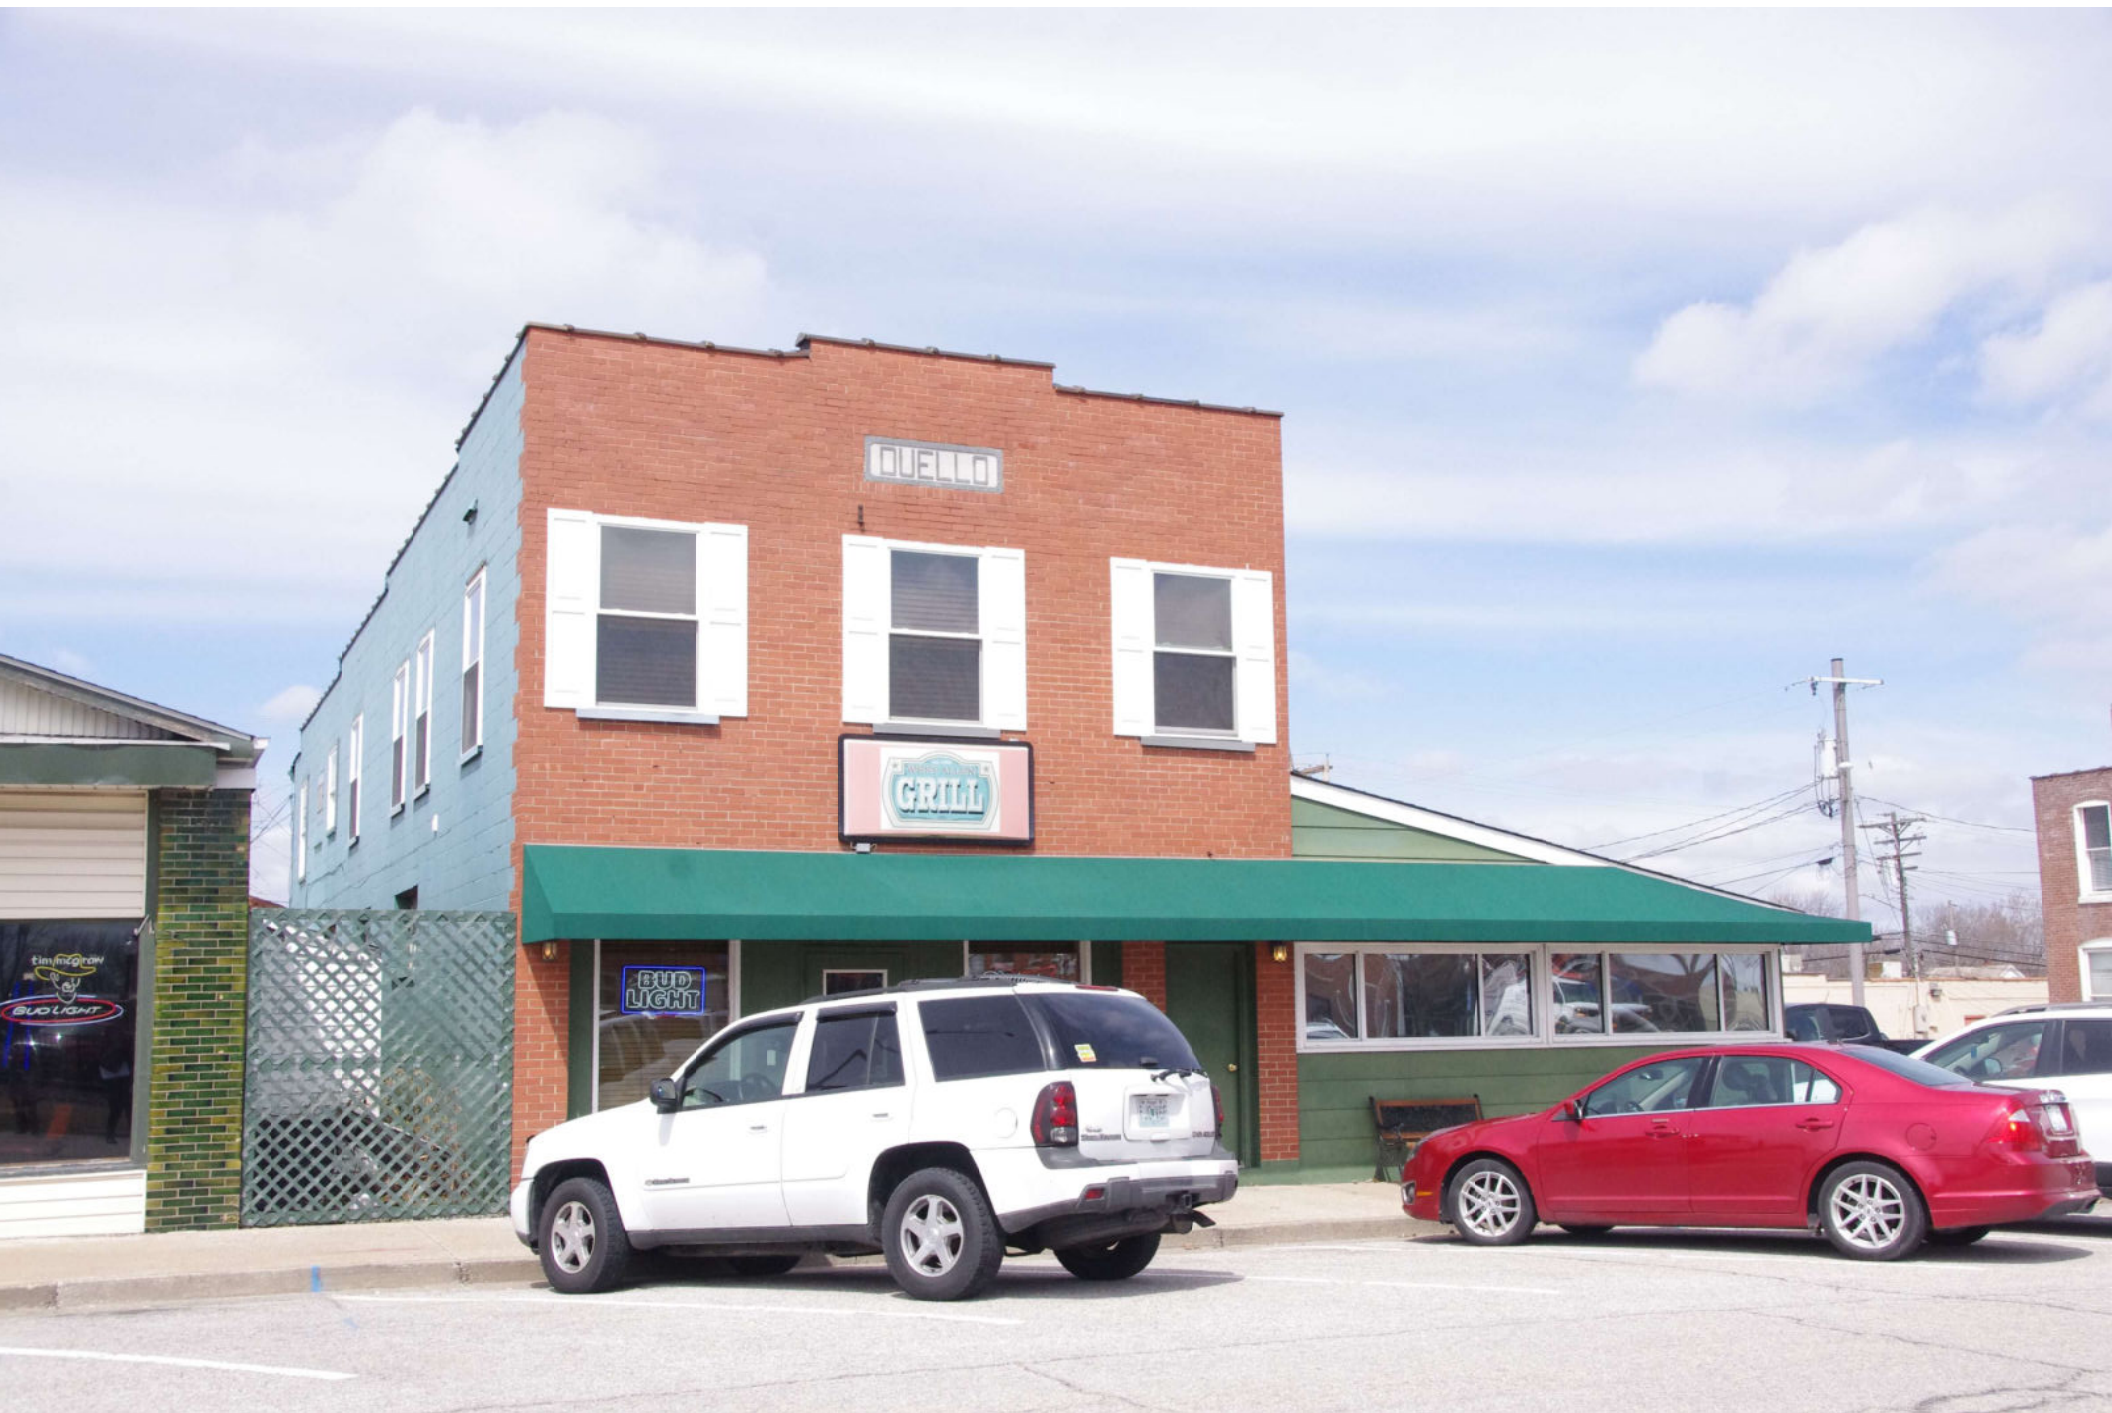
This resource is a two-story brick commercial building with a flat roof surrounded by parapets capped with clay coping tiles. The replacement wood full light entry door is located just west of center, flanked on each side by a wood framed display window. An additional replacement wood slab door is found in the easter bay, probably to access the stairs to the upper level, and the entire first floor is spanned by a canvas awning. The second floor is comprised of three one-over-one vinyl sash windows with two-panel shutters. Centered above these windows is a small stone frieze panel with the name "DUELLO." A one-story shed roof addition is located along the entire eastern side of the building with wide metal siding and paired sliding windows. Above, the two story wall has a quoined effect at the corner where the brick meets the concrete block wall of the side elevations and there are a series of vinyl sashed windows.

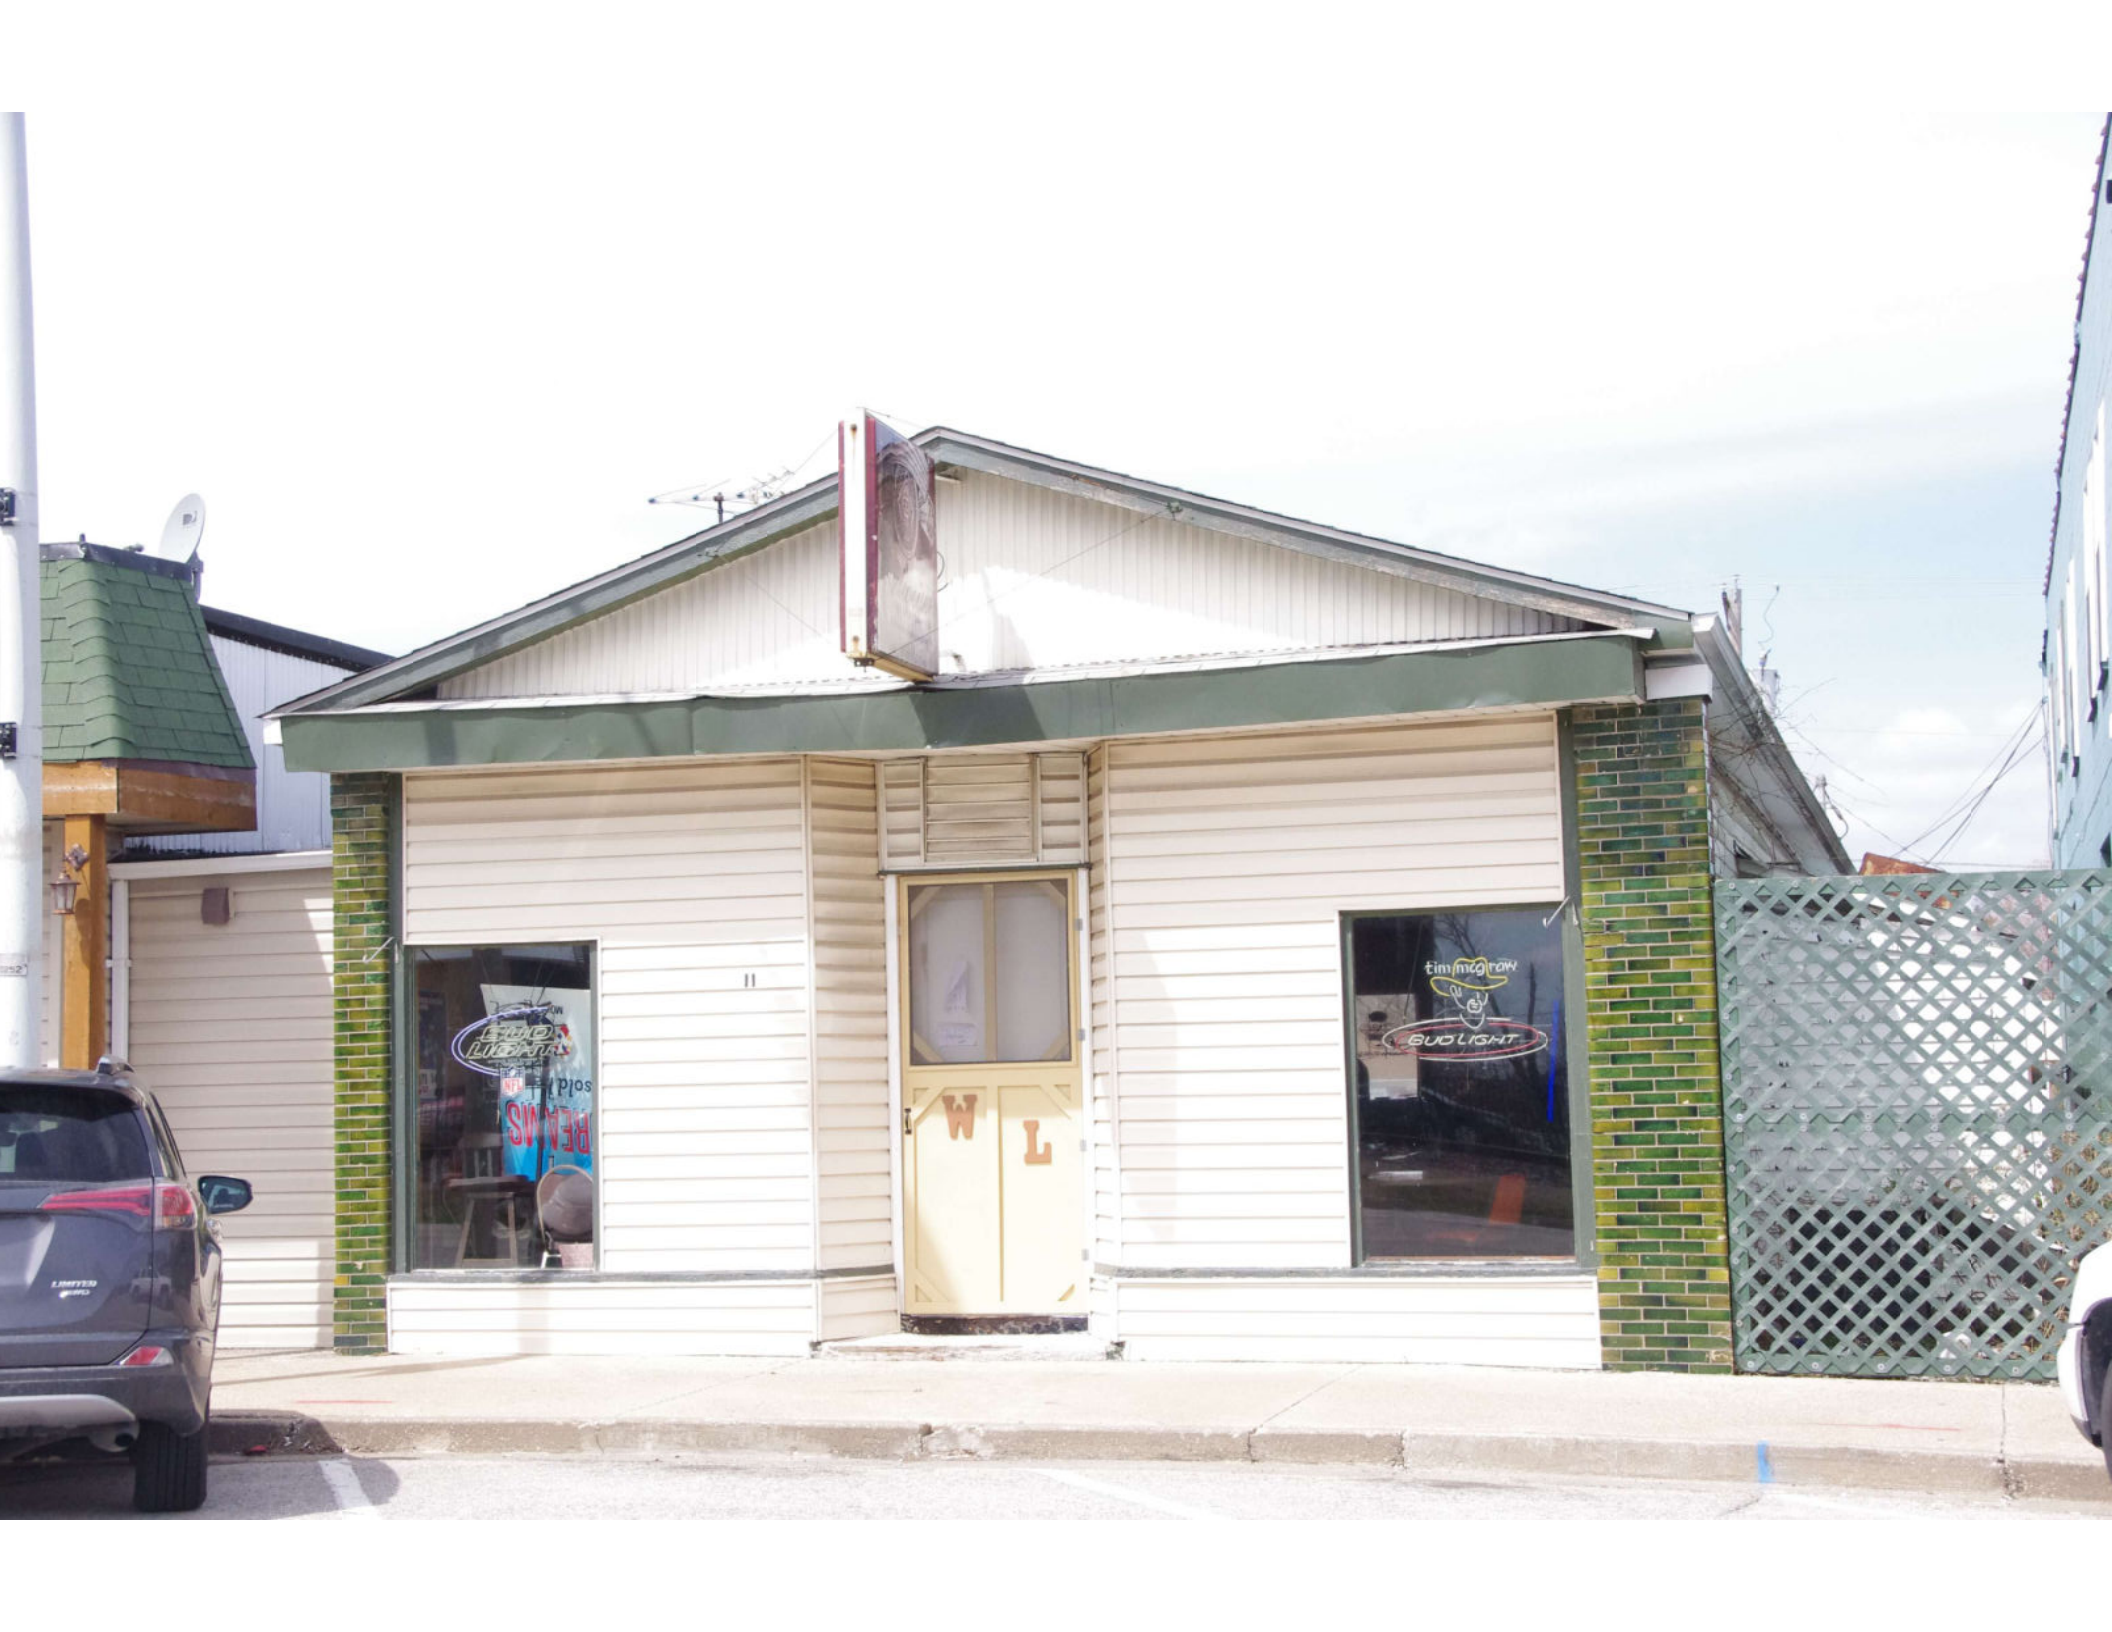
This resource is a one-story, frame storefront building with a gabled roof. Most of the façade, including portions of the display windows have been covered in vinyl siding, but the original display window framing appears intact. There is a small display window in each of the outer bays (originally a larger display window) that flank the recessed central wood and glass door and screen door. Original glazed green brick piers are located on the outer corners of the façade.

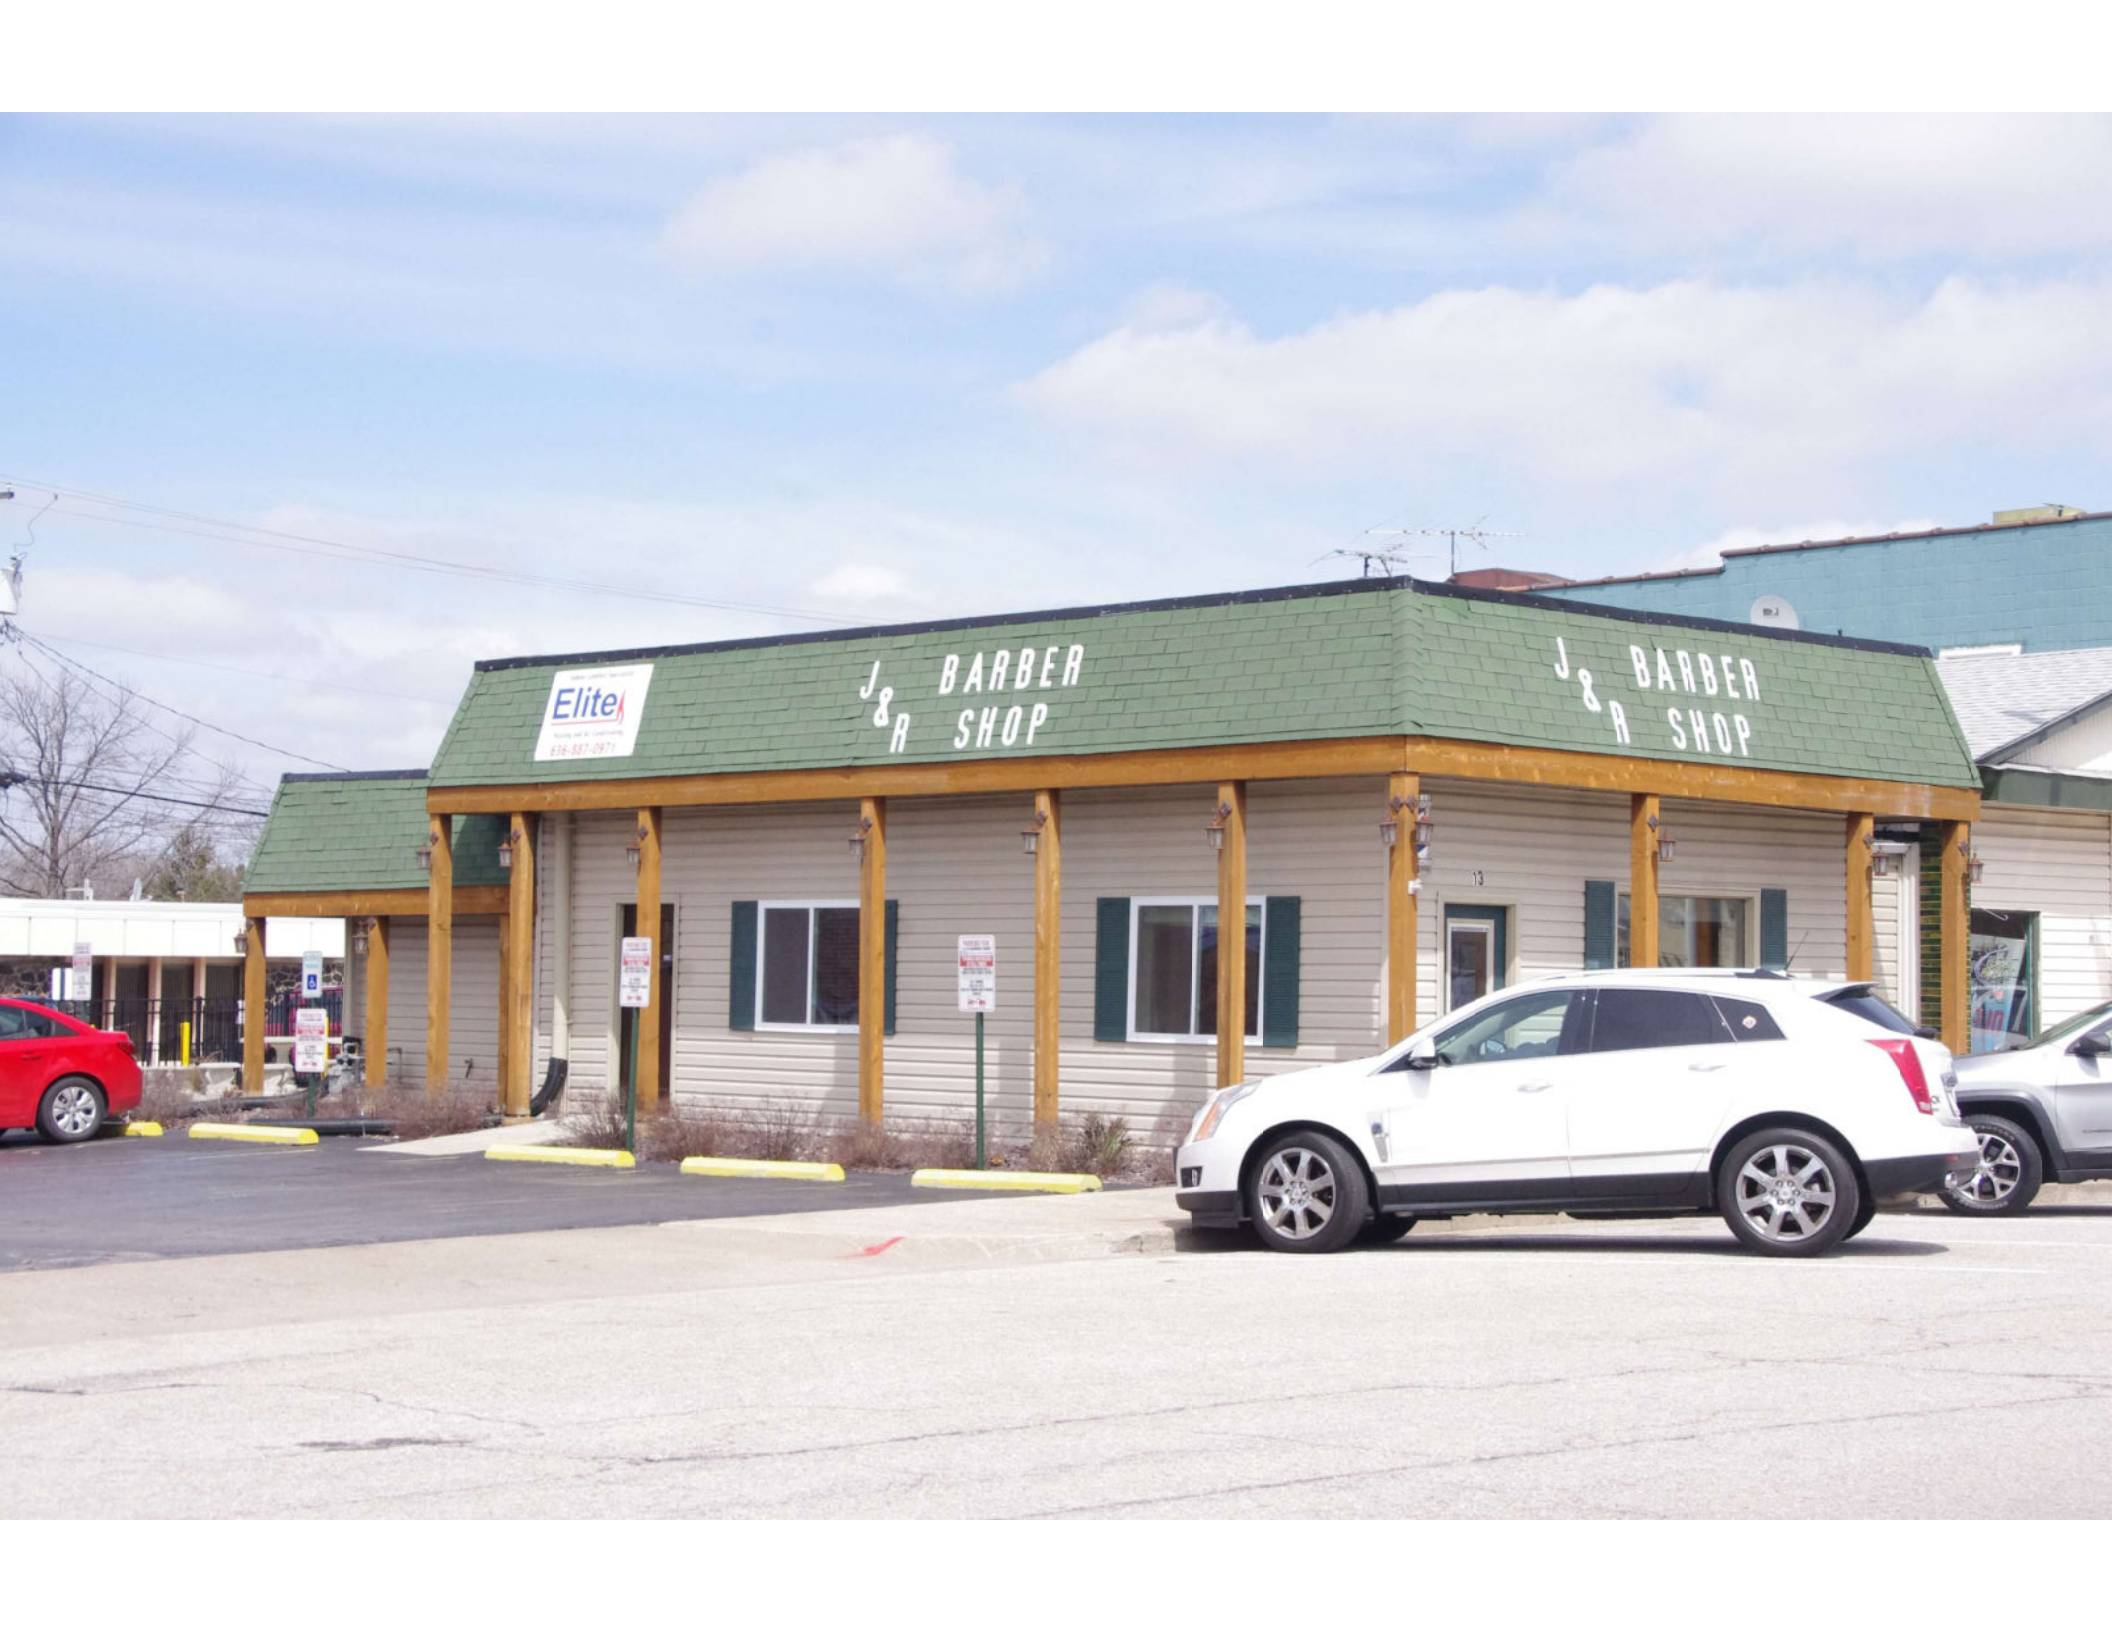
This resource is a one-story, flat roofed, frame commercial building which has been modified with a wrap-around mansard awning supported by wood posts and replacement vinyl siding. The full light wood door is located in the western bay, and a replacement display window fills the eastern bay with two similar display windows in the west elevation wall. A narrow one-story vinyl addition is located on the east side of the building connecting this building to the adjacent building at the façade. There is a one story rear wing that may have been original to the construction since the 1927 fire insurance map shows a one story wing on the back; it now has a recently added matching mansard awning along its west and north wall where there is a rear entry door.

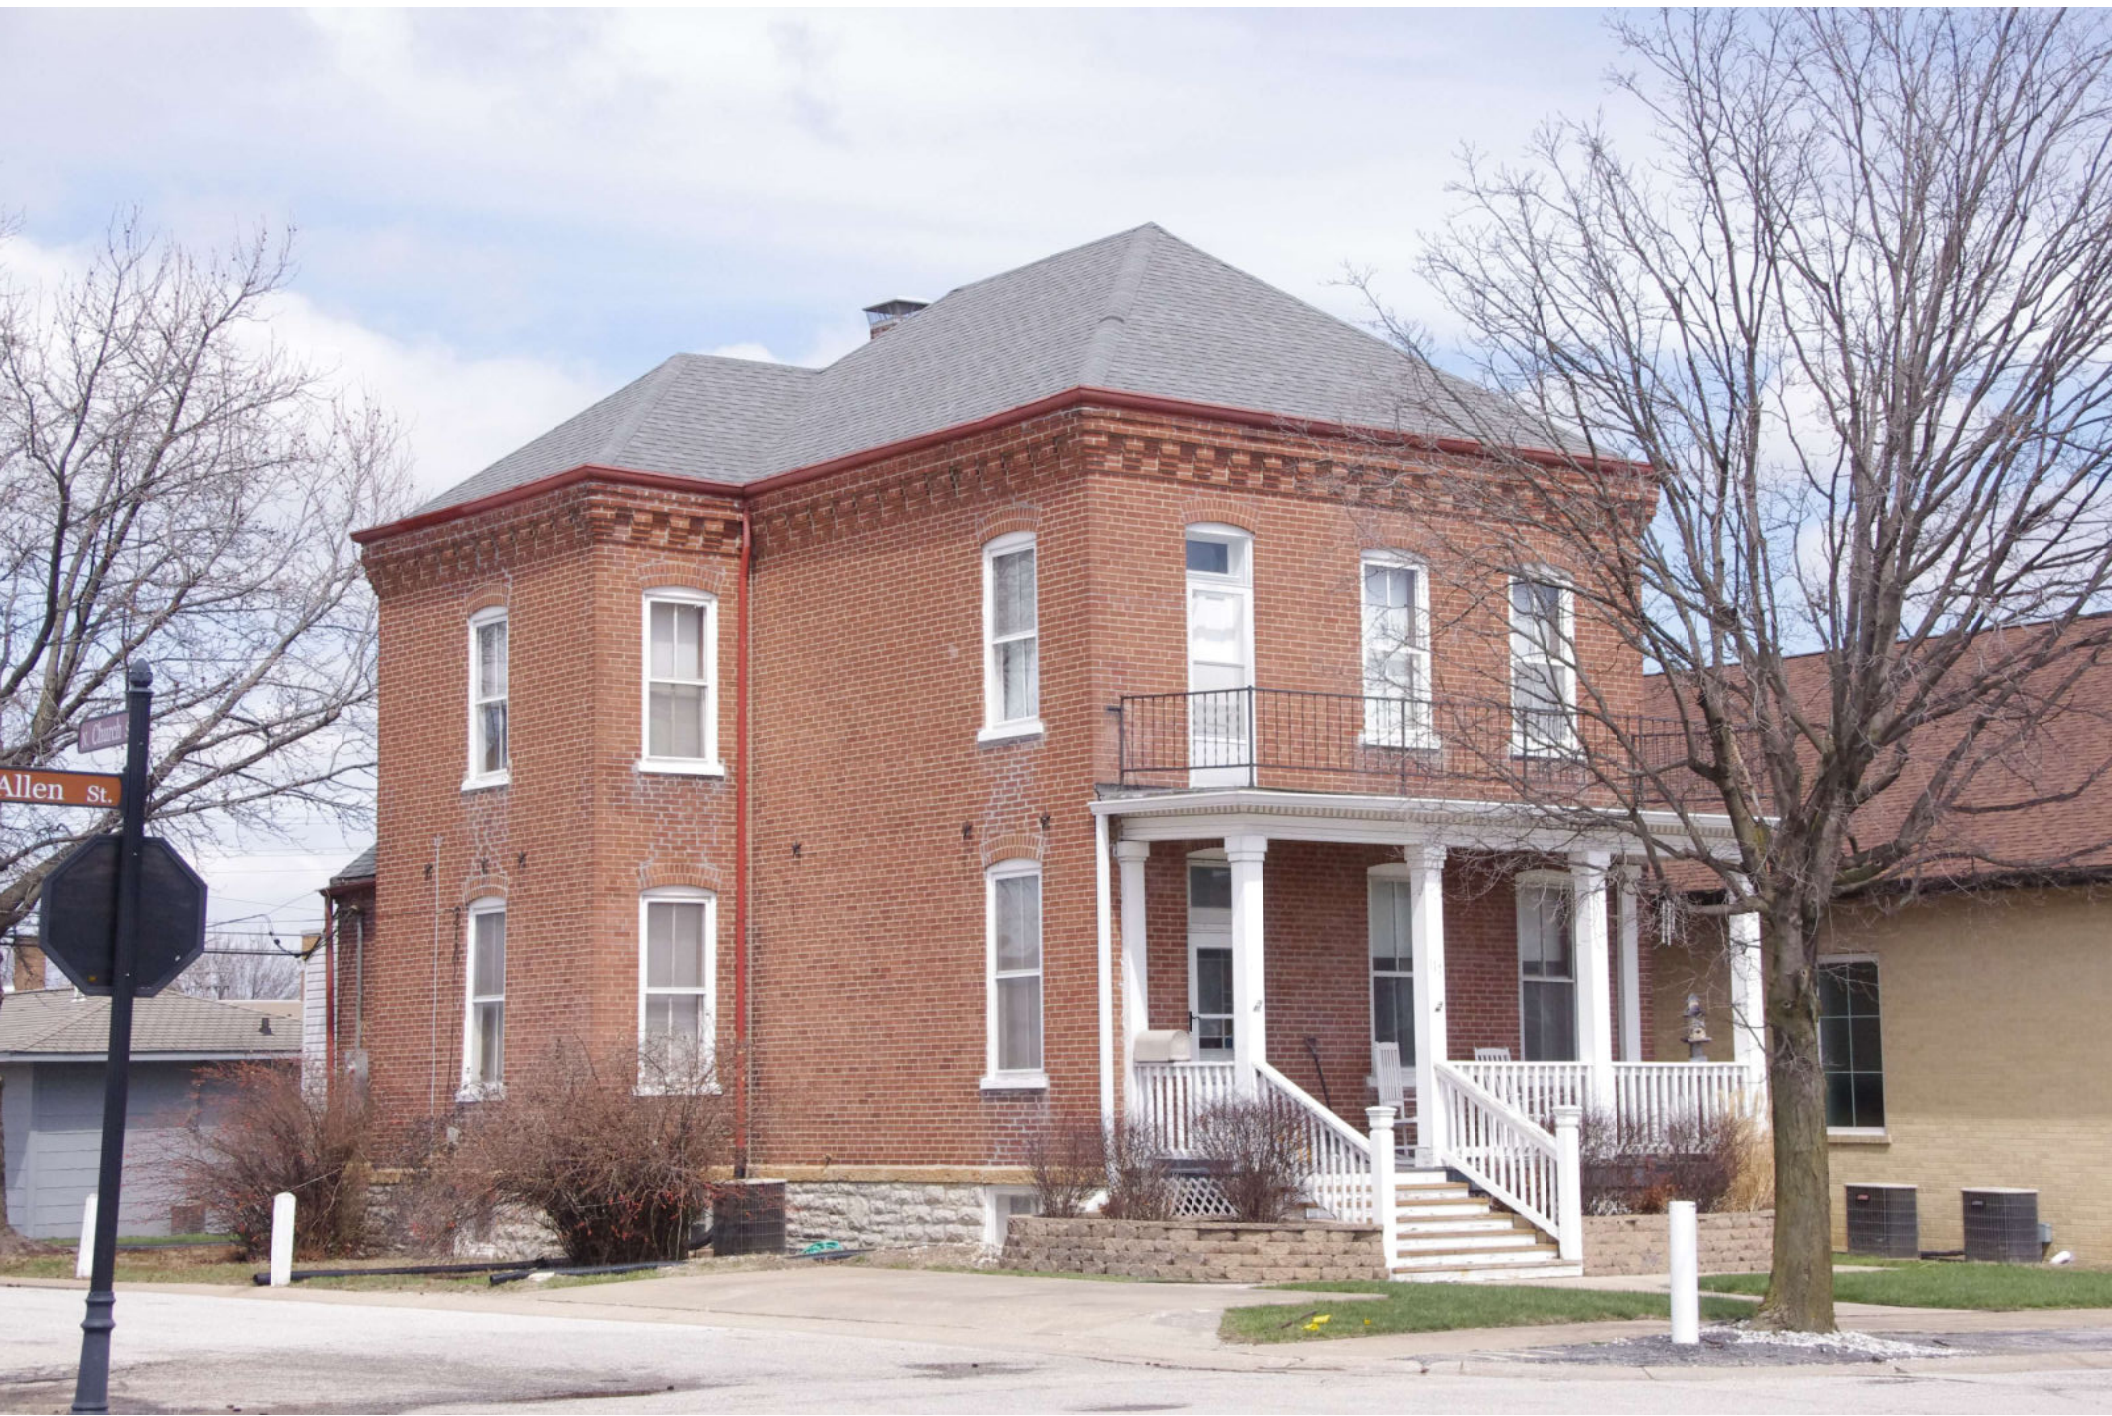
The 2-story, brick house with a stone foundation and a hipped roof has a three bay façade spanned by an open one-story porch with a flat roof with replacement iron railings. The porch has dentil molding on the cornice under the roof and square columns (which may be replacements) as well as replacement wood railings, but it retains the wood porch floor and wood steps. A half light wood door with rectangular transom and arched lintel is located in the western bay on both levels. The remaining two bays on the both levels feature one-over-one wood sashed windows with arched lintels and stone sills. There is brick corbelling that surrounds the building at the roofline. On each side of the house are cross gabled bays extending the full 2-story height (the one on the east is a 5-sided bay).
