**ARCHITECTURAL/HISTORIC INVENTORY FORM**

1. Survey No. SC-AS-012-0001		2. Survey Name: Reconnaissance Level Survey of Historic Downtown Wentzville	
3. County: St. Charles		4. Address (Street No.) 102	Street (name) East Third Street
5. City: Wentzville	Vicinity: <input type="checkbox"/>	6. UTM:	
8. Historic name (if known):		9. Present/other name (if known):	
10. Ownership: <input type="checkbox"/> Private <input type="checkbox"/> Public		11a. Historic use (if known): DOMESTIC/single dwelling	11b. Current use: DOMESTIC/single dwelling
5. City: Wentzville		7. Township/Range/Section:

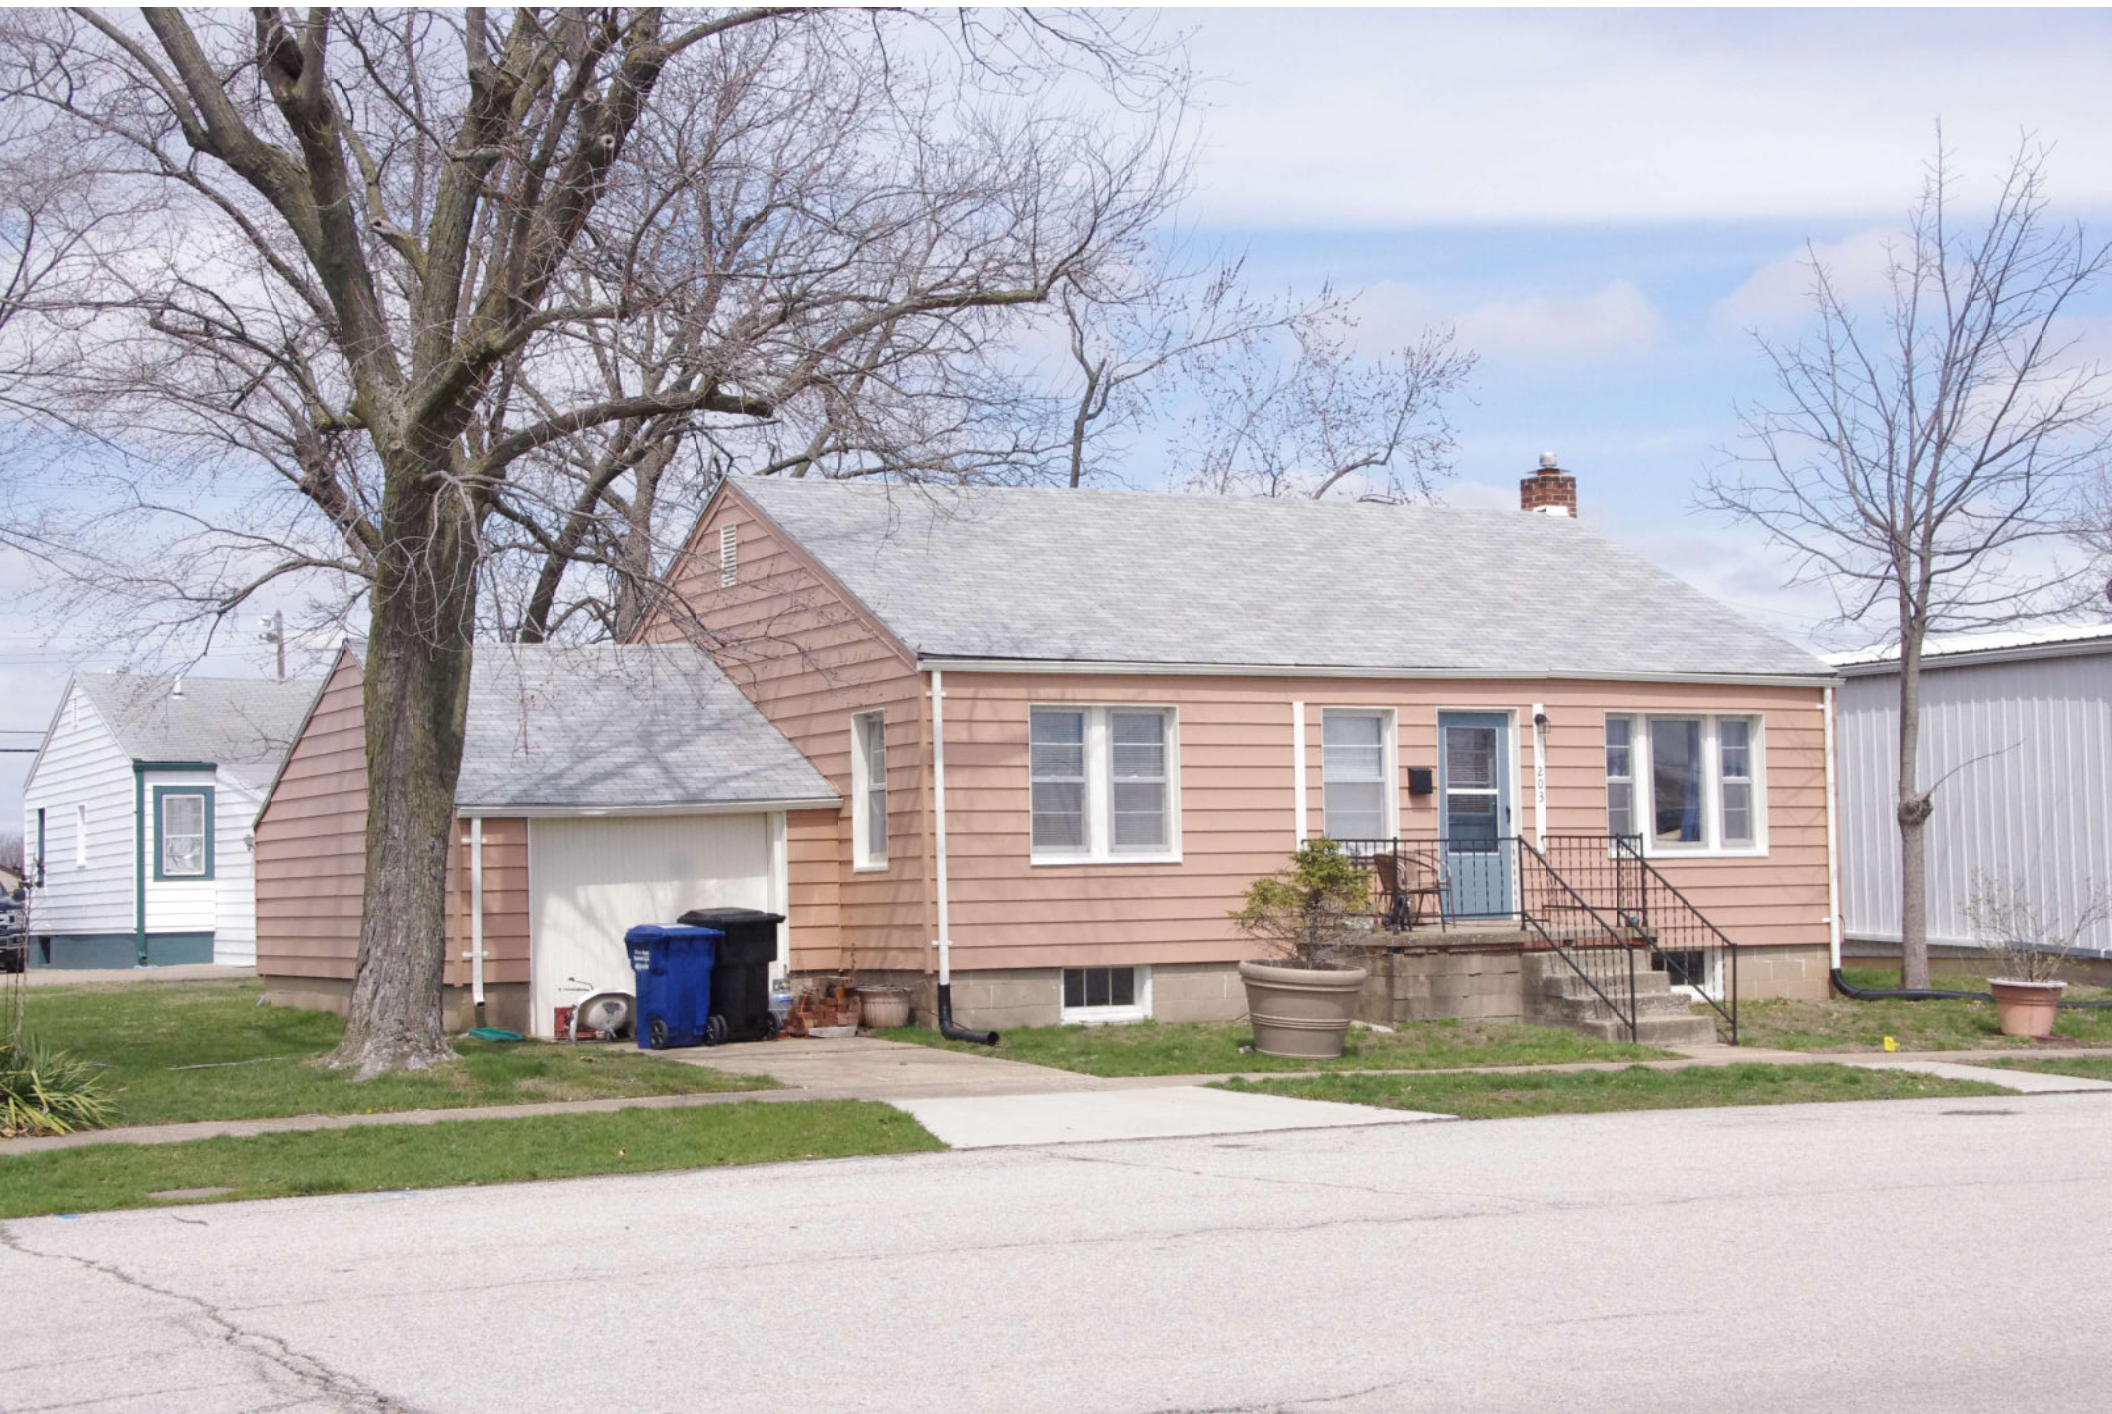
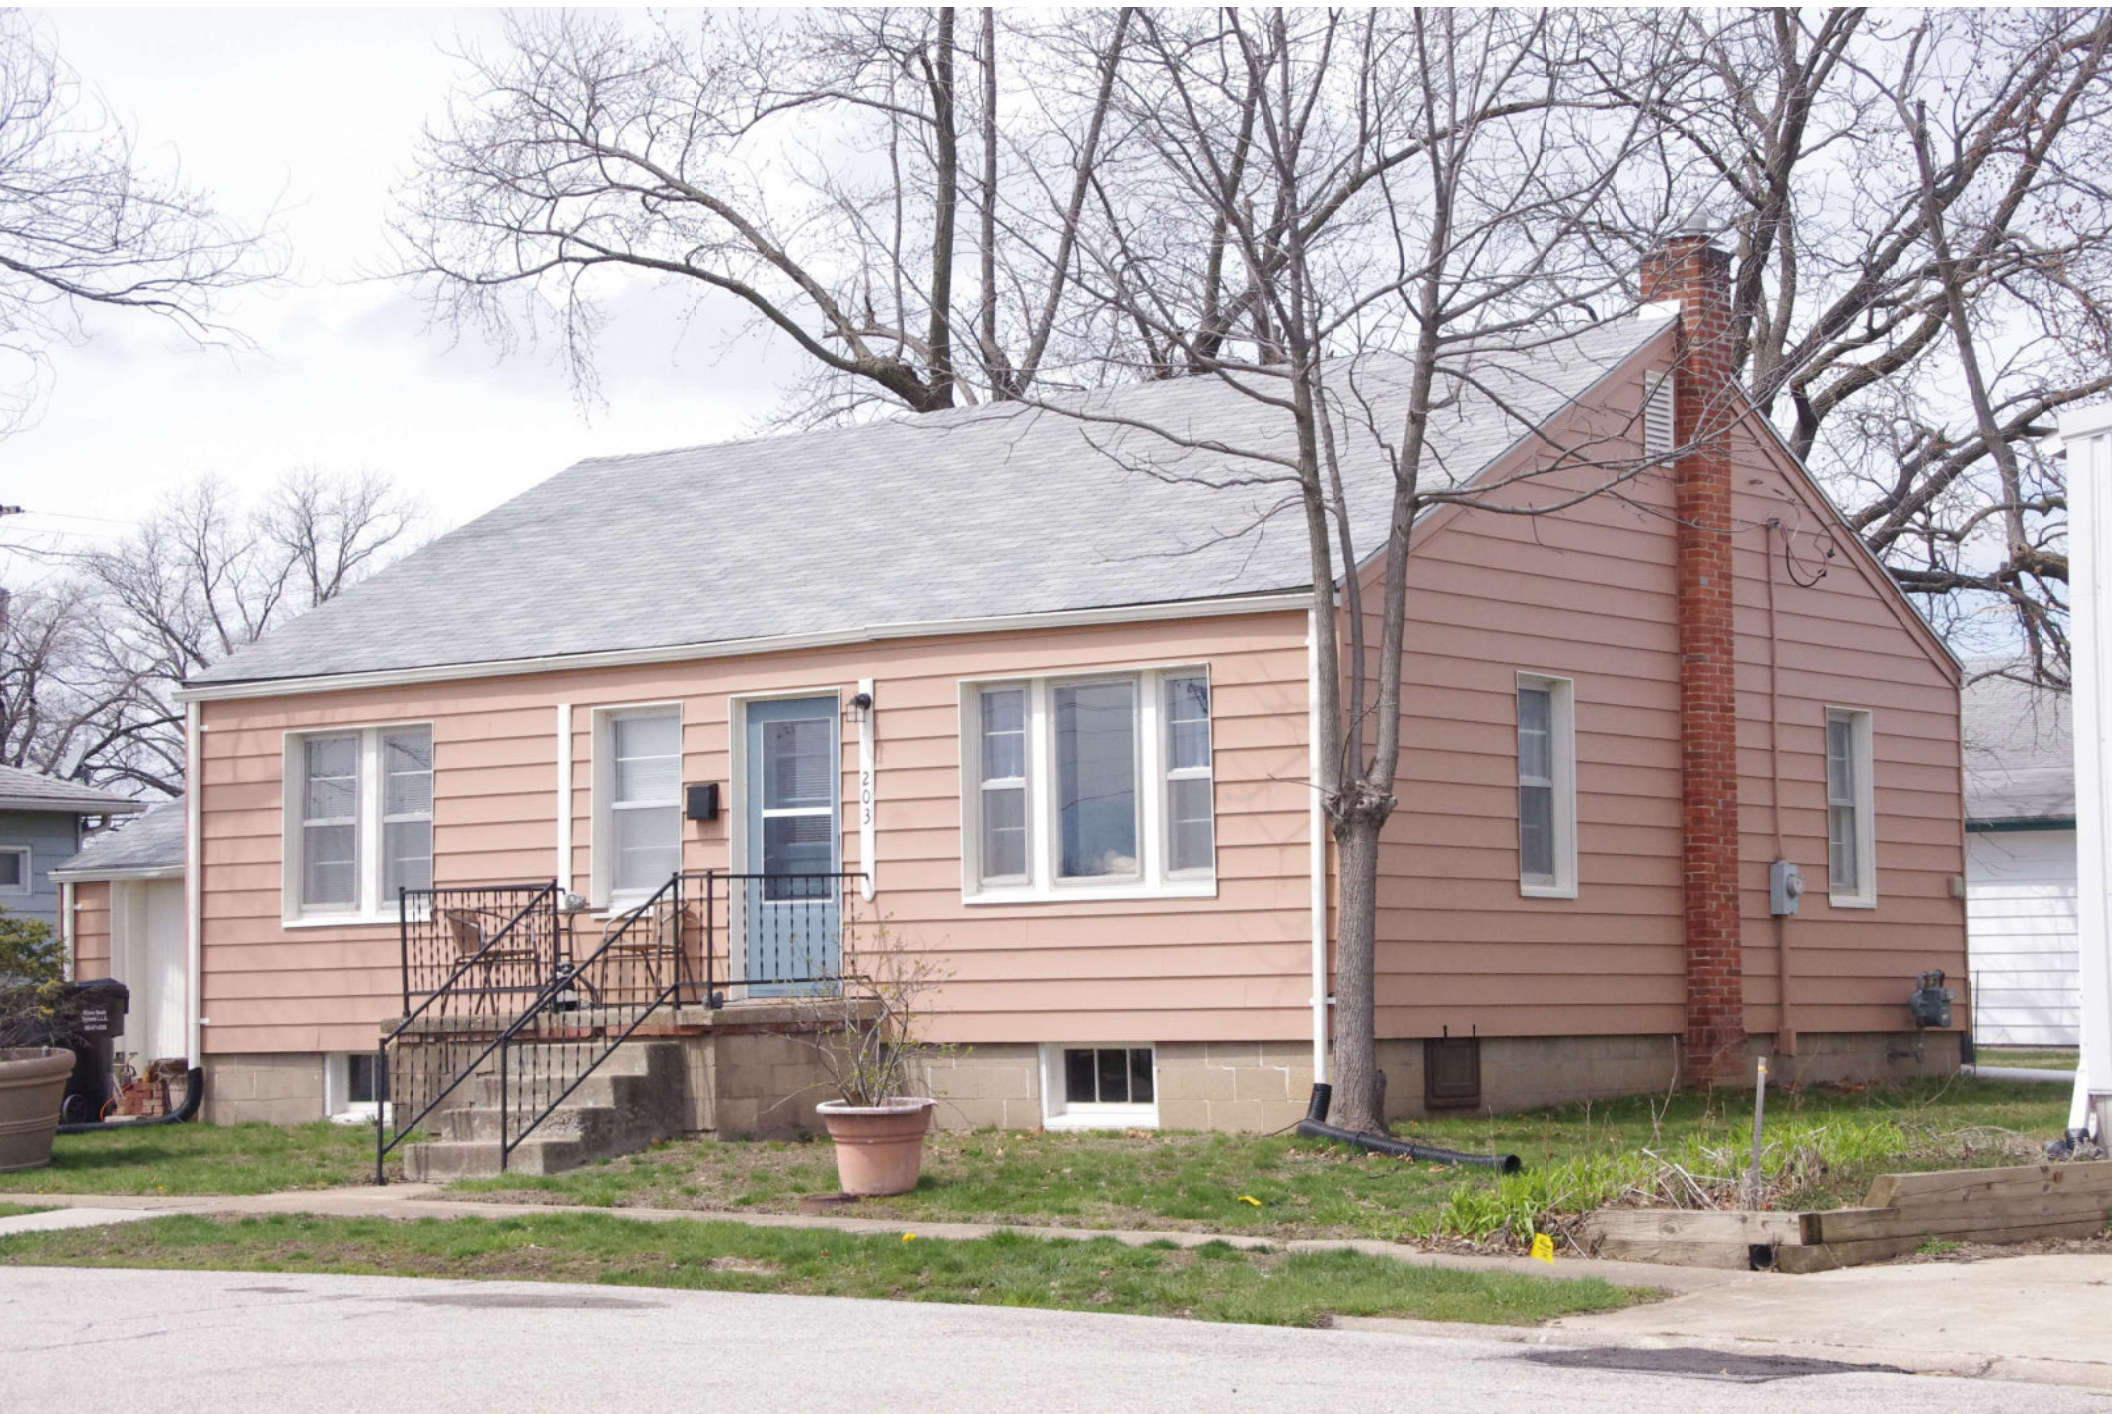
This resource is one-story Cape Cod style house with a side gabled roof and a chimney on the east end. The siding has been replaced with aluminum siding but it retains the original half light wood door with 3 horizontal lights and 3 horizontal panels. It is accessed by a concrete stoop and located just east of center. Beside it is a two-over-two sash window, one of the original horizontal light windows. Similar windows are found paired in the western bay. A fixed pane "picture" window with two-over-two sashed sidelights is featured in the eastern bay. On the west side of the house is a shorter, one story, side gabled, one-car garage with the original vertical board, flat, overhead door.

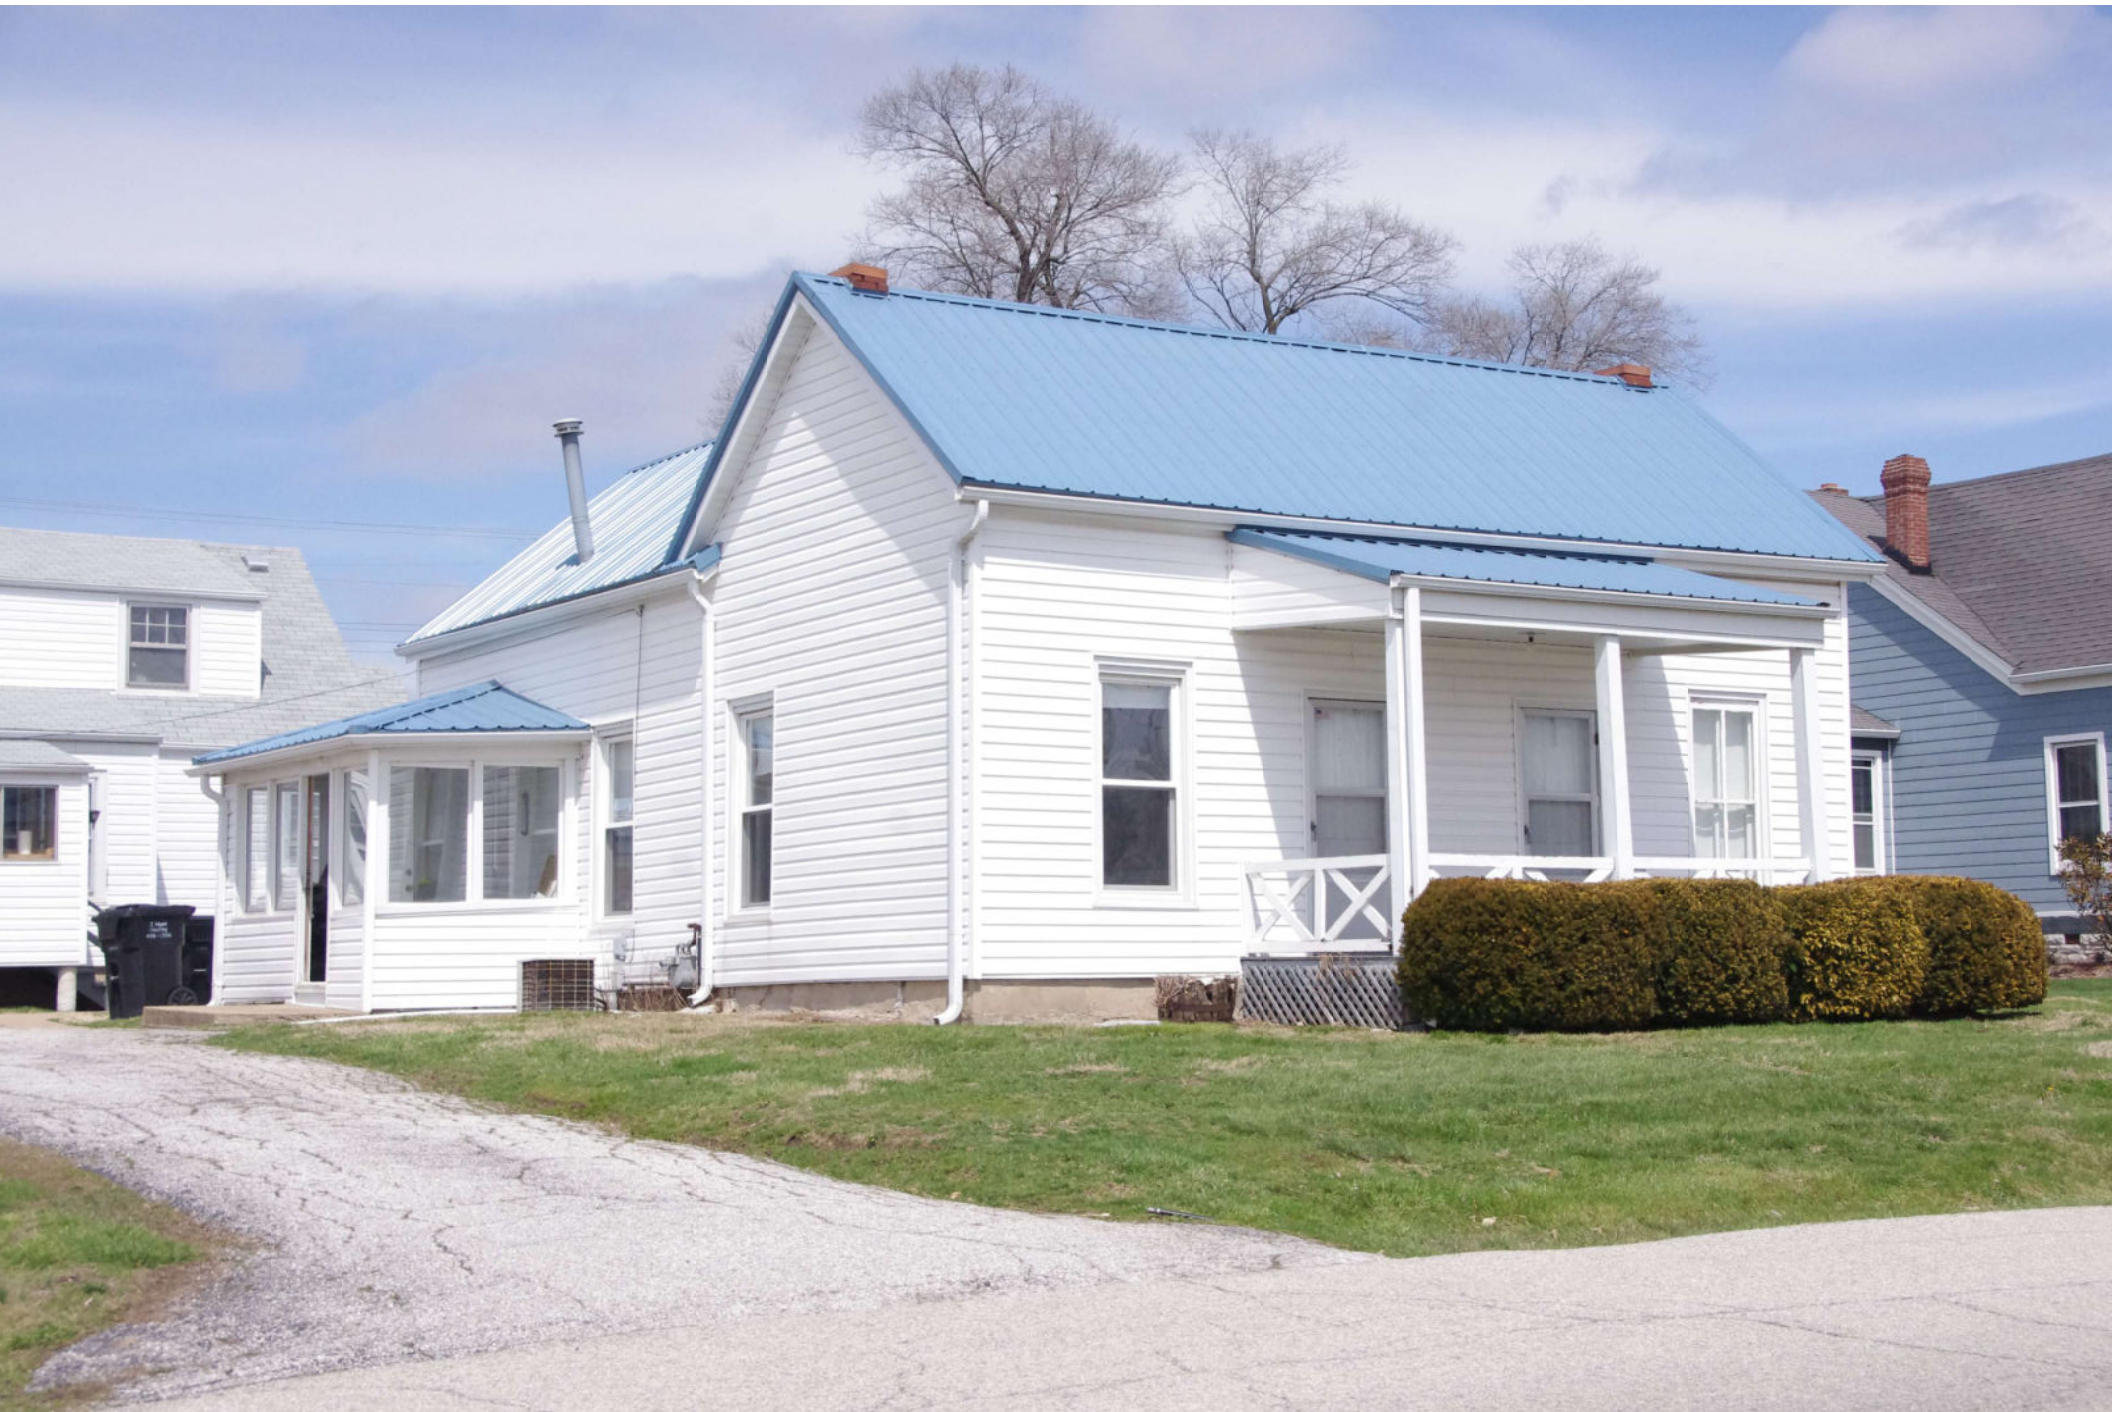
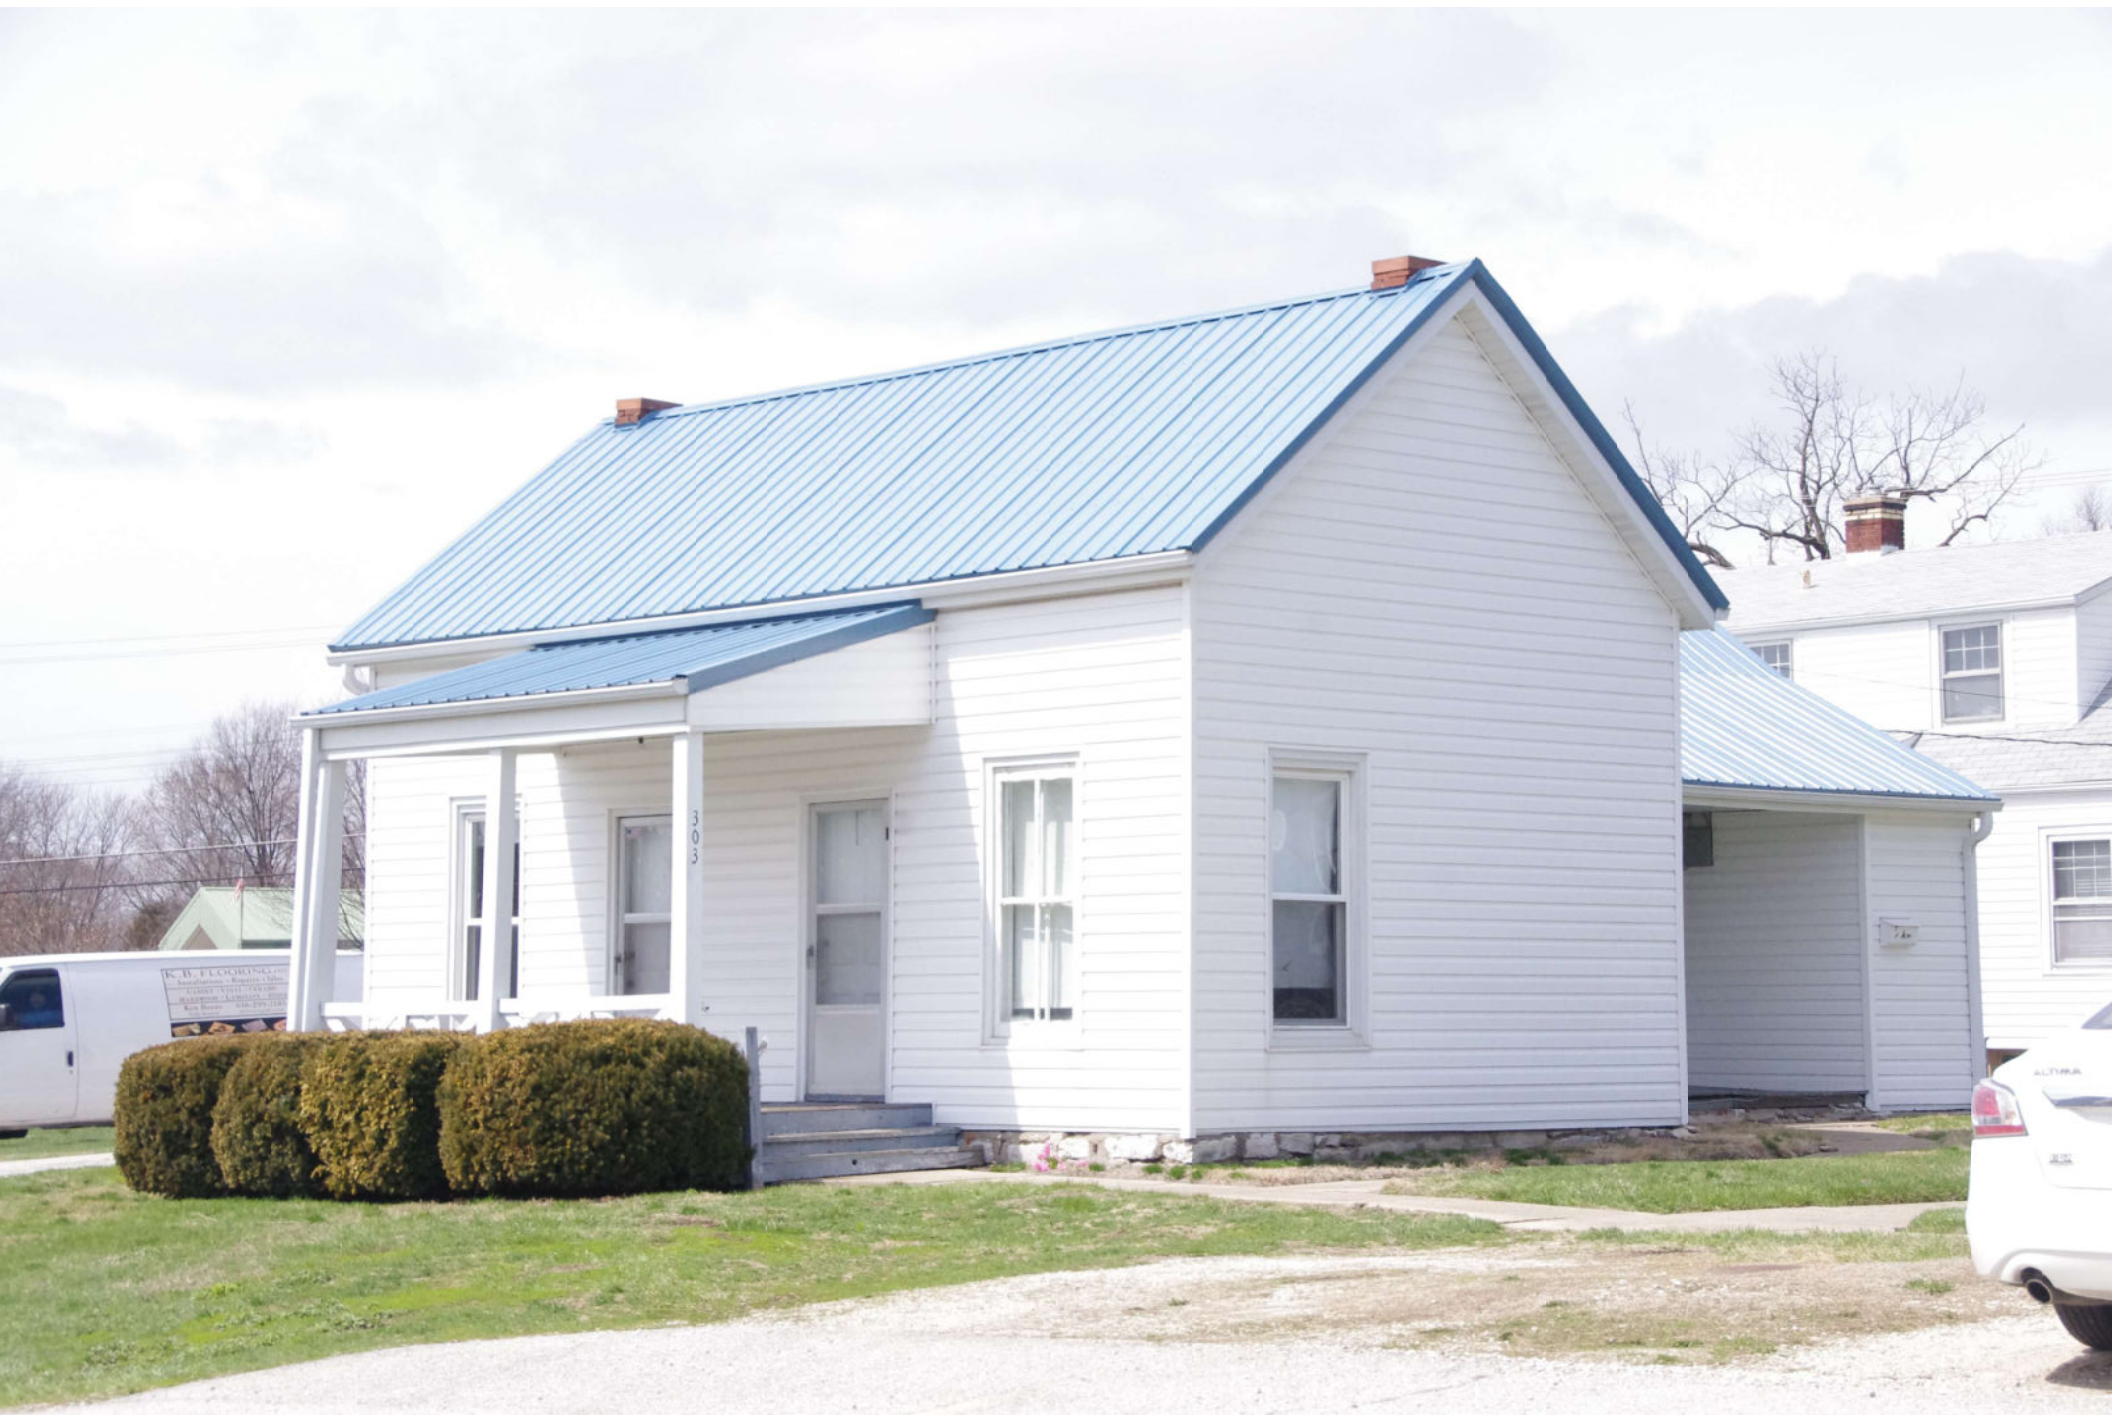
This resource is a one-story, hall-and-parlor plan, wood frame, two-family house with a side gabled roof and chimneys on both ends. The house has been clad with replacement vinyl siding. There are two, 4-panel wood doors under the shed roofed, open porch that has simple square corner posts and replacement railings but still retains the wood porch floor and side entry steps. To each side the outer bays are comprised of a window, with the one in the east bay retaining an historic two-over-two wood sashed window while the one in the west bay is a replacement one-over-one vinyl sashed window. The rear of the house is cross gabled, with a recessed breezeway with a wood floor on the east side and a projecting one story hipped roof, enclosed side porch on the west (which was probably added around 1950 since it appears to be on a concrete base).

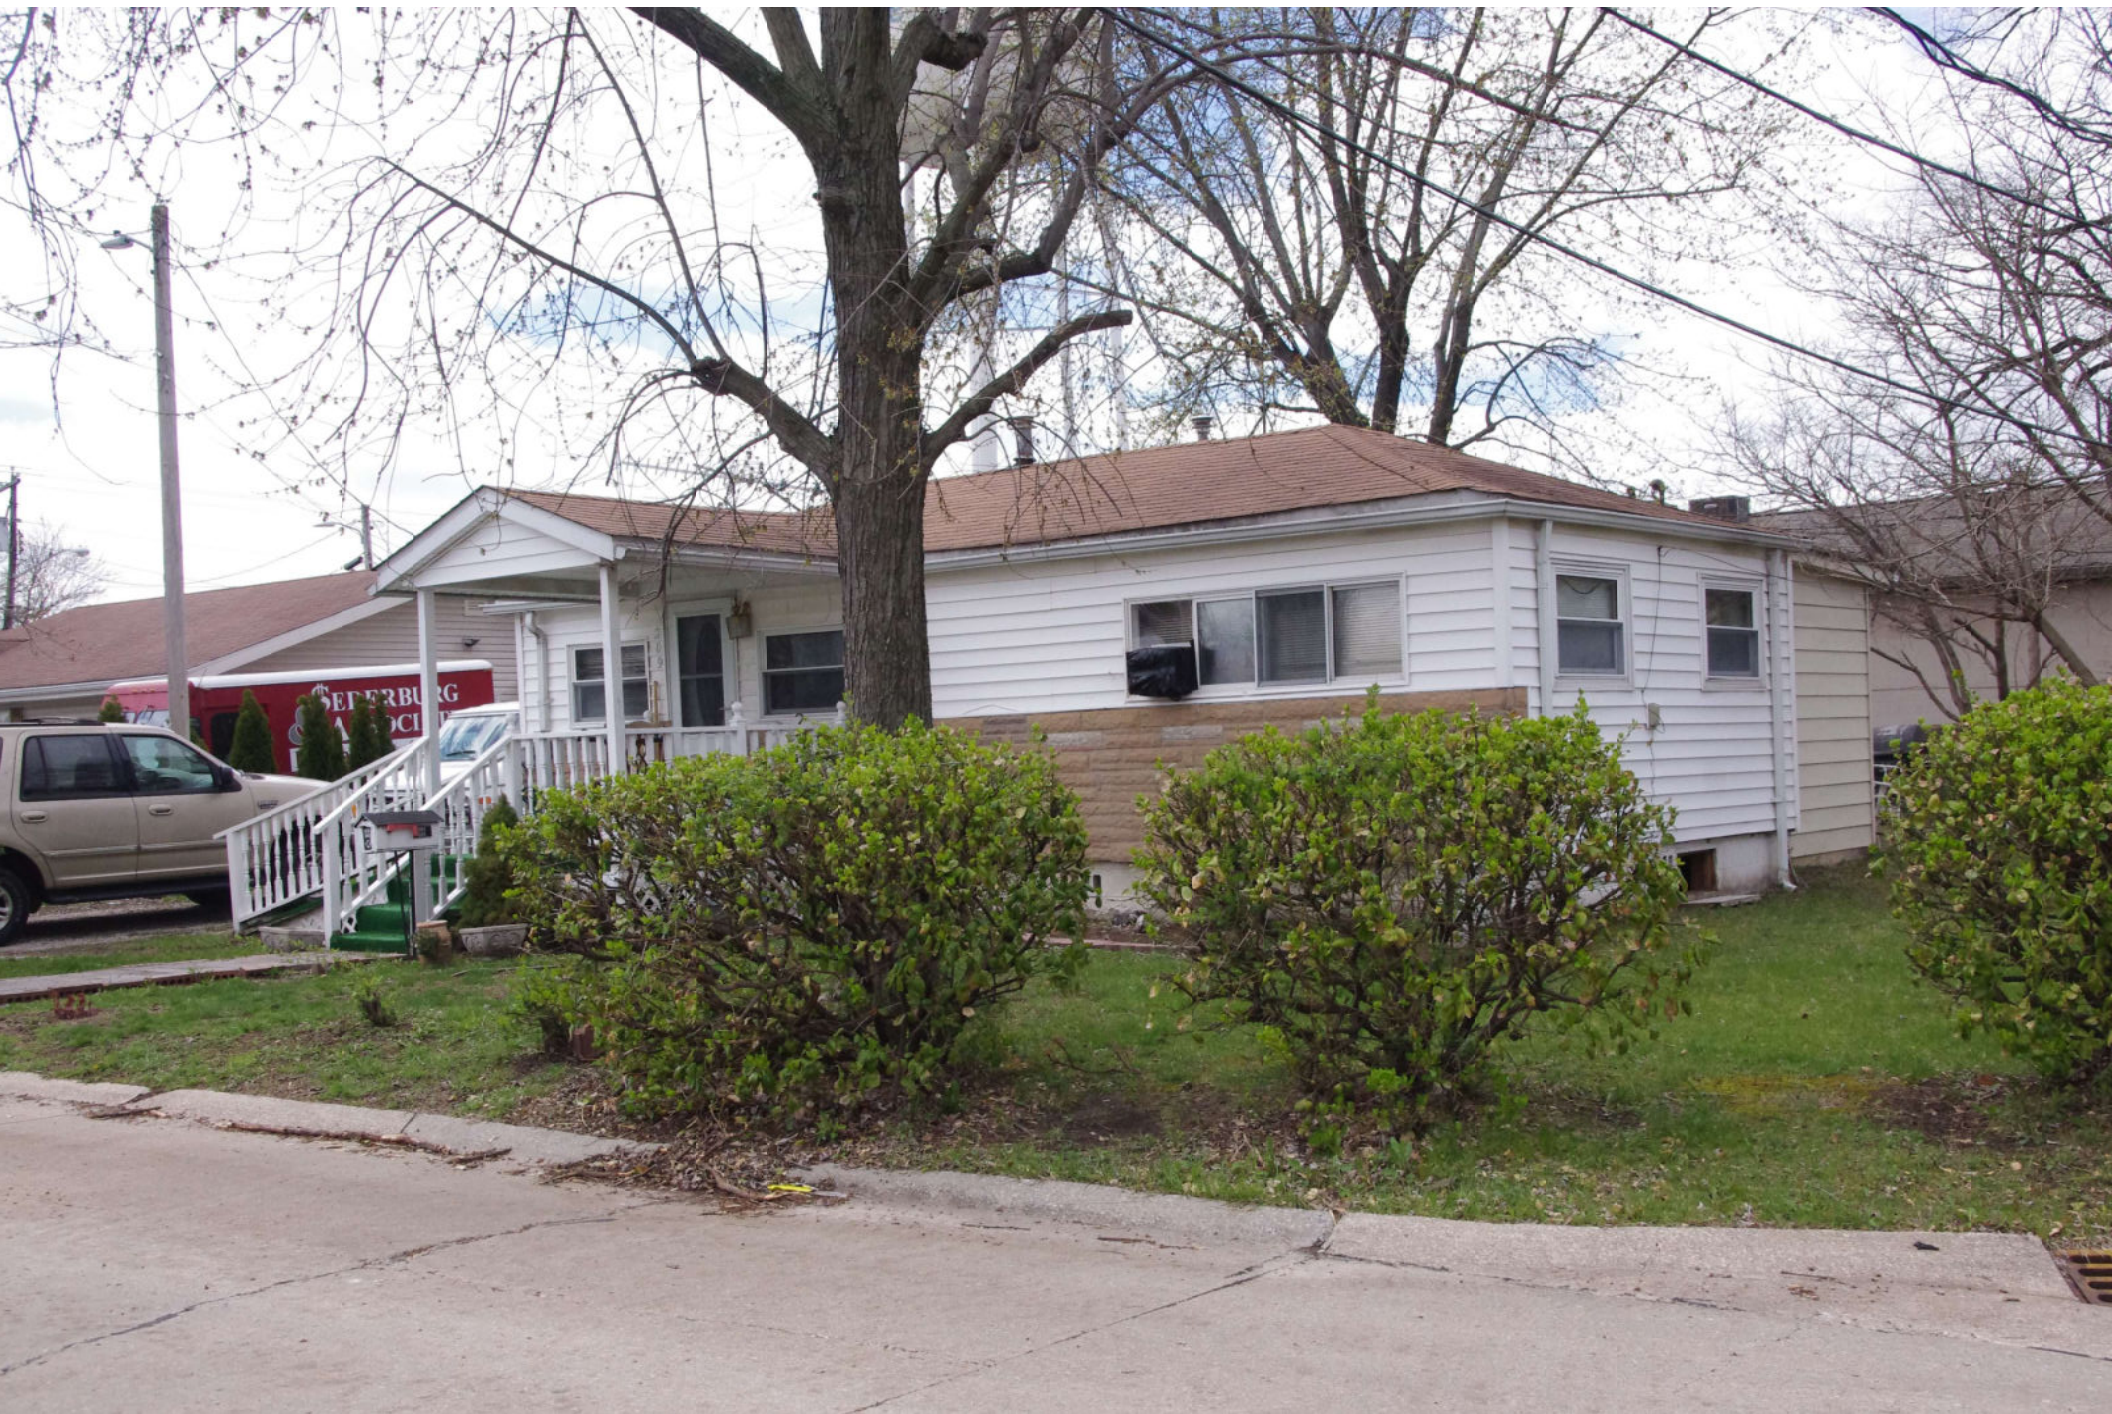
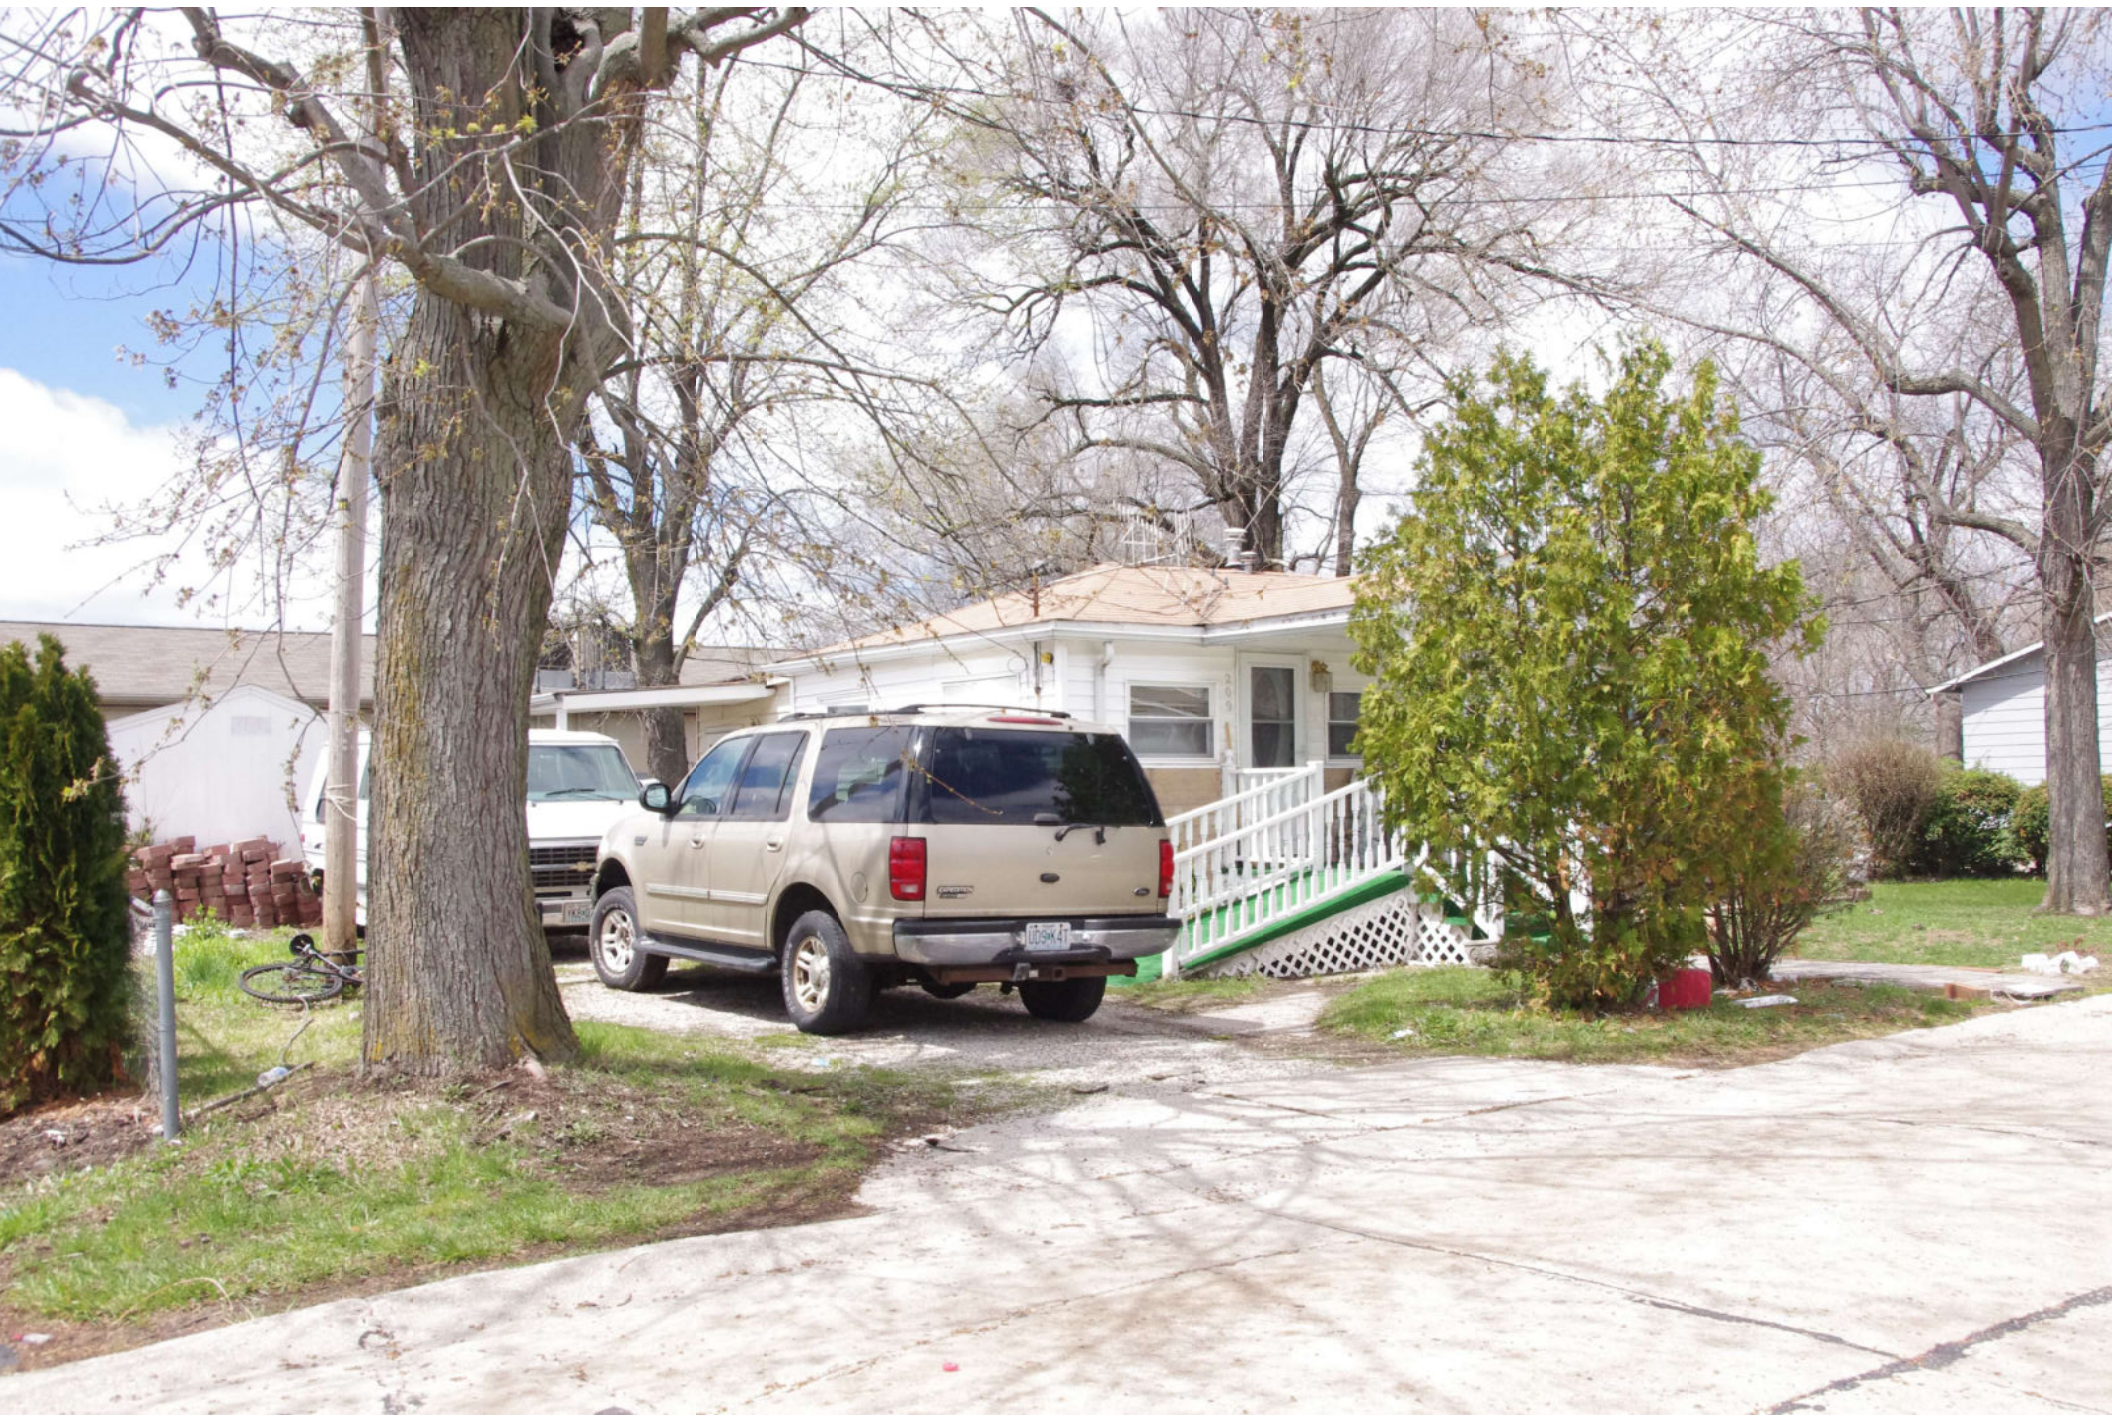
This one story, shallow hipped roof, Ranch style house has siding spanning across the upper portion of the façade walls with a faux stone, ashlar pattern wall on the lower half. While the siding has been replaced with vinyl siding, the faux stone appears original and characteristic of many modest Ranch designs. Located in the southern bay of the façade, the gabled roof porch has a concrete floor and simple, square corner posts, which all appear original to the design; however, the spindlework railing on the porch and steps, as well as the wheelchair ramp, are recent additions. The front door has been replaced with an oval light entry door and it is flanked by small, sashed window openings, with replacement vinyl sashed windows. At the northern end of the façade there is a four-light, horizontal, sliding window. On the rear, there is a one story, vinyl siding addition.

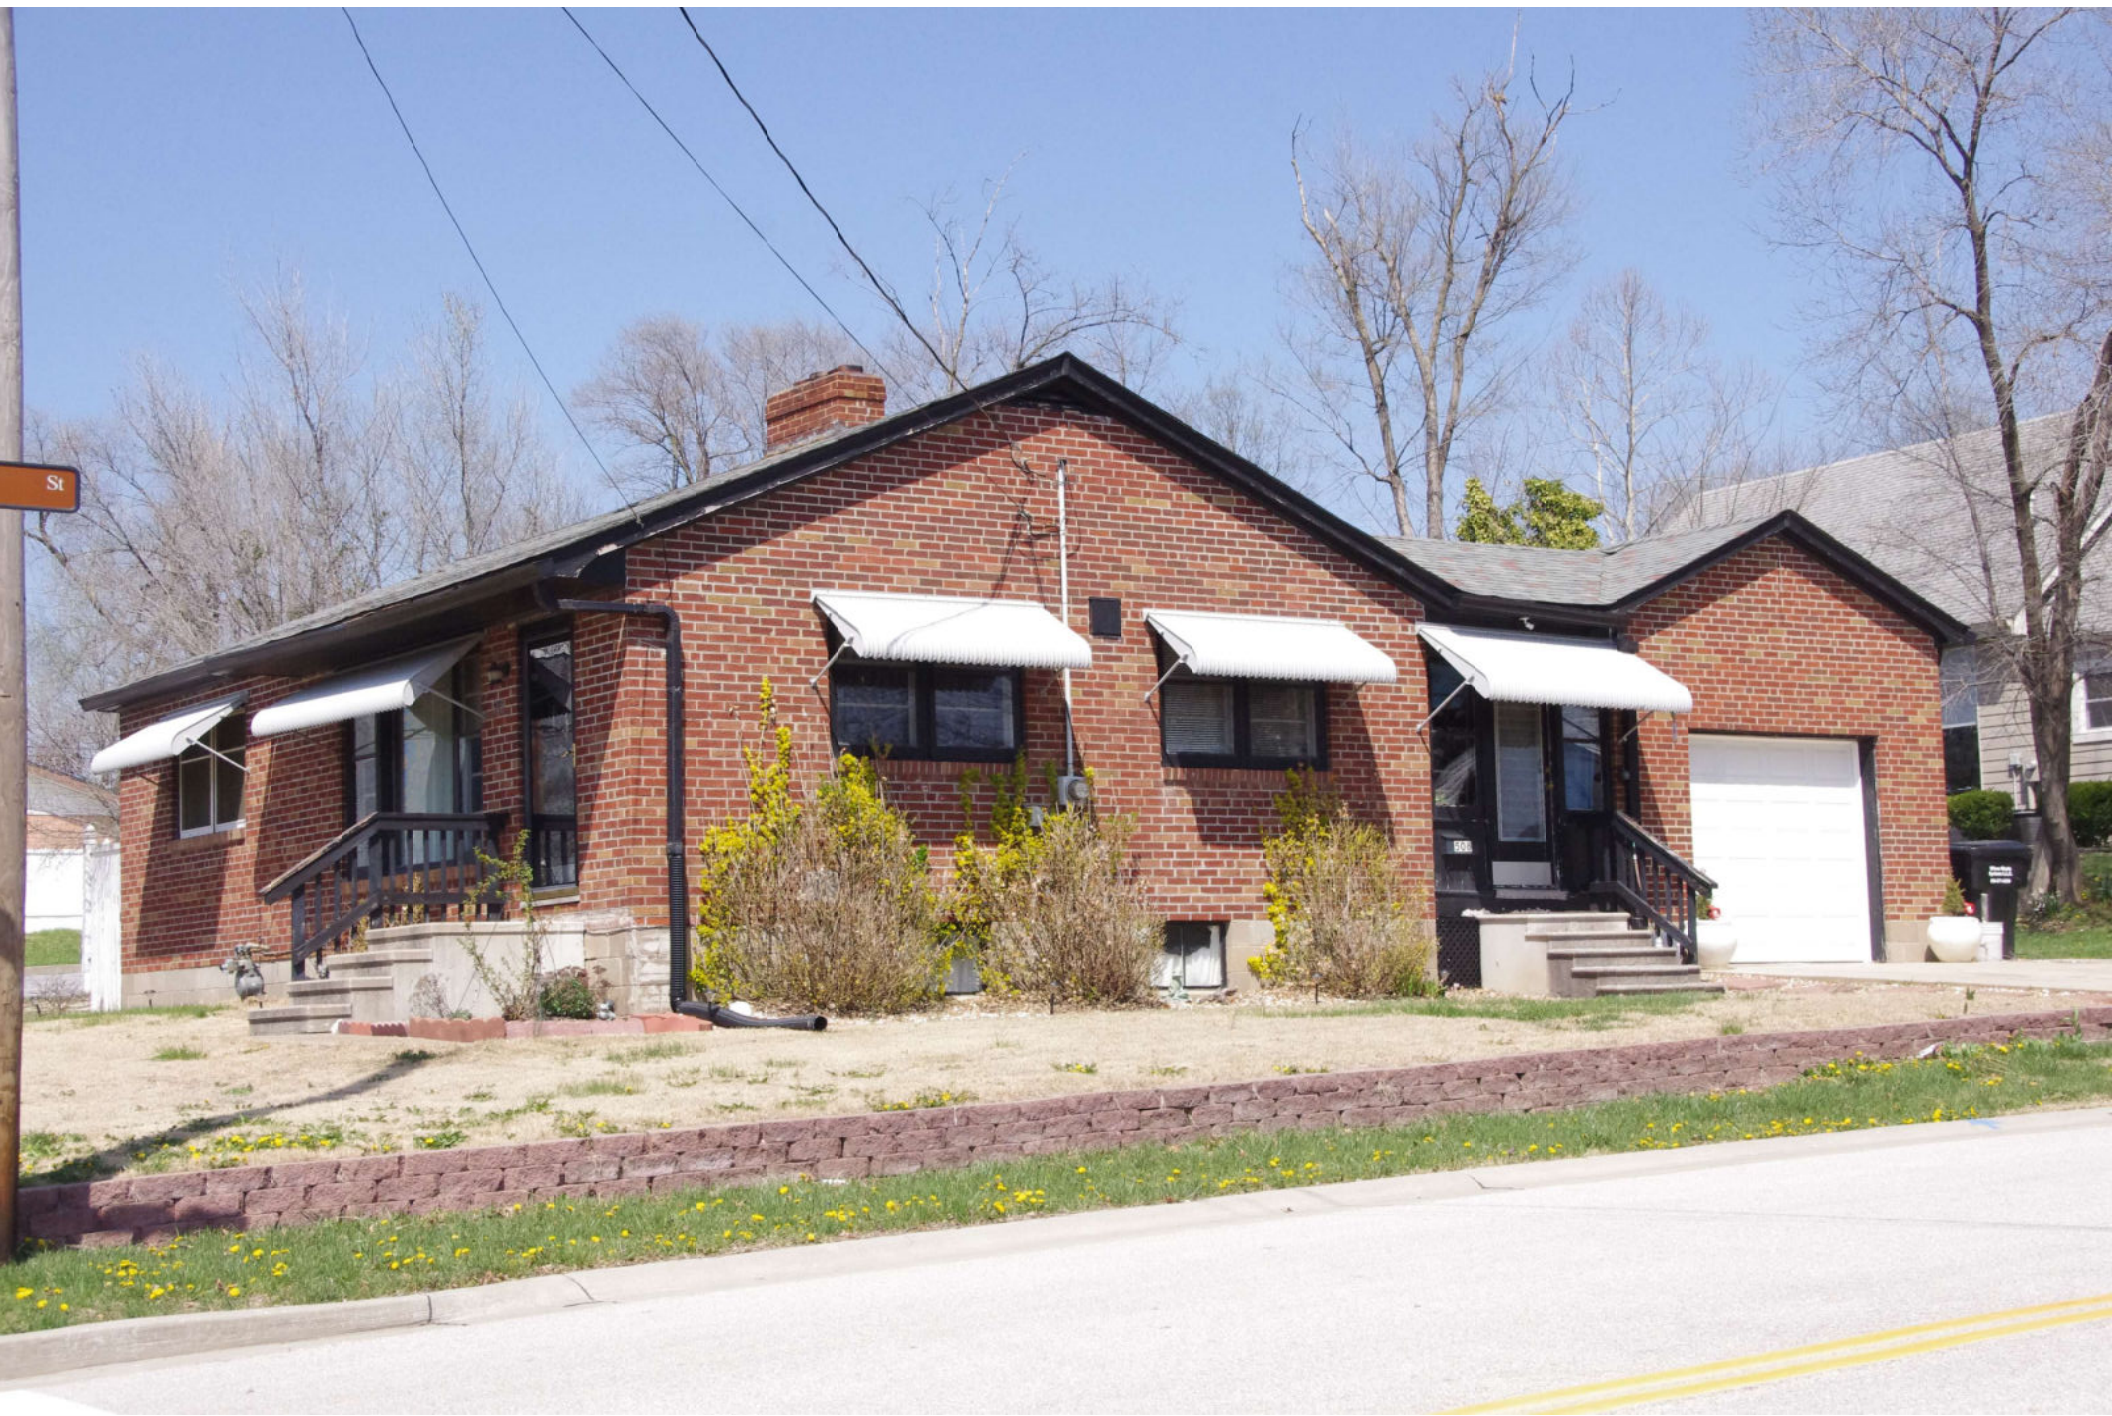
This resource is a one-story side gabled house with the wide eaves, the picture window flanked by narrow sashed windows and the broad central ridge chimney common to modest Ranch houses. The wood door is located in the southern bay and has a small round light, it has a simple concrete stoop and a replacement wood railing. The picture window is located in the center bay and there are paired sashed windows in the north bay of the façade as well as two sets of paired sashes in the gable end facing Sixth Street. All of these original windows have horizontal lights. Shed shaped metal awnings have been added over the windows. On the Sixth Street elevation there is an enclosed breezeway entry with a concrete stoop that connects the house to the end gabled, one car garage with a replacement overhead door.
