**ARCHITECTURAL/HISTORIC INVENTORY FORM**

1. Survey No. SC-AS-012-0001		2. Survey Name: Reconnaissance Level Survey of Historic Downtown Wentzville	
3. County: St. Charles		4. Address (Street No.) 102	Street (name) East Third Street
5. City: Wentzville	Vicinity: <input type="checkbox"/>	6. UTM:	
8. Historic name (if known):		9. Present/other name (if known):	
10. Ownership: <input type="checkbox"/> Private <input type="checkbox"/> Public		11a. Historic use (if known): DOMESTIC/single dwelling	11b. Current use: DOMESTIC/single dwelling
5. City: Wentzville		7. Township/Range/Section:

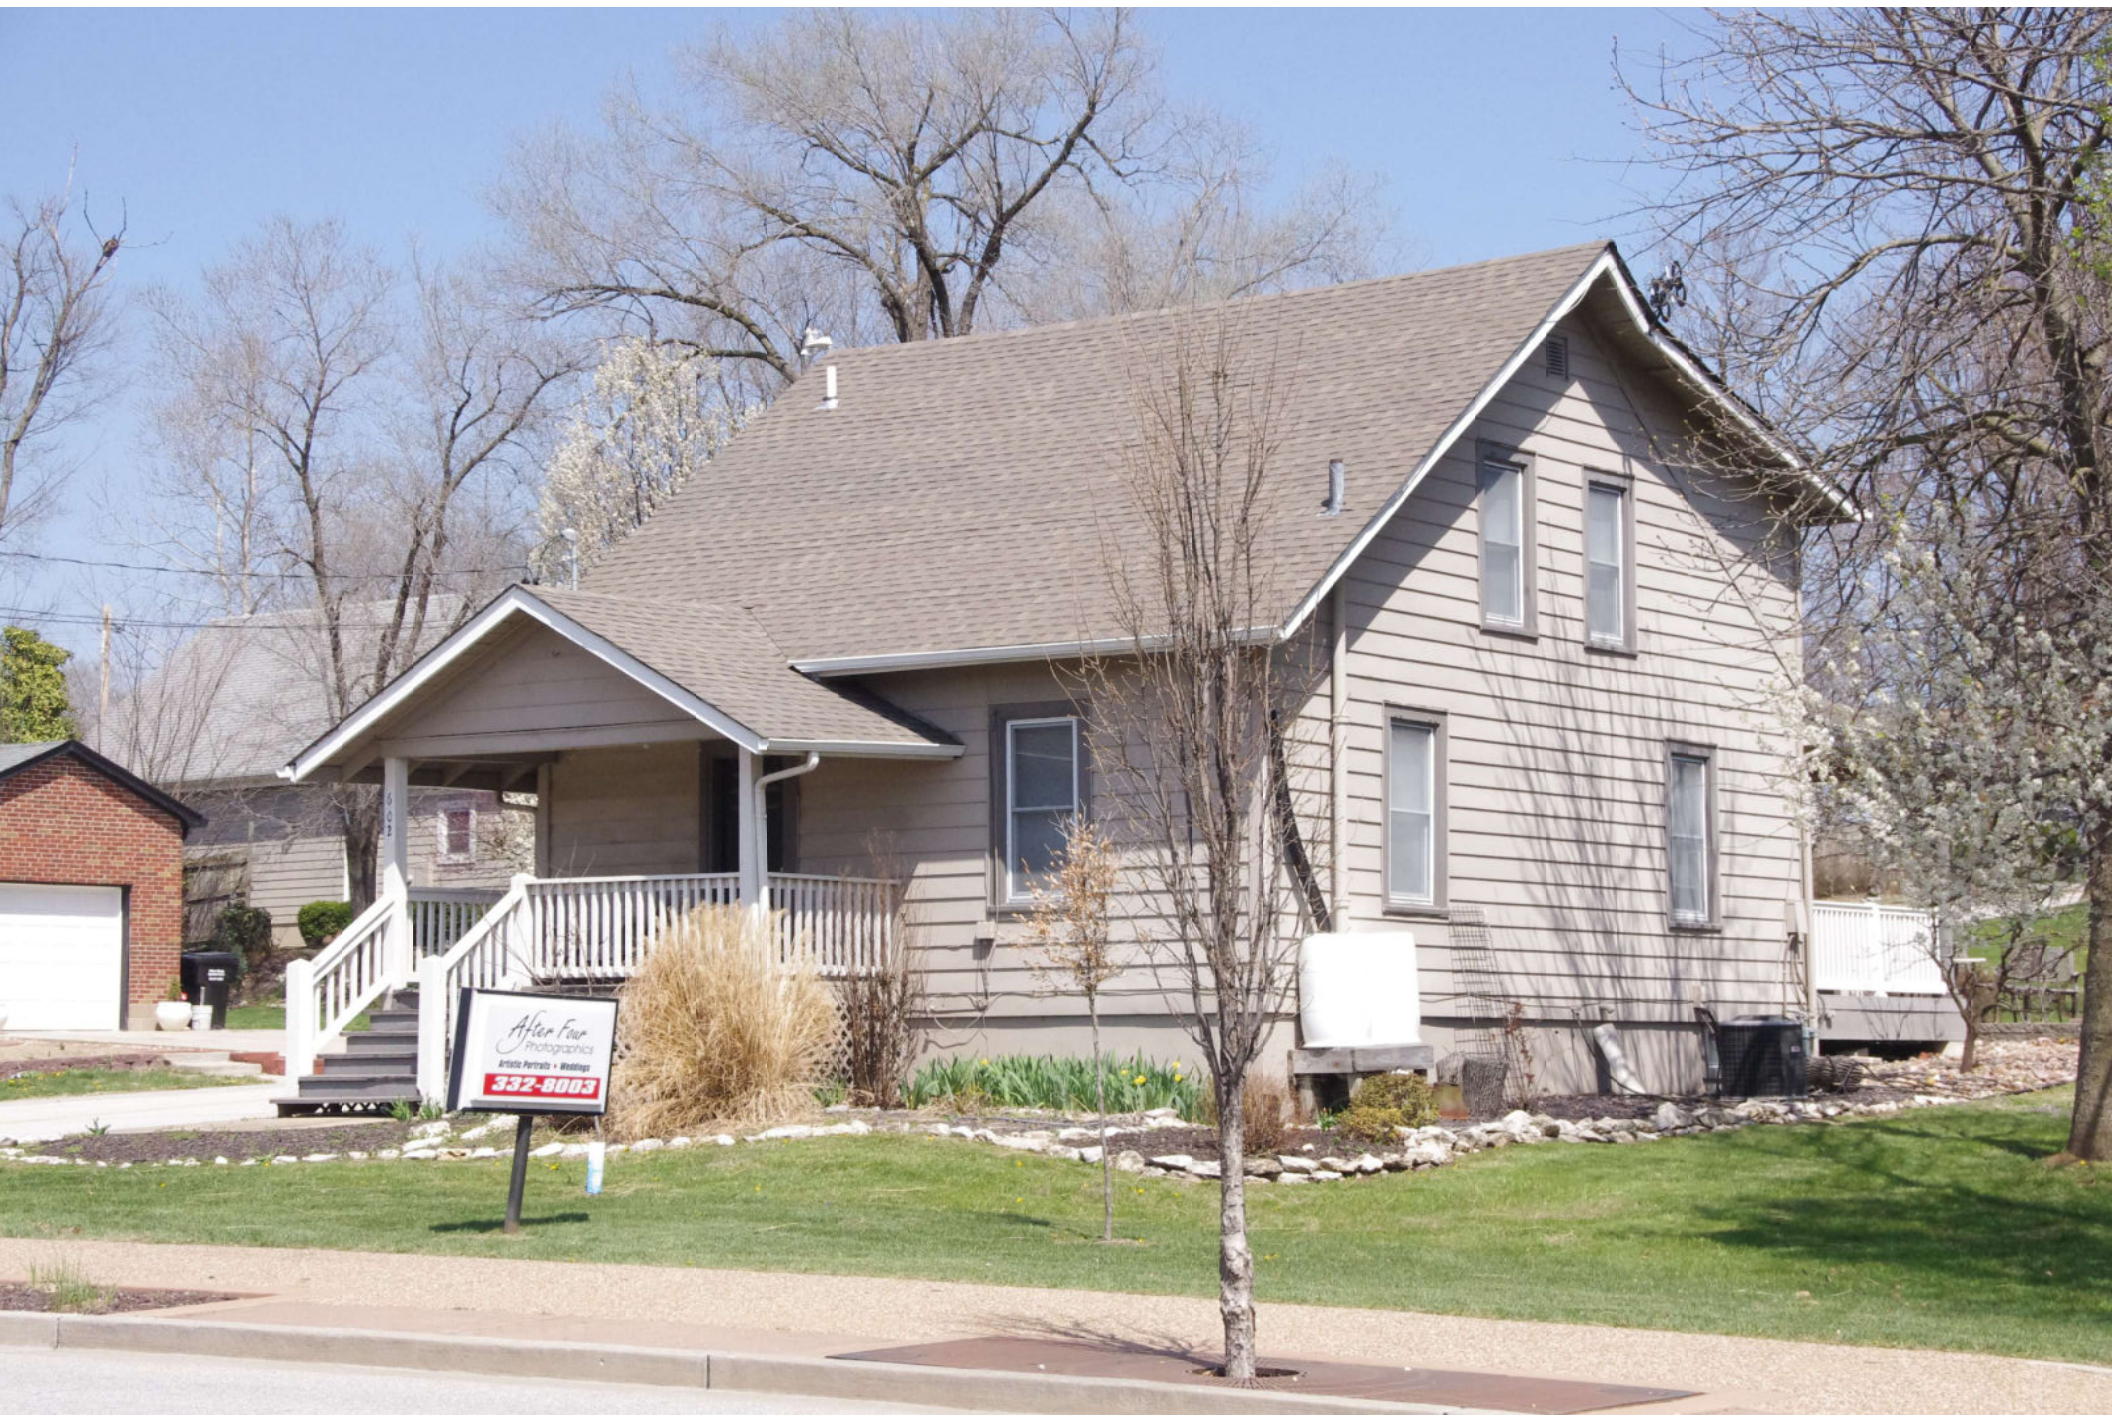
This resource is a one-story side-gabled house that has the bungalow form common to Craftsman houses, but renovations have replaced many of the details that are associated with this style: wide vinyl siding and and 1/1 sashed windows have replaced the original finish details, but it does appear that the wide eaves retains the open rafters. The façade is divided into two bays, with the gabled roof porch spanning the north bay supported by square wood posts resting on the wood porch floor with wood steps leading up from the sidewalk. The railing for the porch has been replaced with a modern deck style railing. The front door has been replaced by a six panel door. The northern bay contains a one-over-one sash window. On the rear is a full width broad gabled porch which appears to be a later addition or alteration.

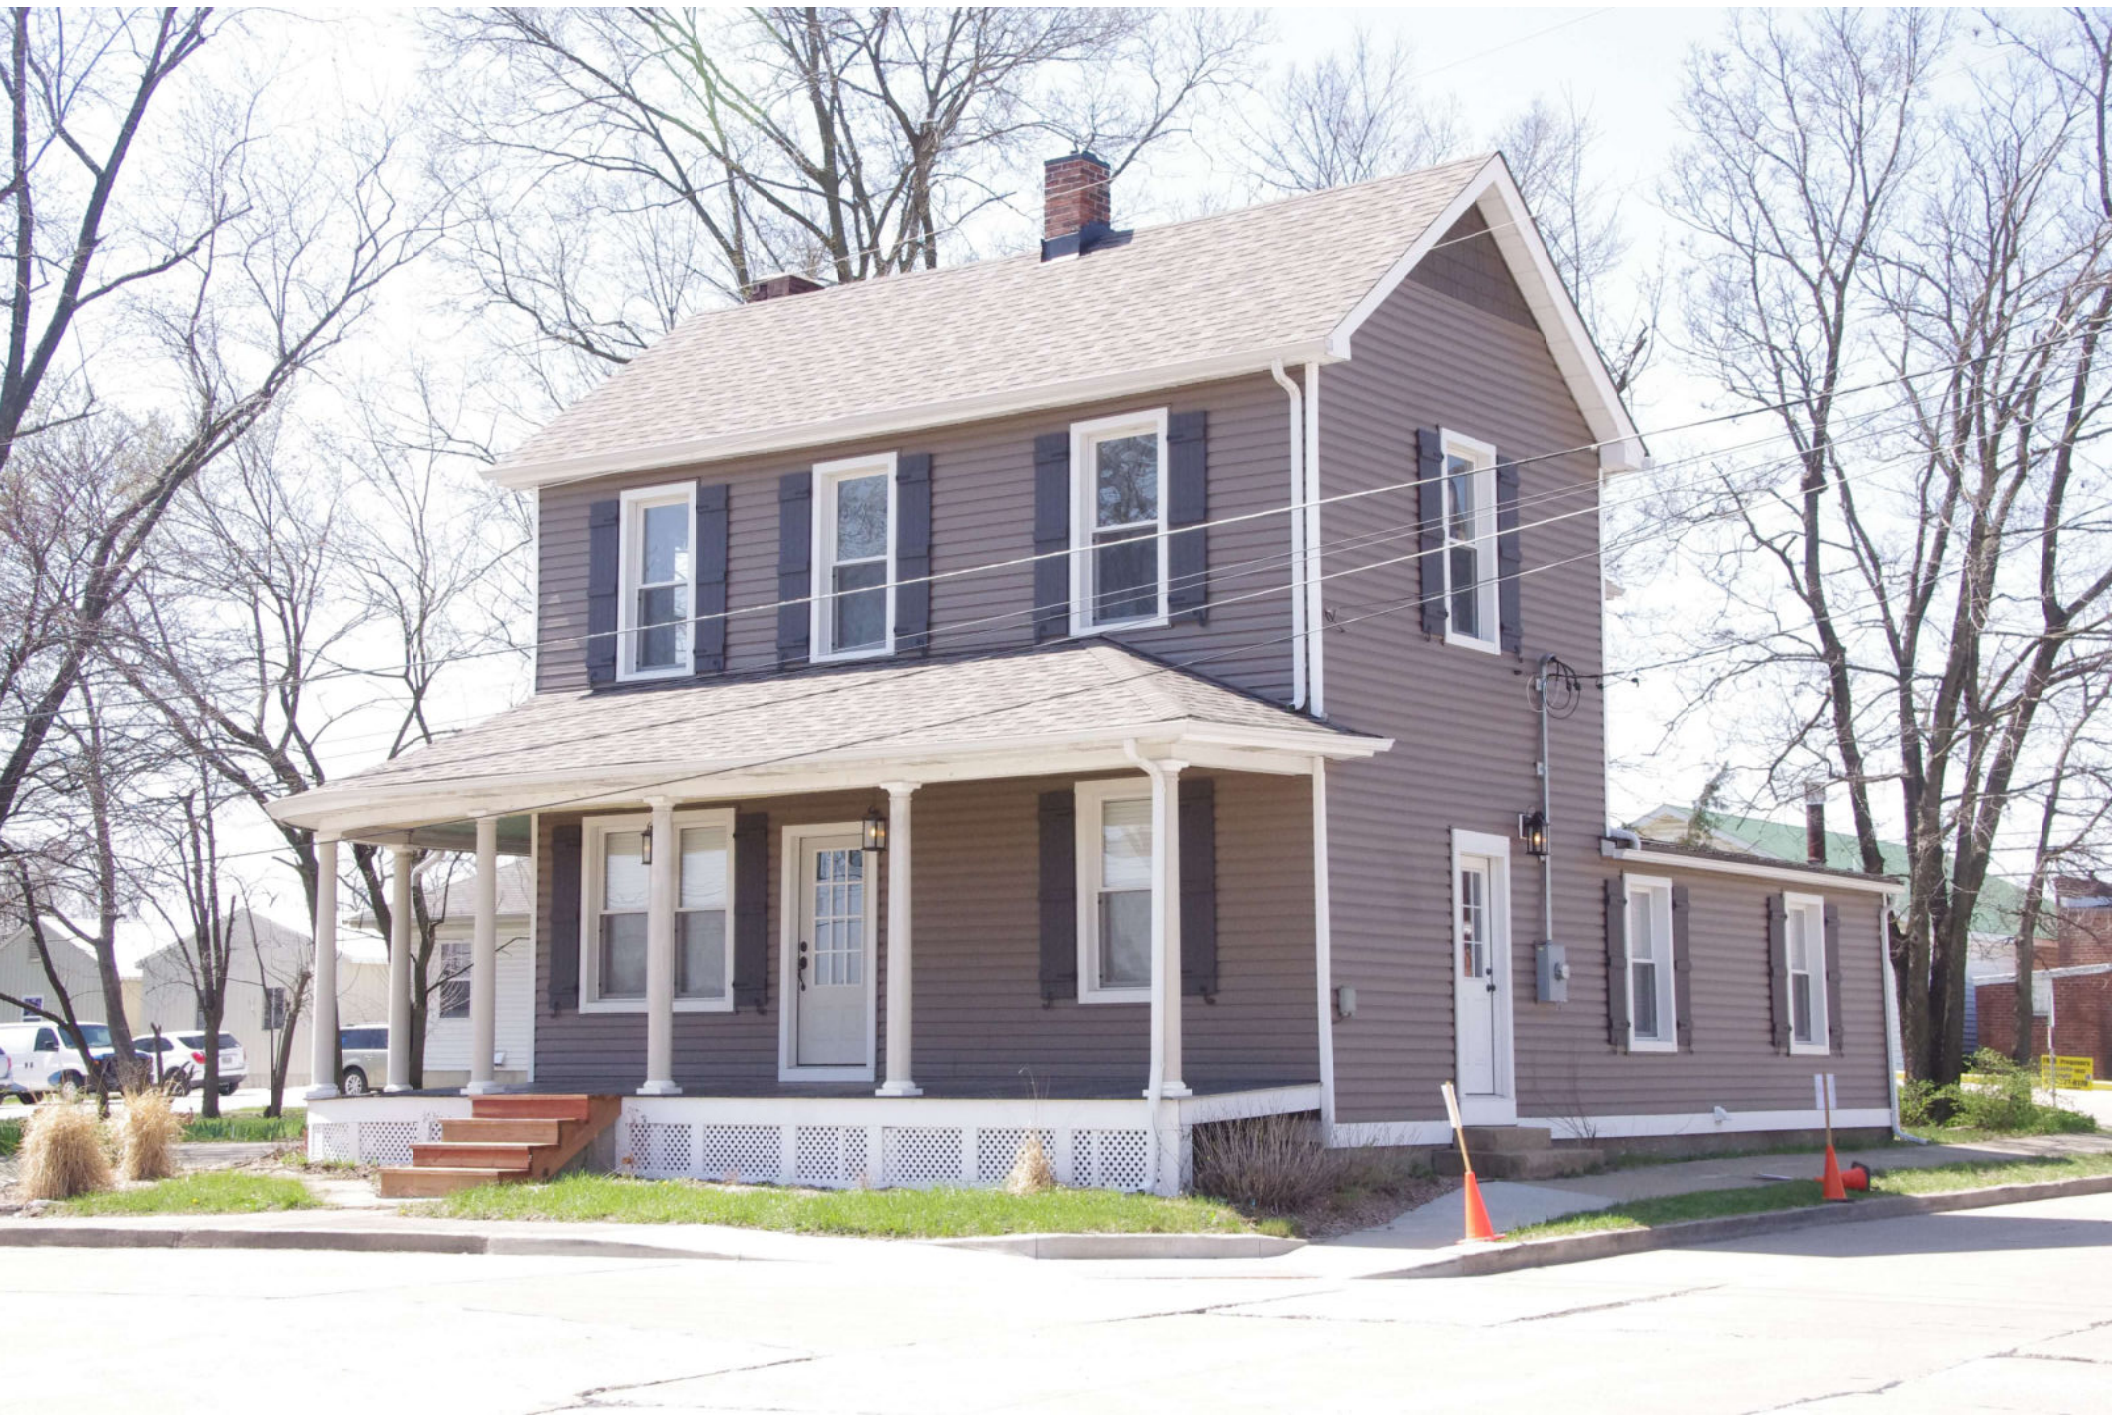
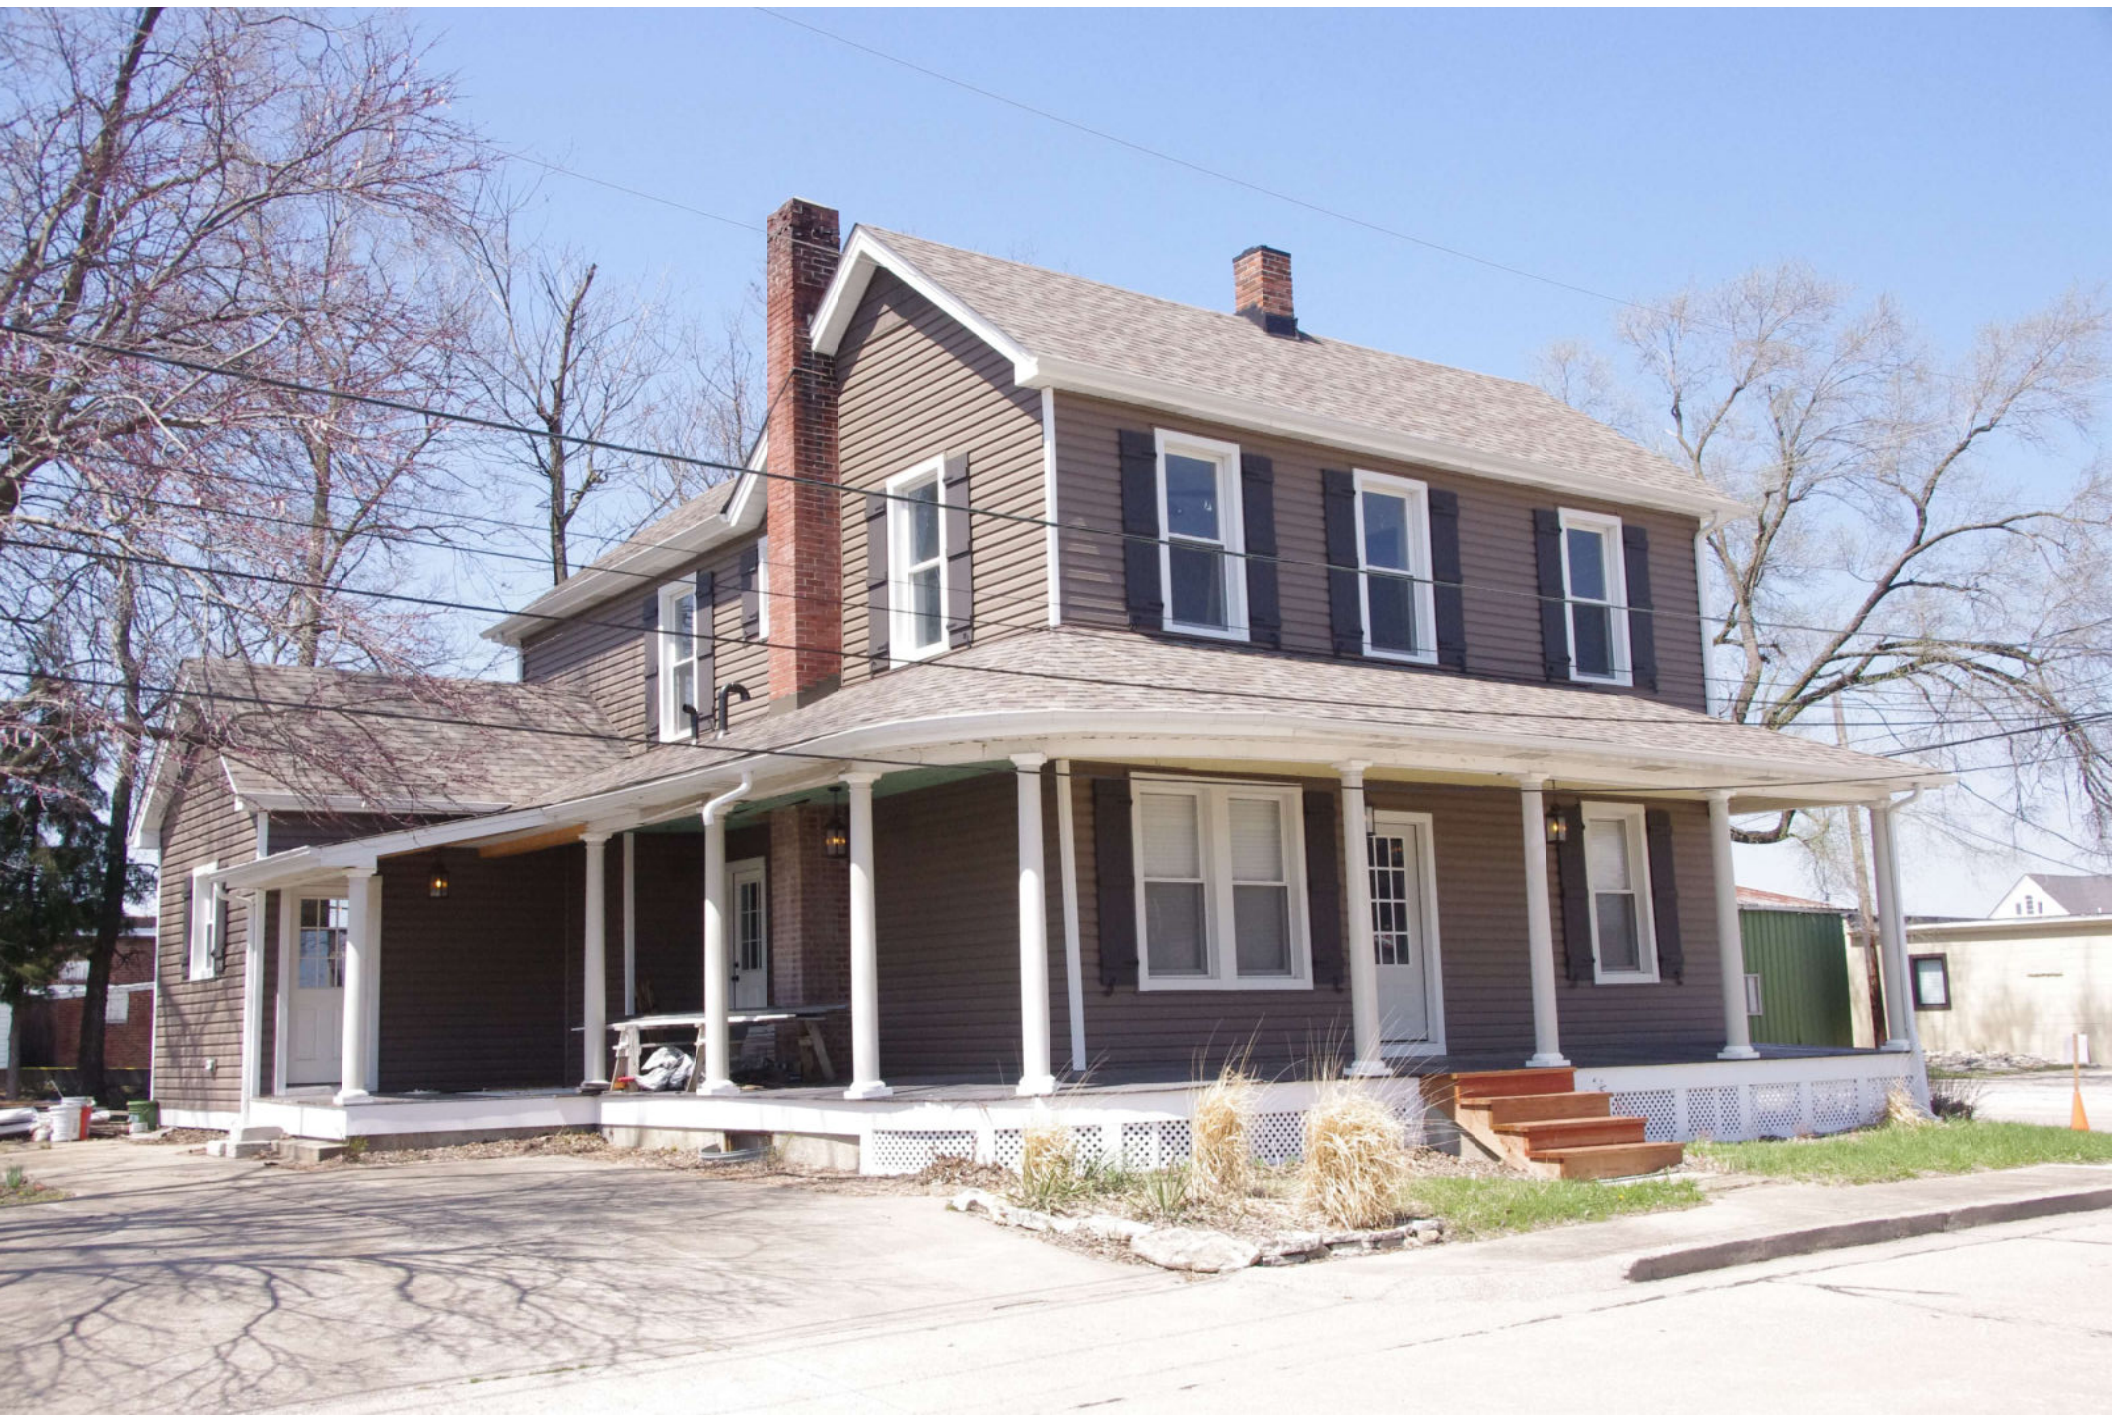
This resource is a two-story I-house with a two-story wing (creating an L-shape plan) with a wrap around porch with tapered columns on the wood porch floor, and shingle roof. Metal and glass door is located just south of center. All of the windows have been replaced with one-over-one vinyl sashes and faux shutters have been added. The windows are found paired in the southern bay. The remaining bay on the first level and three on the upper level feature a single window. The building has a one story section on the north side in the interior of the ell that appears on the 1927 fire insurance map as an enclosed space; it has a shed roof with two sashed windows aligned with the second floor windows on the south wing. The original siding was replaced with vinyl shiplap siding recently and the front door replaced with a 12 light, 2 panel steel door. The original side entry (Pitman elevation) door was still in place until this renovation--it was visible in a Google photograph behind the storm door and had two vertical, arched top lights that with wood panels below.

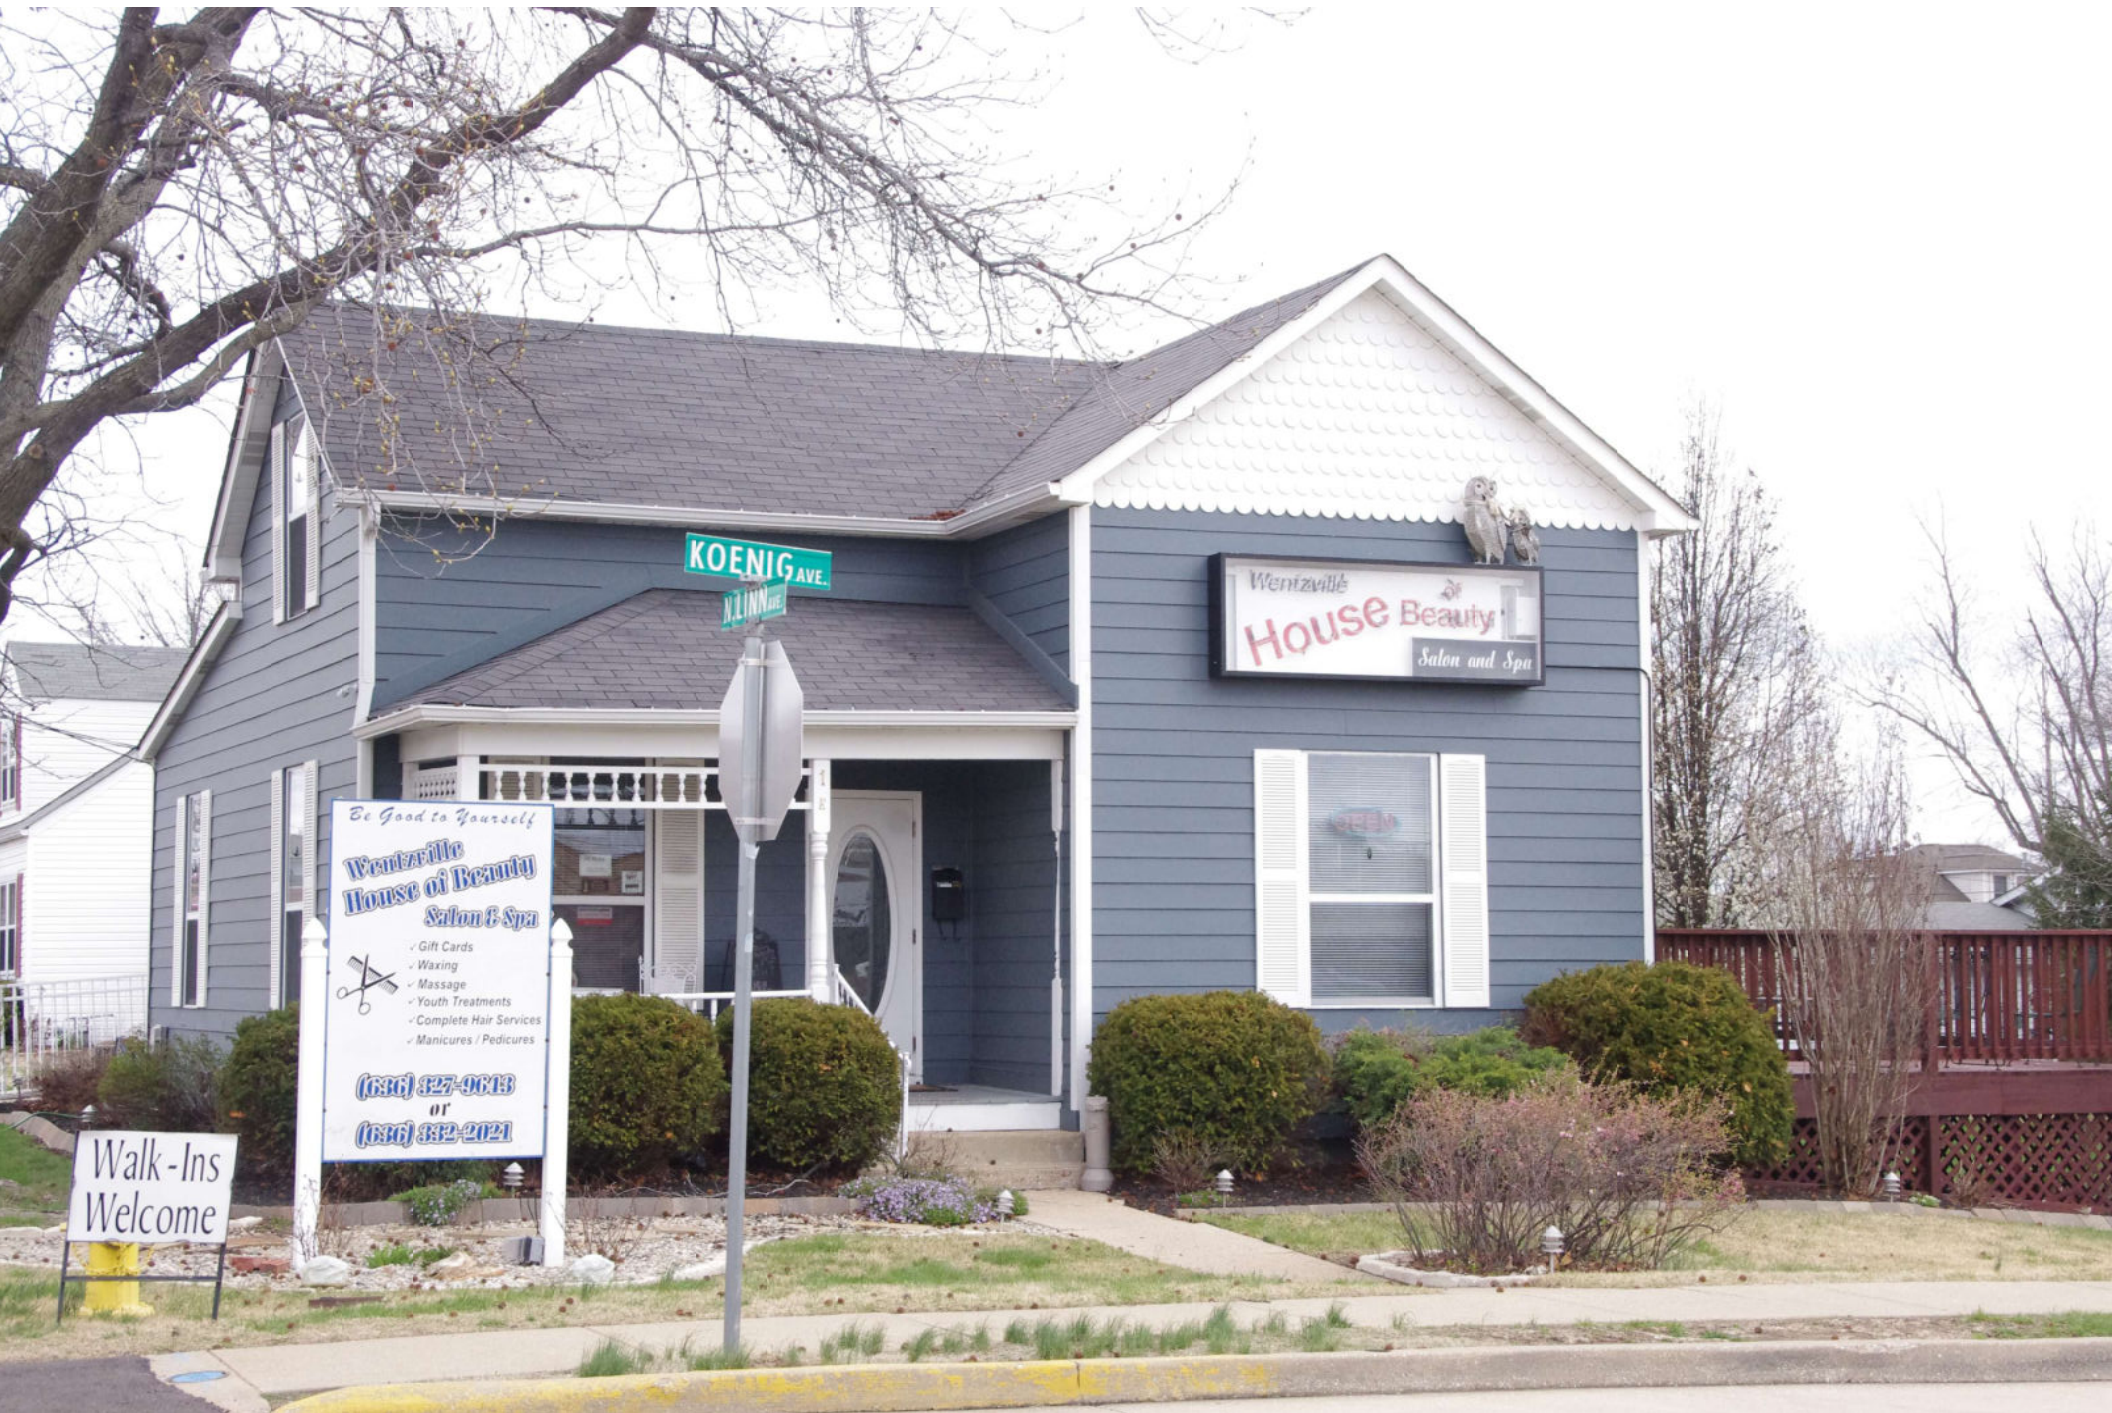
This is a 1.5-story gable-and-wing house with an asphalt shingle roof and replacement Hardy board siding. The hipped roof features turned spindles and supports and spindlework fretboards (which are visible in the historic photo) and wood decking. The full light wood door includes an oval light wood storm door. There are large one-over-one replacement windows, on west of the entry and one located in the eastern, gabled bay. Hardy board fish scale shingles fill the gable end but this pattern is not historic since historically there was a second floor sashed window in the gable end. A large deck has been added on the east side of the building. The windows and siding were likely replaced when the building was converted from residential to commercial.

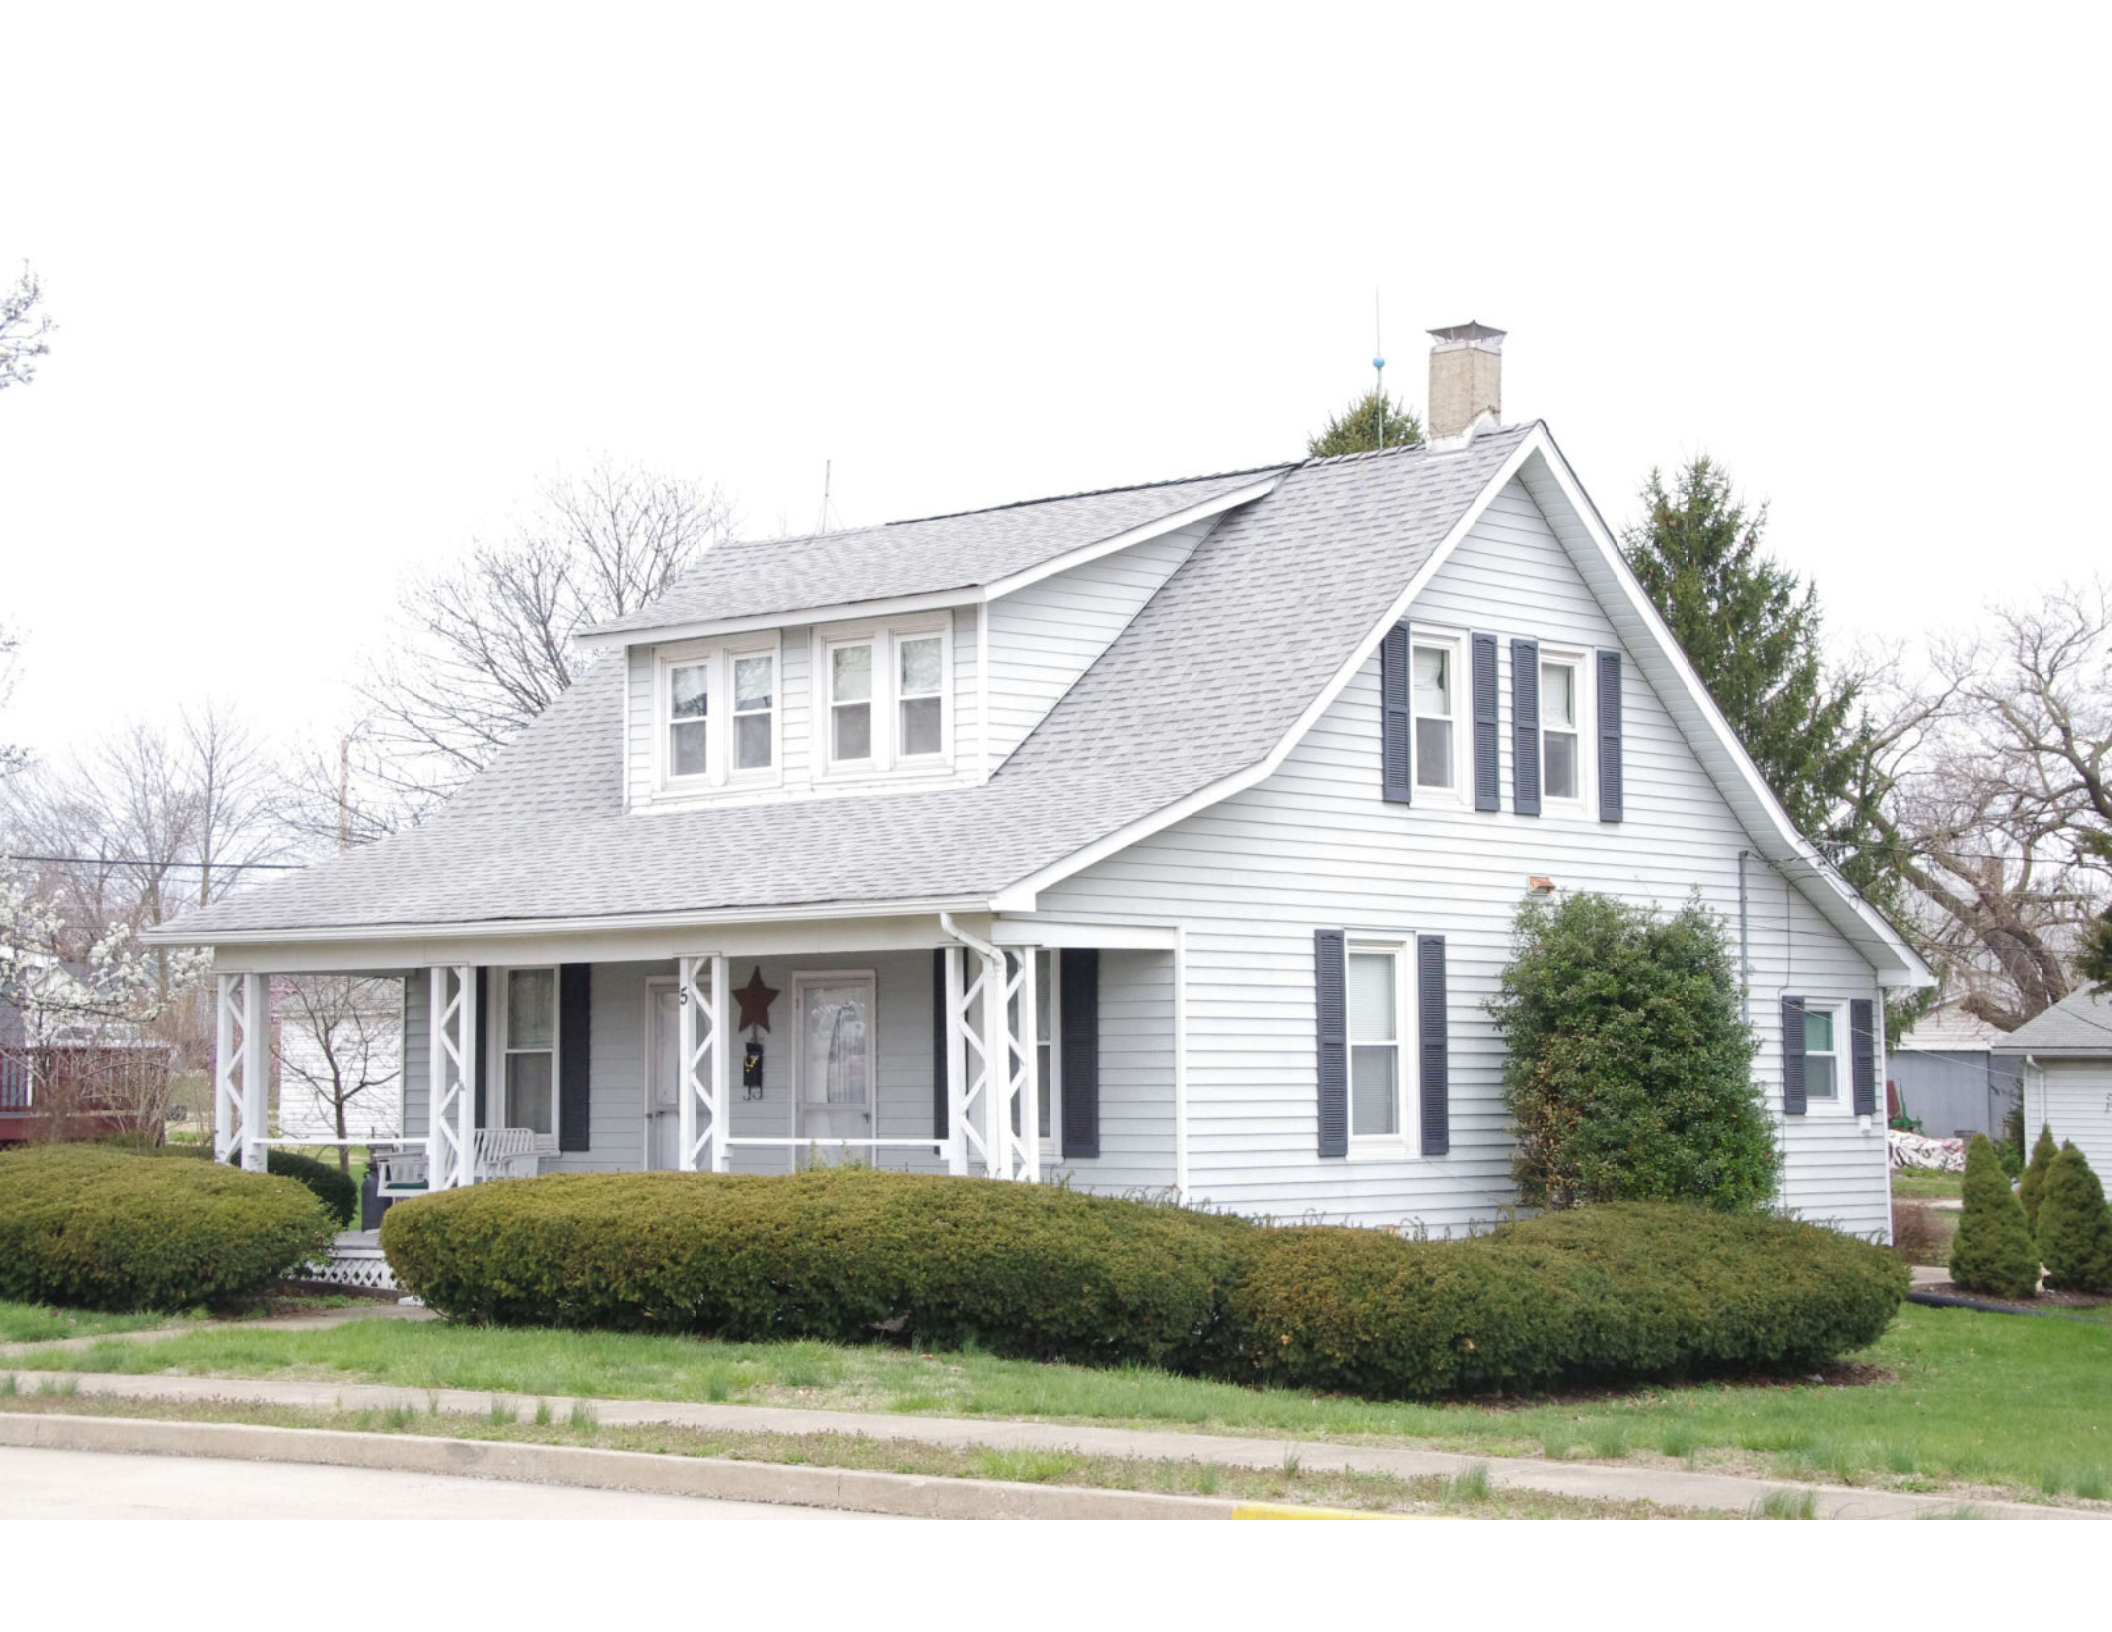
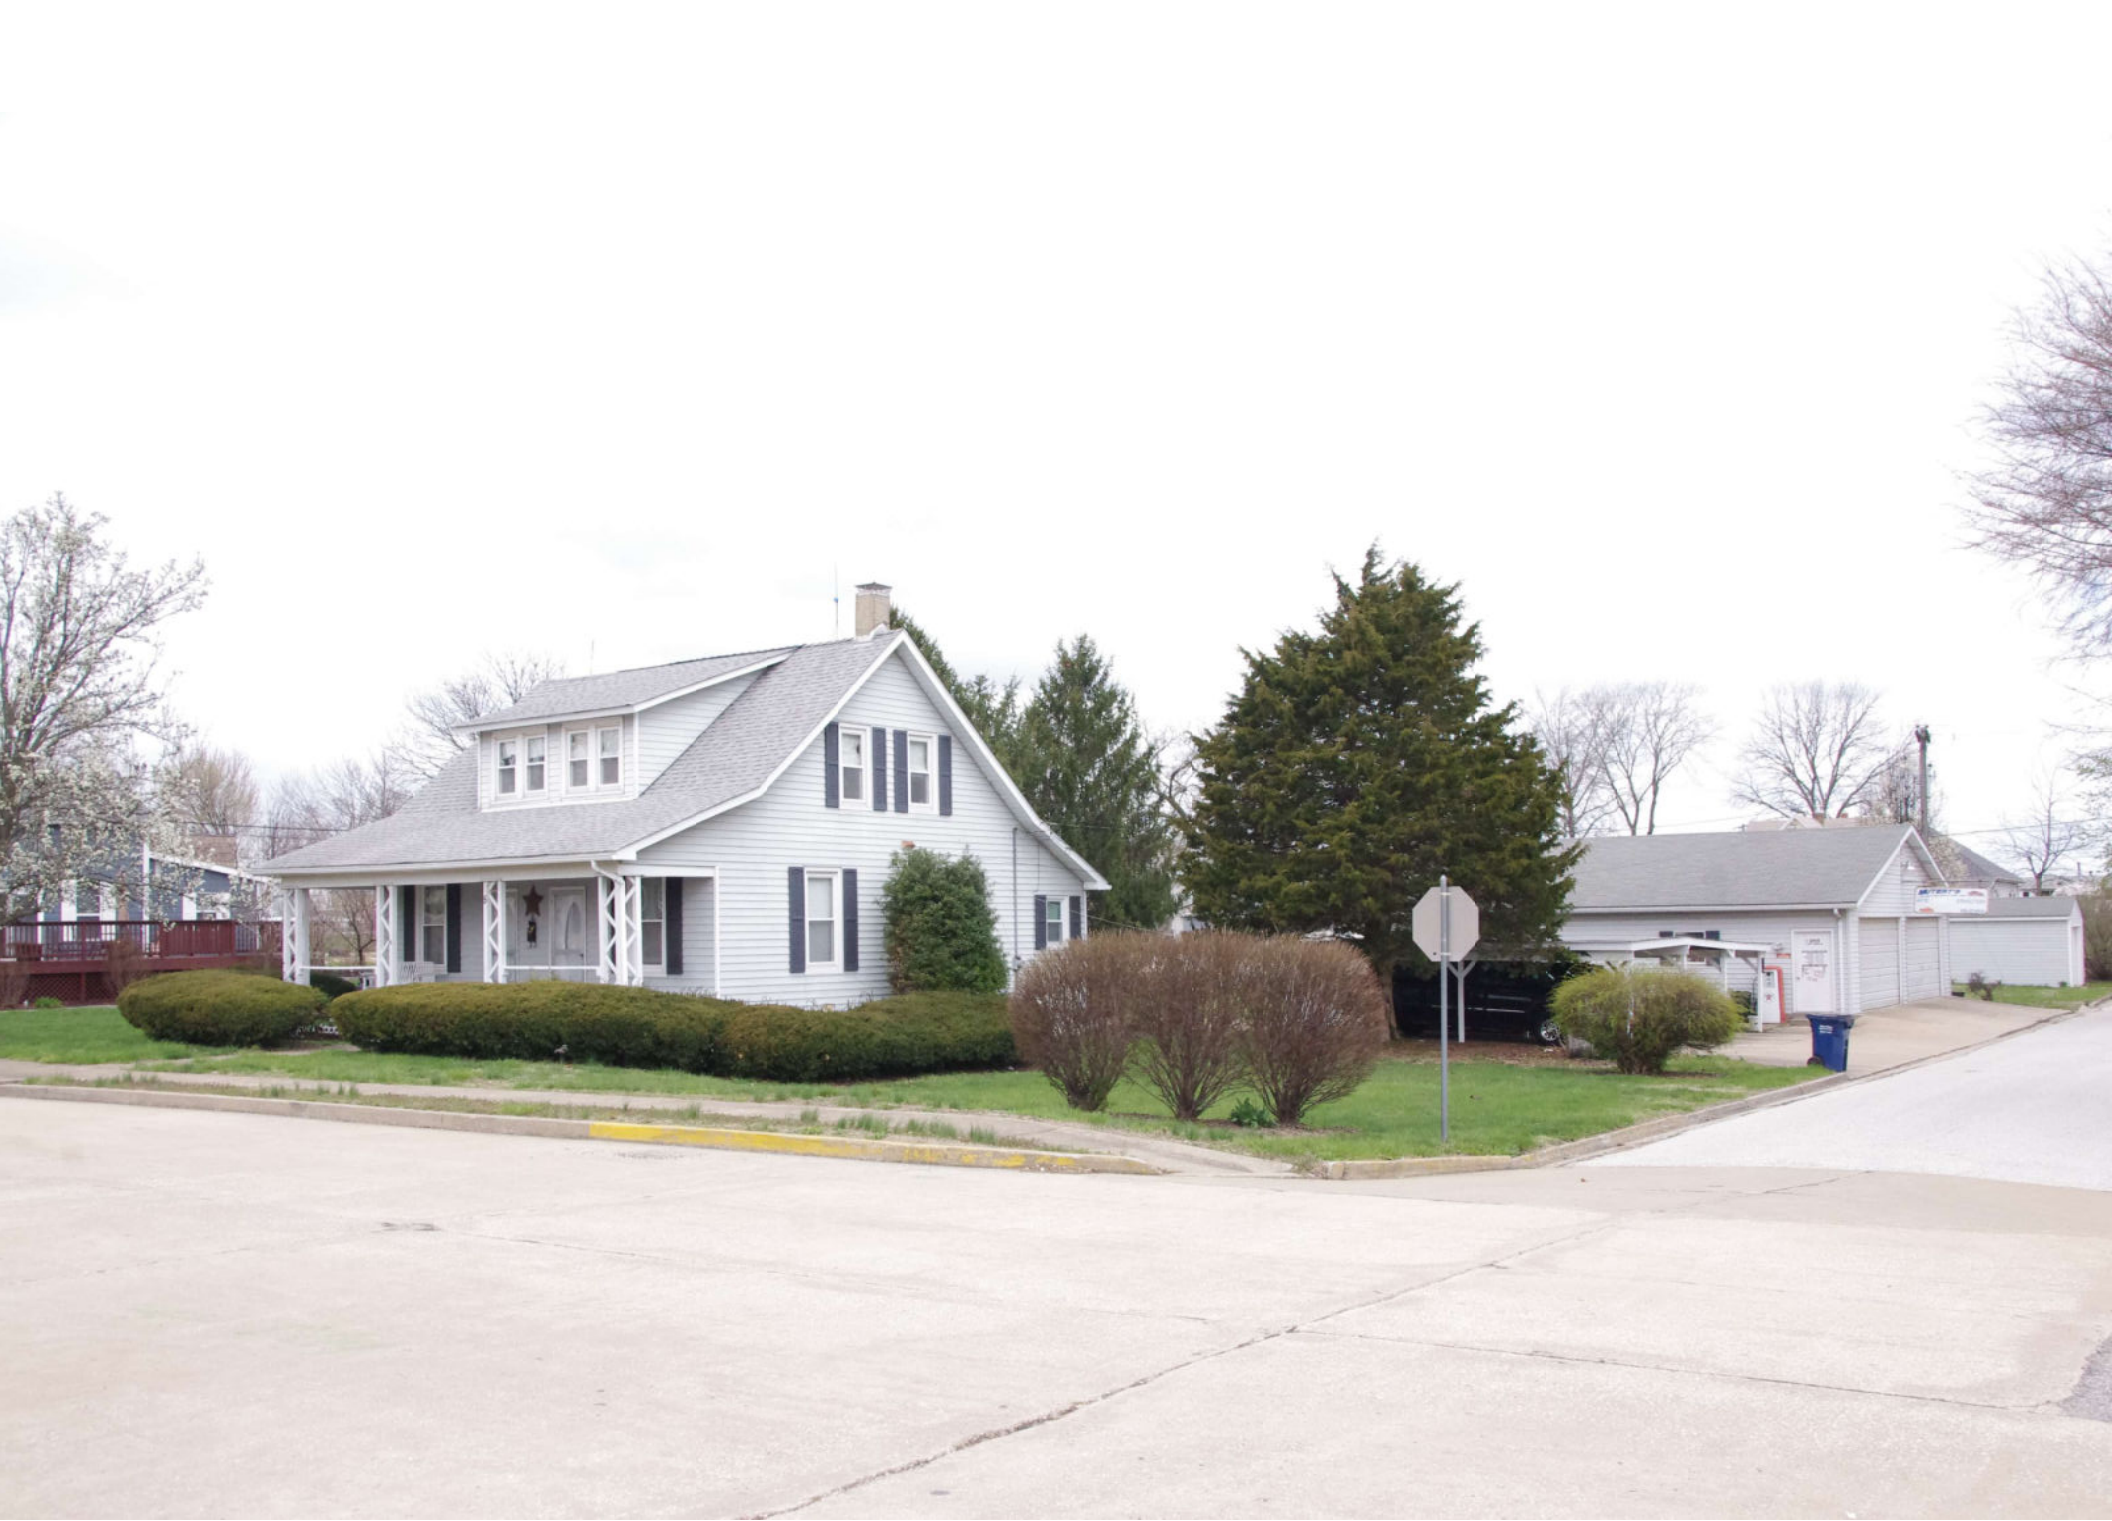
This is a one-and-a-half story vinyl sided house with a side gabled roof. The first level features a full length, shed roofed, open porch with zigzag wood supports (which appear to be a 1970s era alteration) and wood decking. Across the back of the house, there is a similar shed roof first floor extension of the gable roof. The house retains the two oval light, wood front doors behind the storm doors, located in the central bays. One-over-one sashed windows fill the outer bays. A shed dormer features two sets of paired one-over-one windows. A stucco chimney emerges from the east end of the ridge. The vinyl siding, fake shutters and storm windows were recently added.

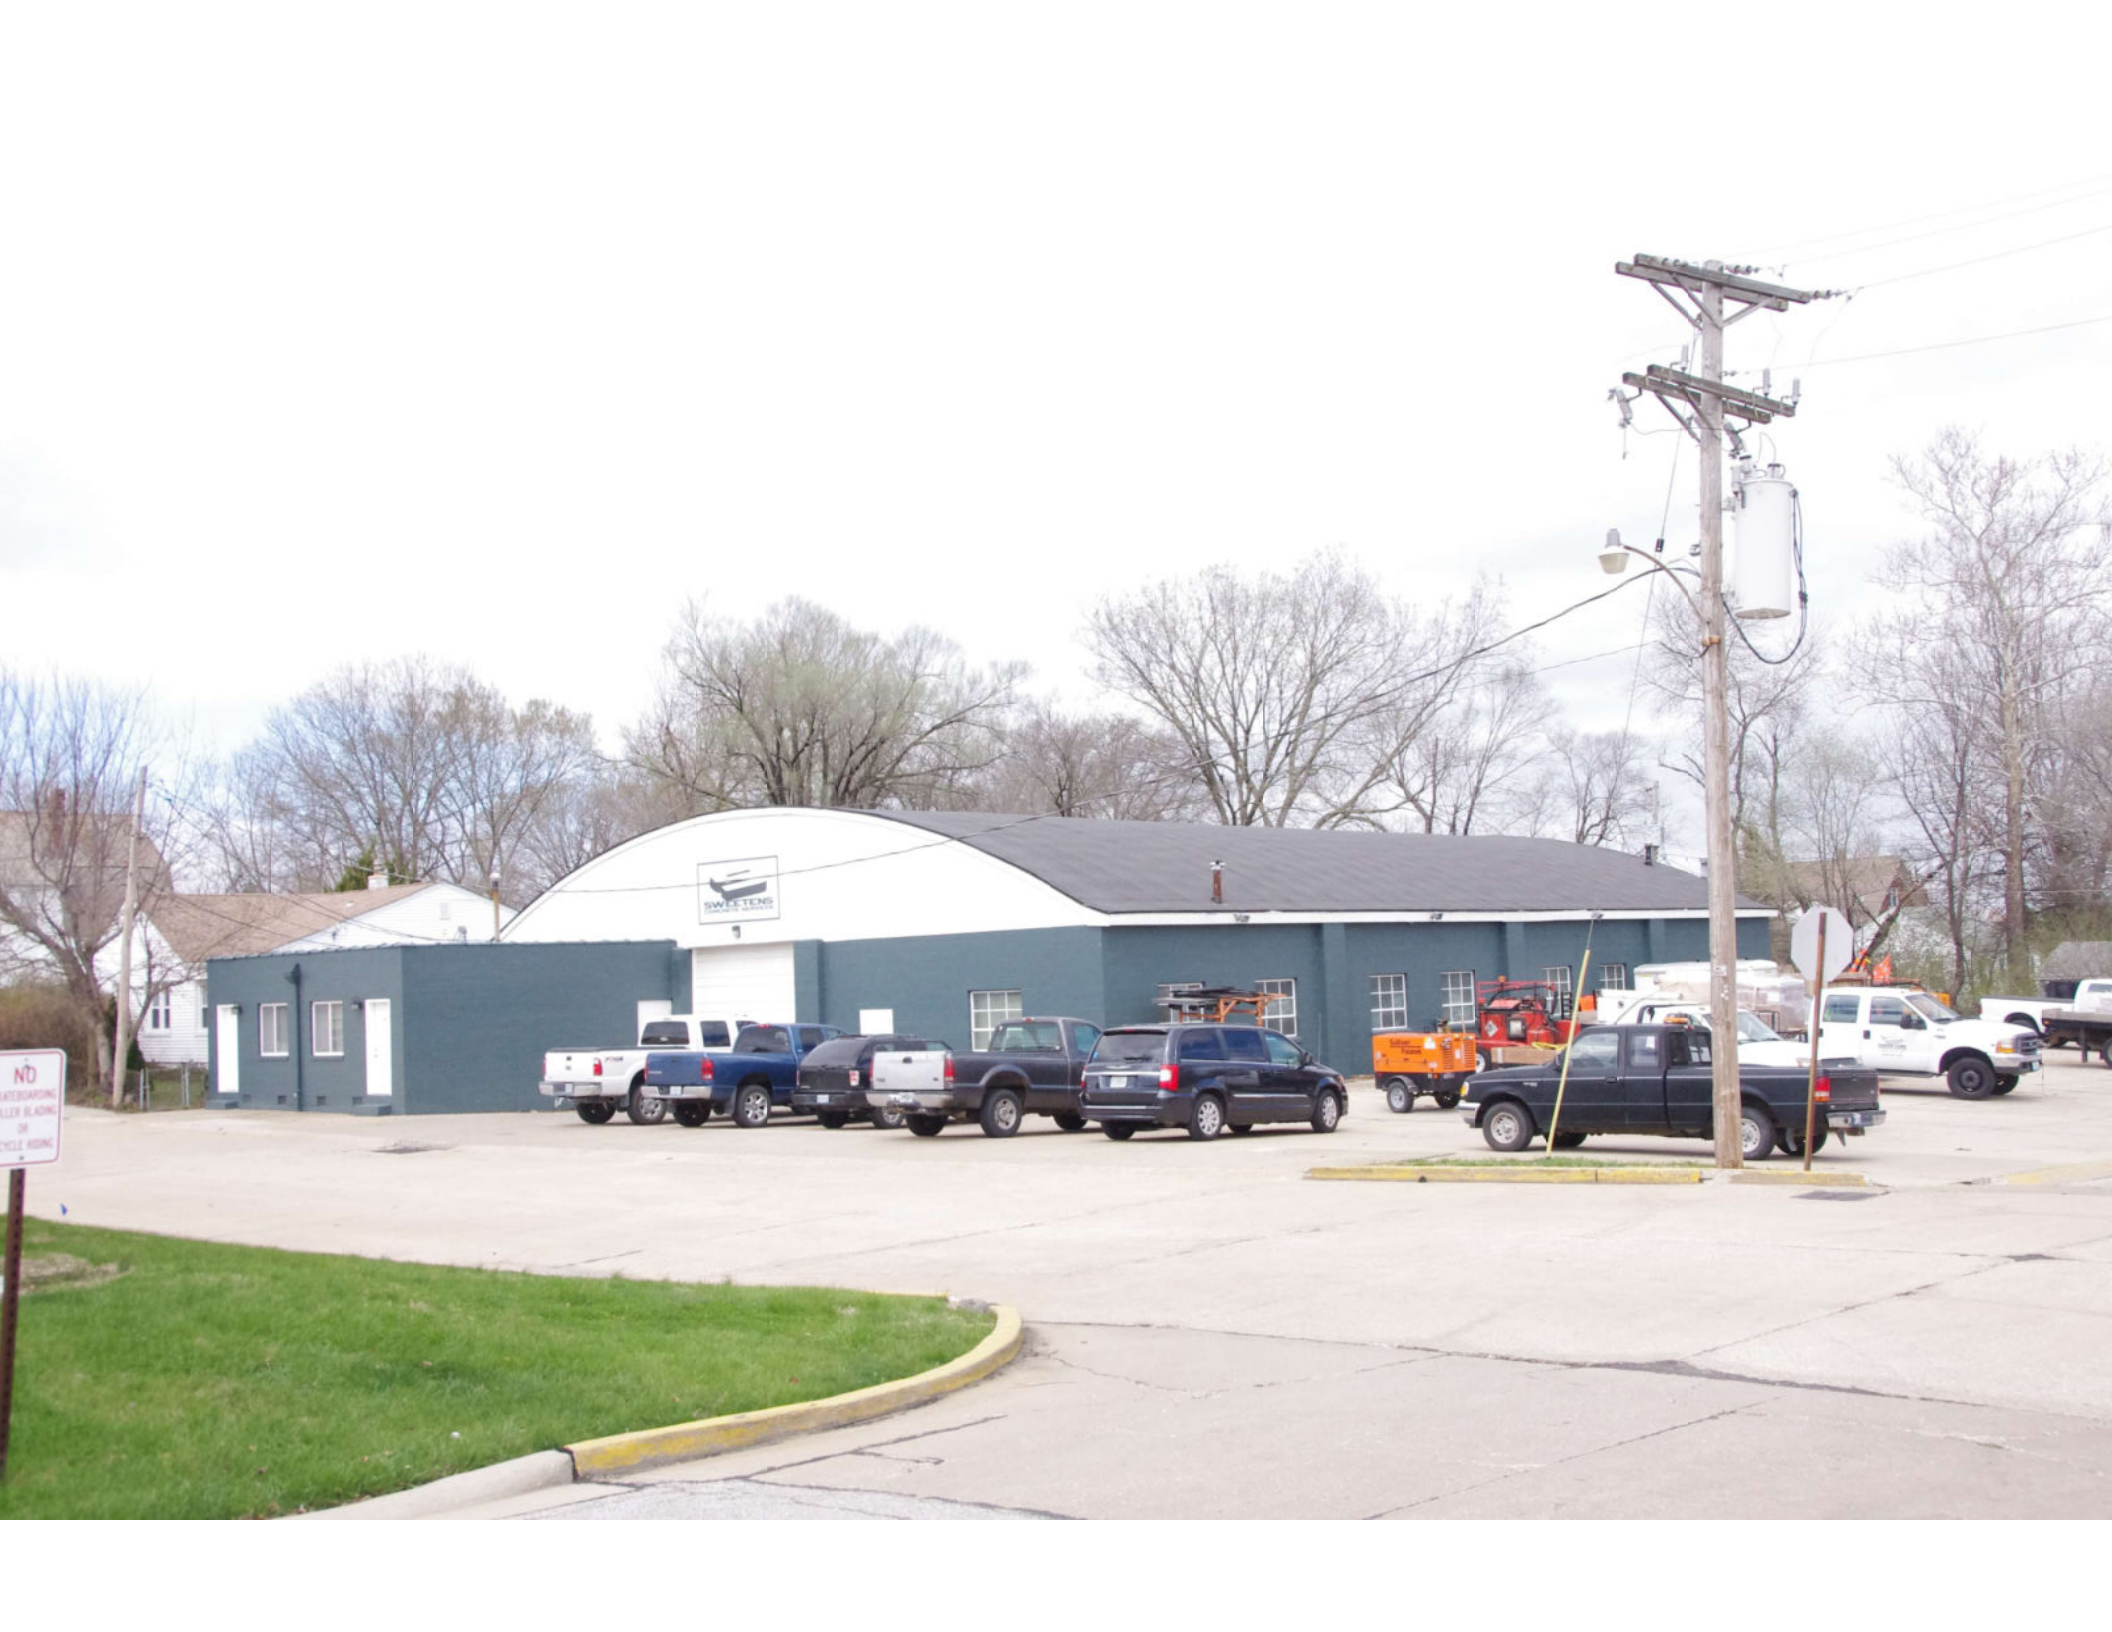
This resource is a one-story, painted concrete block, industrial building with an barrel shaped roof with a one-story, flat roofed, brick office wing connected to its south façade (western half). The central bay of the industrial building has an overhead garage door and the eastern bay contains a metal door and nine-light steel industrial window respectively. The east side of the building has nine of these nine-light steel industrial windows. A one-story, two bay office wing features a clay coping tile parapet cap around the flat roof of the painted brick walls, and it each bay features a steel door and sliding one-by-one pane replacement window.
