**ARCHITECTURAL/HISTORIC INVENTORY FORM**

1. Survey No. SC-AS-012-0001		2. Survey Name: Reconnaissance Level Survey of Historic Downtown Wentzville	
3. County: St. Charles		4. Address (Street No.) 102	Street (name) East Third Street
5. City: Wentzville	Vicinity: <input type="checkbox"/>	6. UTM:	
8. Historic name (if known):		9. Present/other name (if known):	
10. Ownership: <input type="checkbox"/> Private <input type="checkbox"/> Public		11a. Historic use (if known): DOMESTIC/single dwelling	11b. Current use: DOMESTIC/single dwelling
5. City: Wentzville		7. Township/Range/Section:

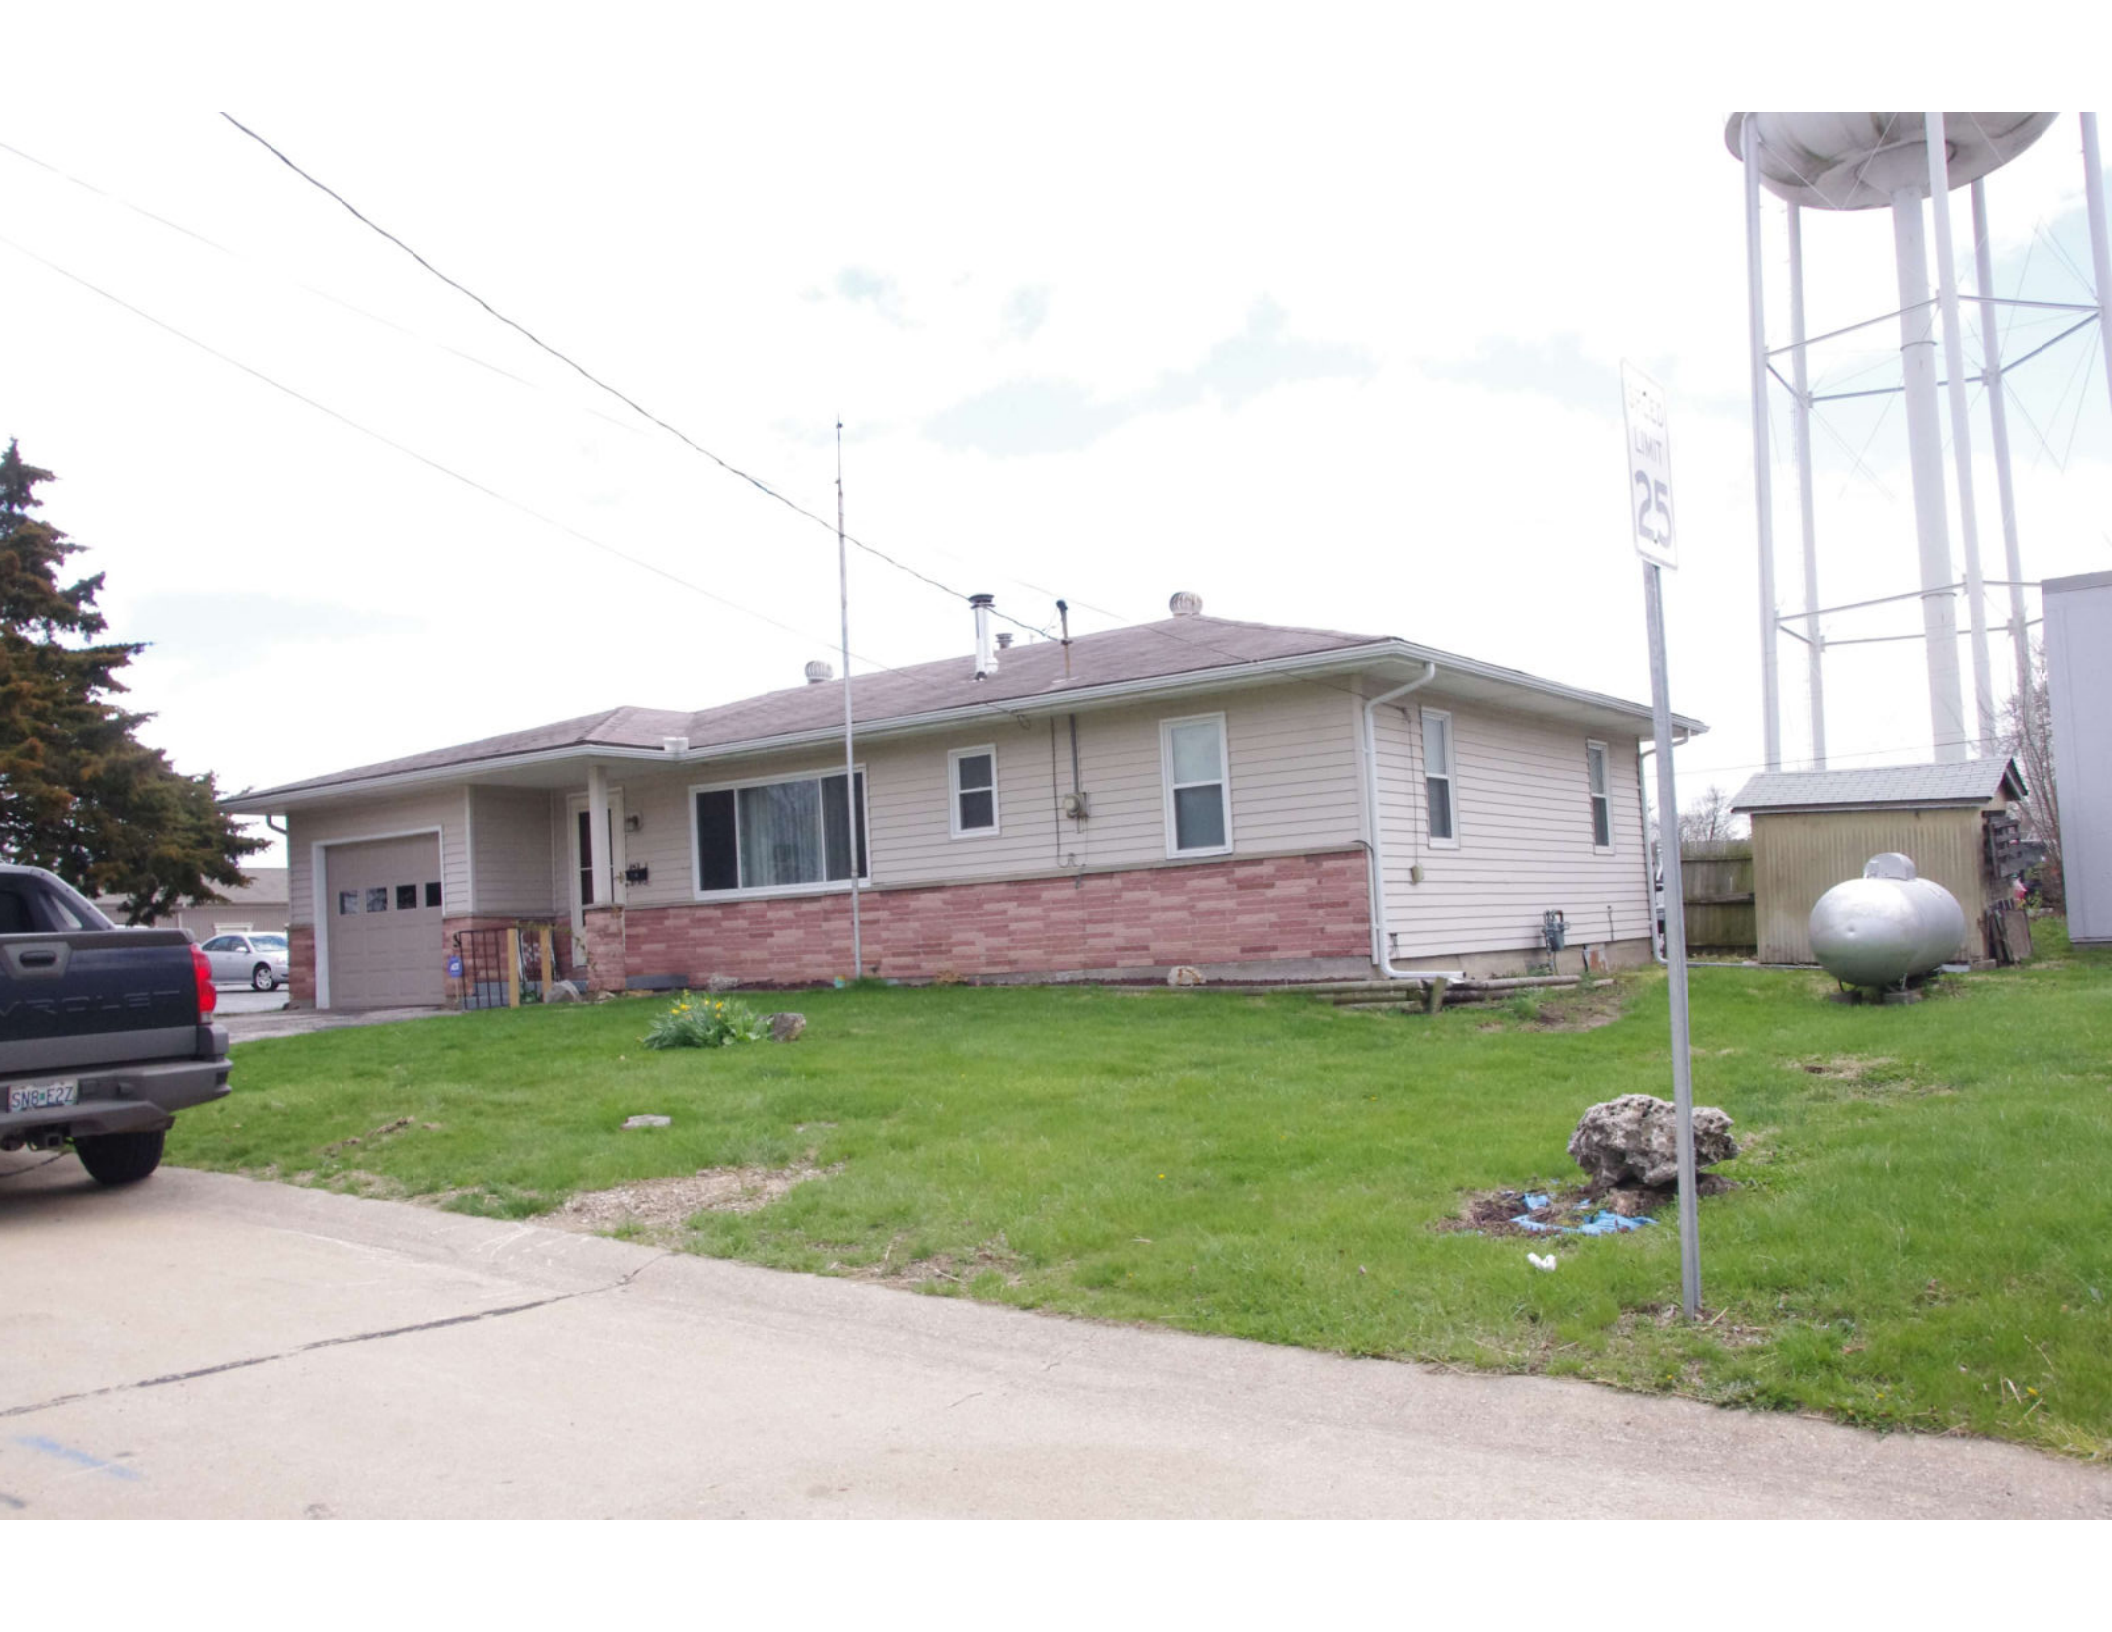
This resource is a one-story Ranch house with a shallow hipped roof with wide eaves. A one-bay garage wing projects north from the main façade. Under its roof, beside the garage door, is an open porch with a brick plinth block supporting the square corner post. It has a wood paneled door with a wood framed storm door. A picture flanked by single light casement windows fills the center bay. A small one-over-one sash window fills the next bay, with a large replacement one-over-one sash window on the west end. The building is faced with replacement vinyl siding, with a salmon colored brick half wall.

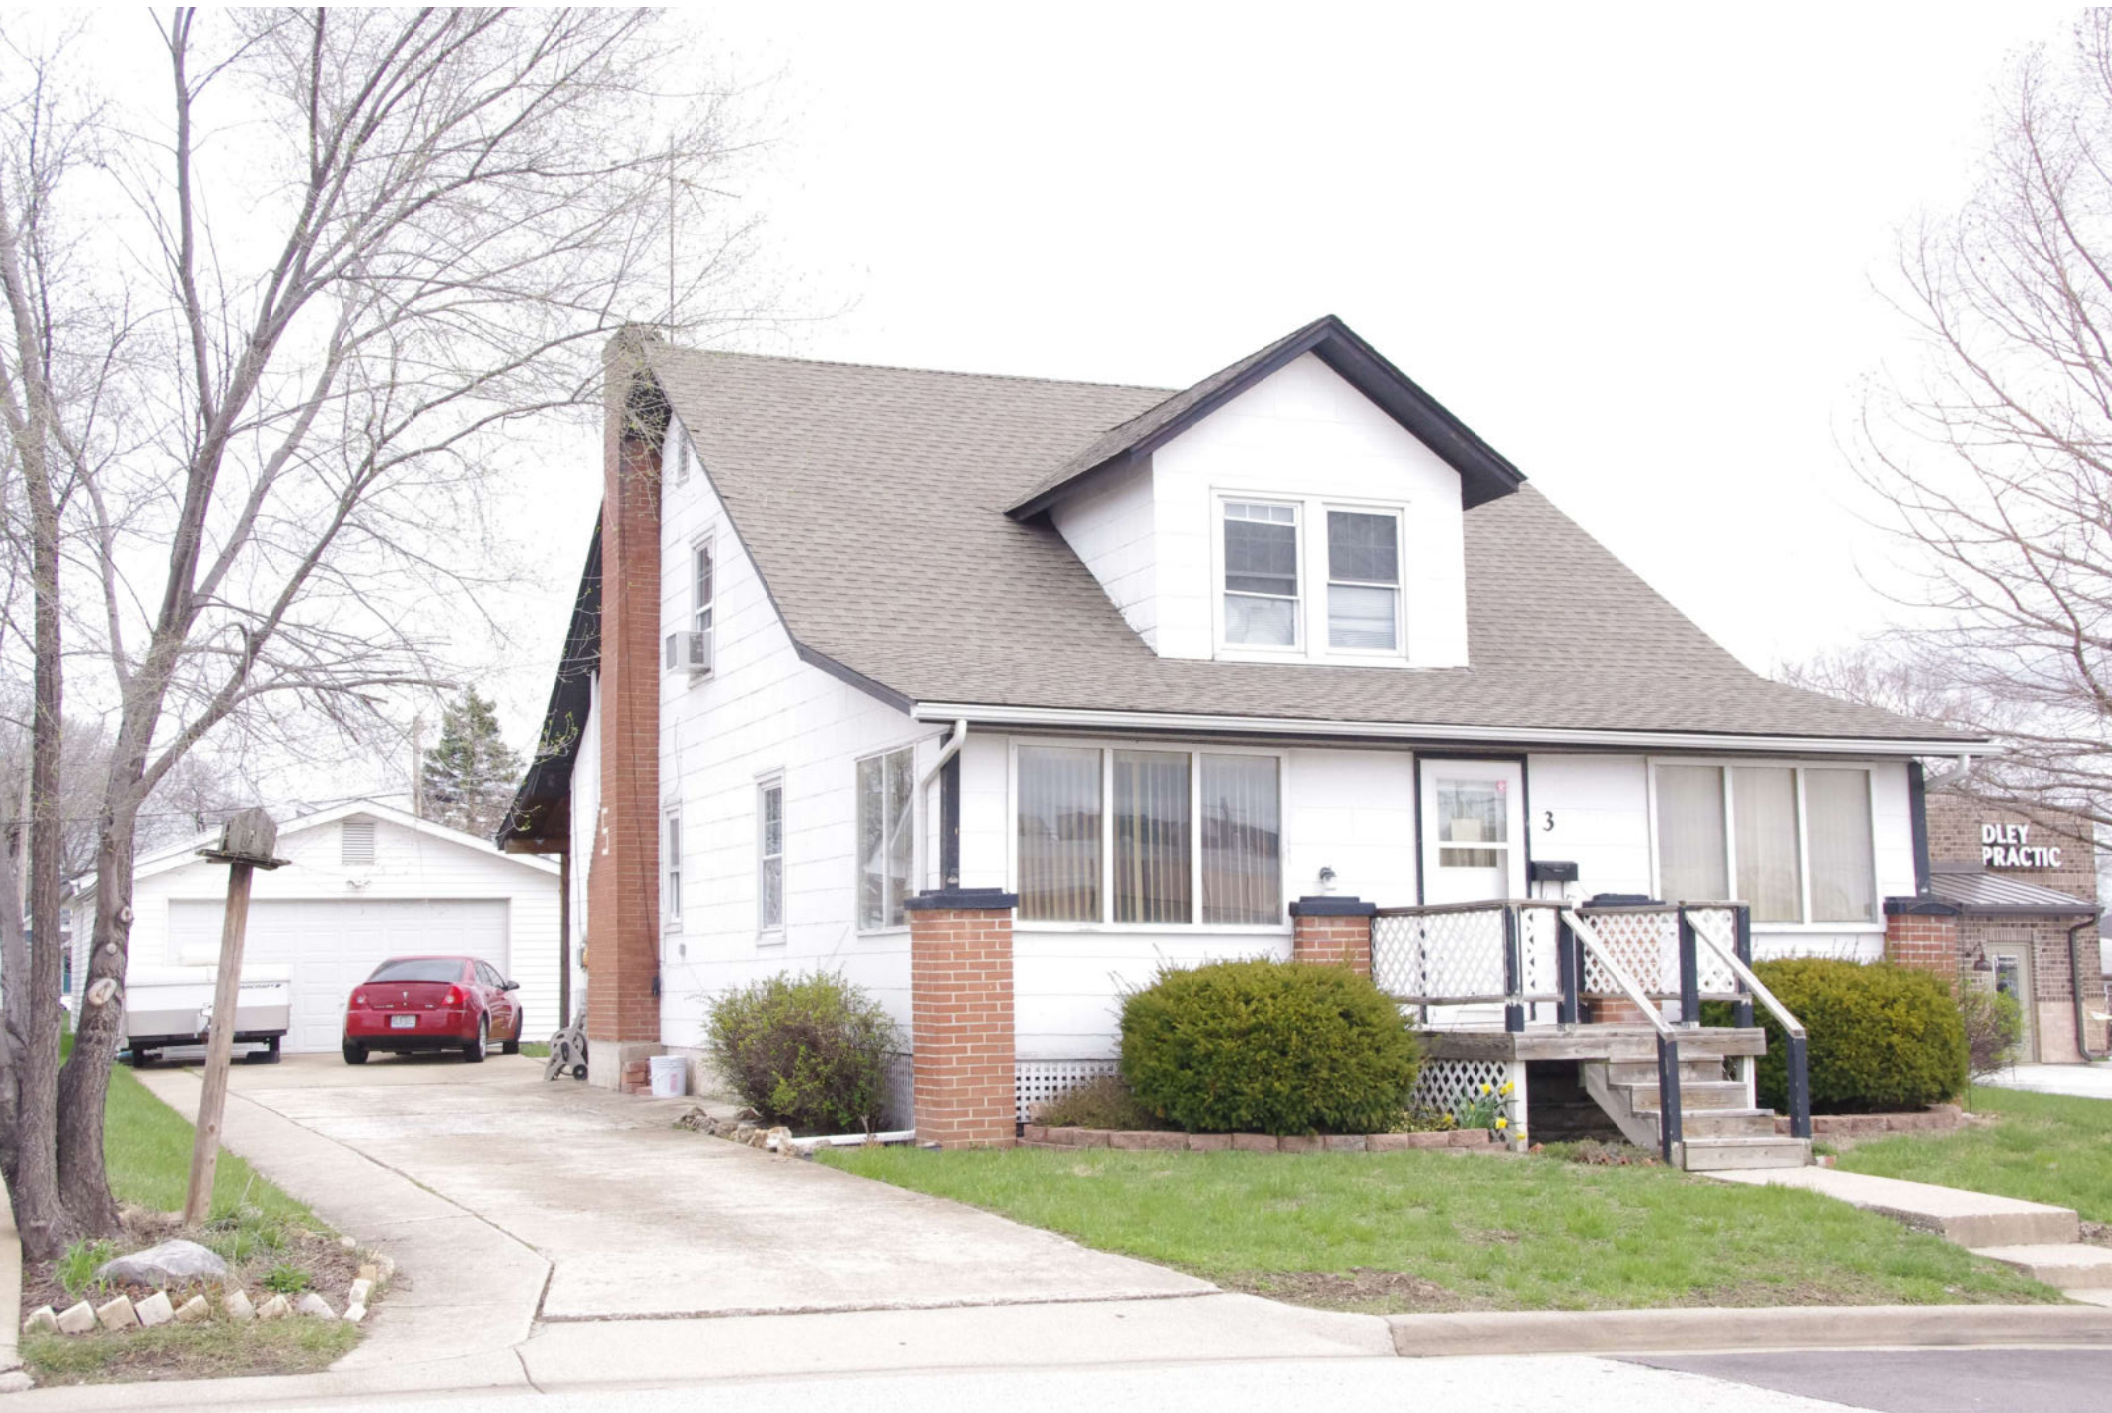
This resource is a one-and-a-half story bungalow with asbestos siding and a shingle roof. The original brick half piers are still visible on the closed porch, which features 3 one-pane windows clustered on either side of the central wood door. The enclosure of the porch was done early in the history of the house, probably in the 1950s since it is clad with asbestos siding (slightly different pattern). A wooden stoop accesses the entrance to the enclosed front porch. A gabled dormer featuring 2 six-over-one vinyl replacement windows is centered in the half-story.

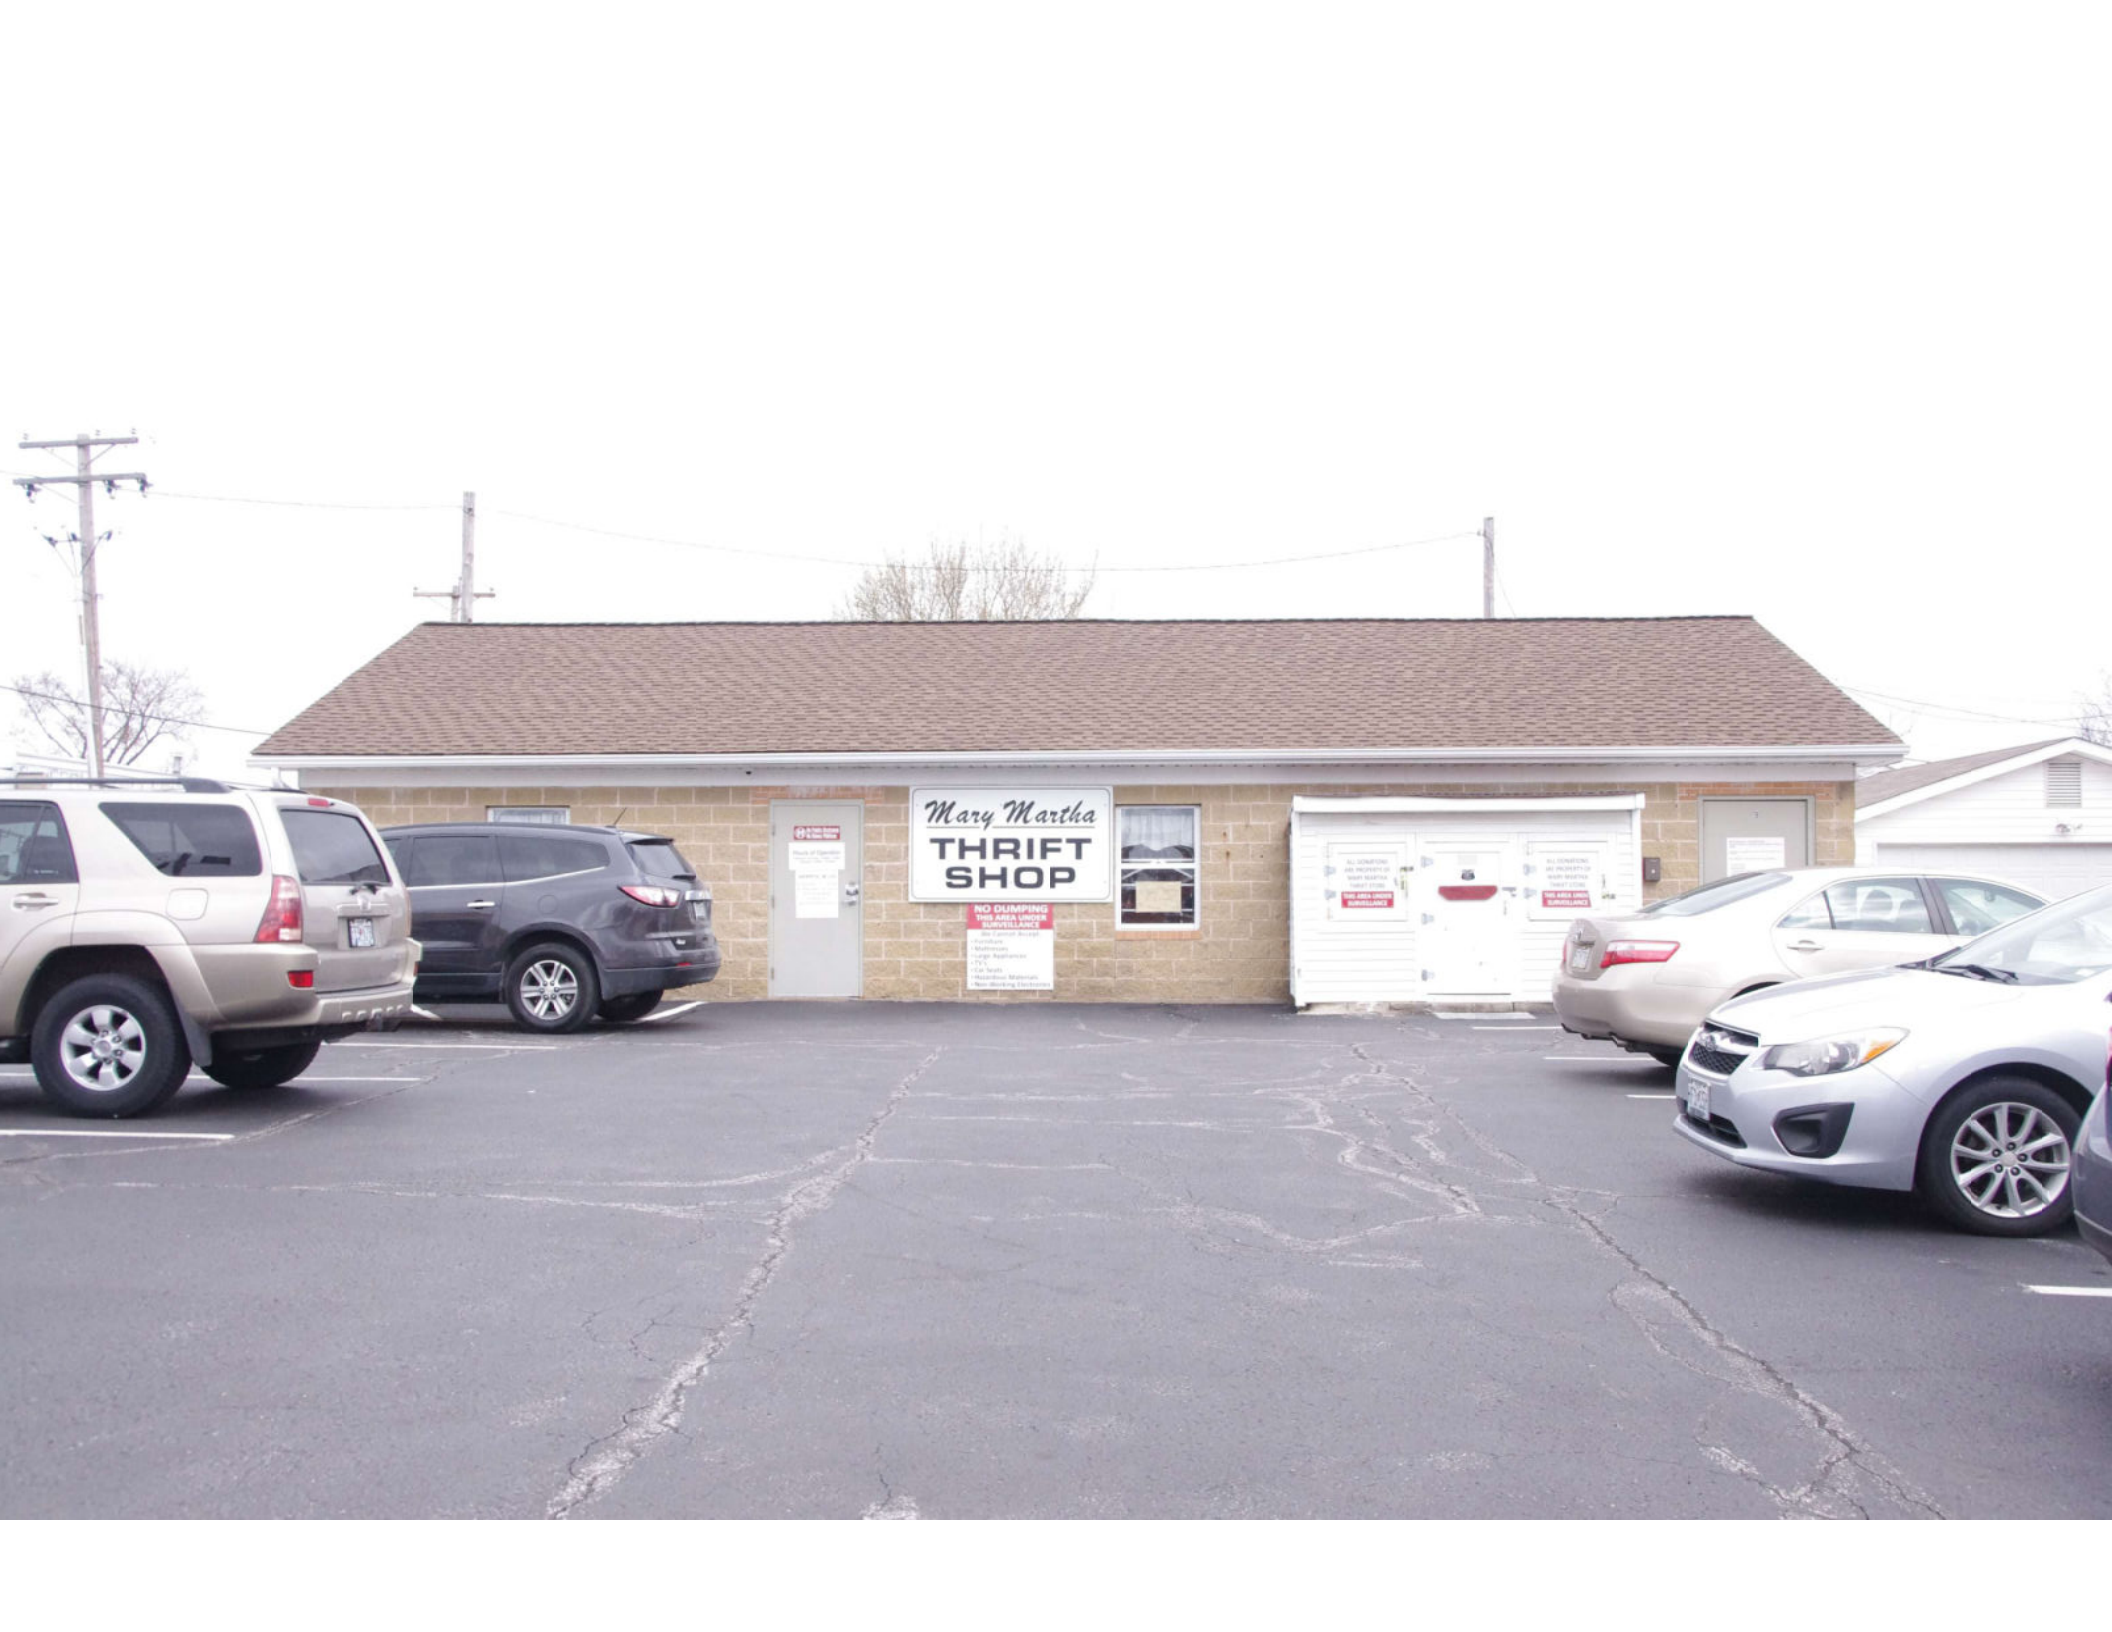
This resource is a one-story concrete block building with a side gabled shingle roof. The building features metal entrance doors in the second and fifth bays. The remaining bays feature one-over-one vinyl replacement windows. A vinyl sided donation box occupies the second bay from the east. Behind the side gabled portion of the building there is what appears to be recent addition--a large, intersecting gabled wing made of rock-faced concrete block, and it appears that the original building was originally a smooth concrete block that has been sandblasted to expose its surface, making it appear to be a similar rock-faced block (although the coloration of the two sections varies with the old being tan and the new being gray). There is a small section on the north side of the original side gabled building where the wall is still the painted block wall, an indication that this original building is much older than it currently appears. There are paired, aluminum framed doors on the west side of the rear wing at the south end where it joins with the original building.

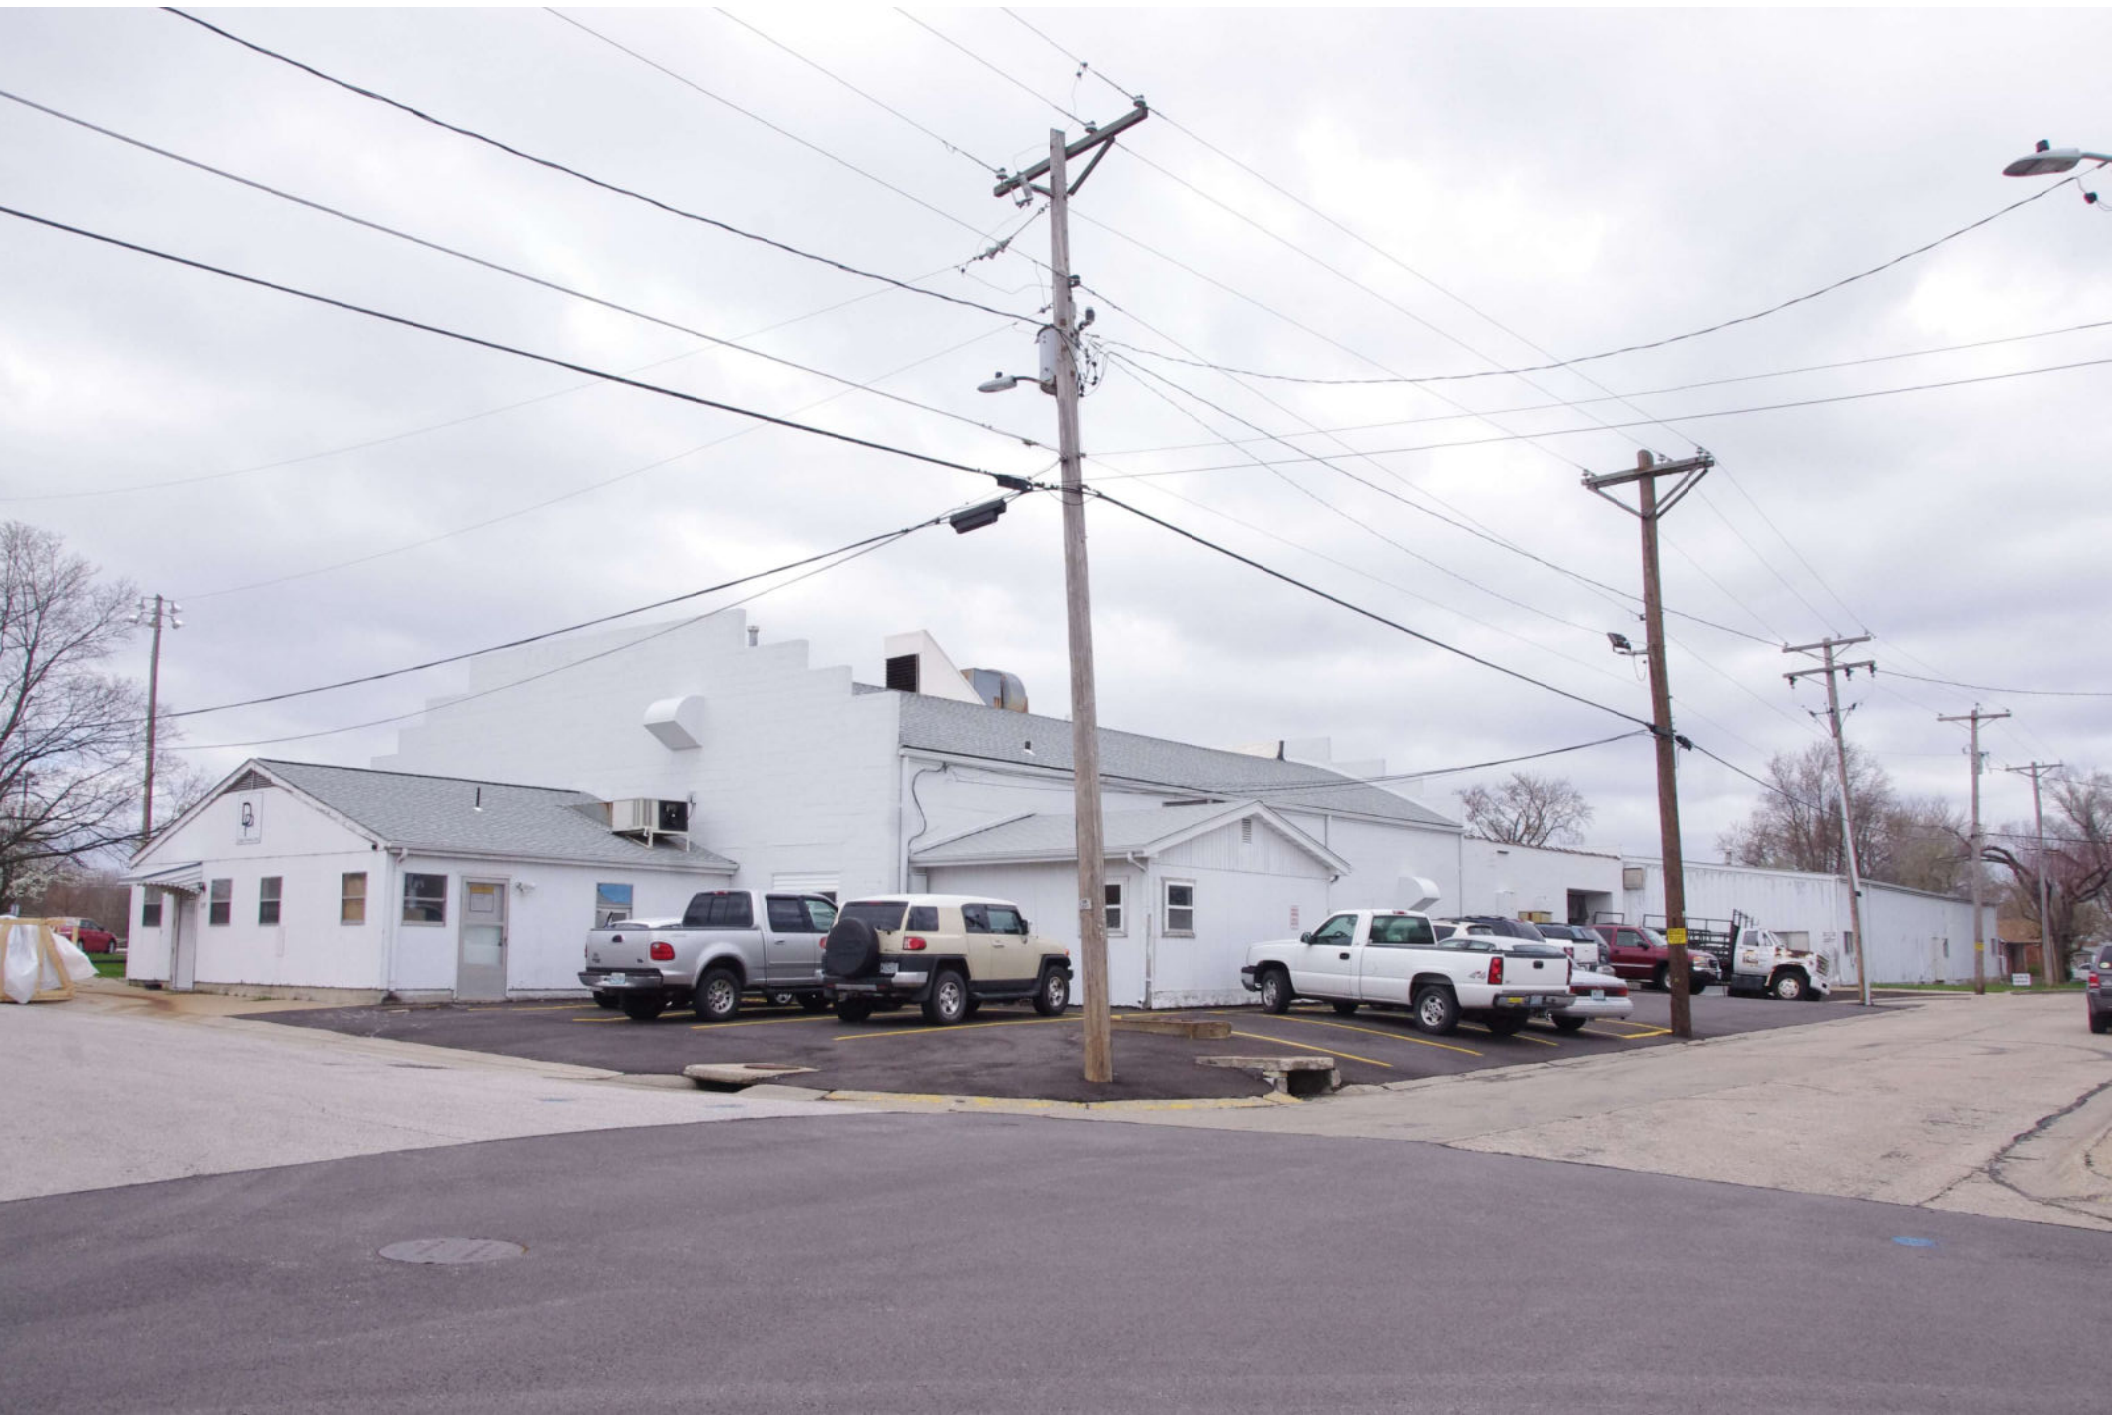
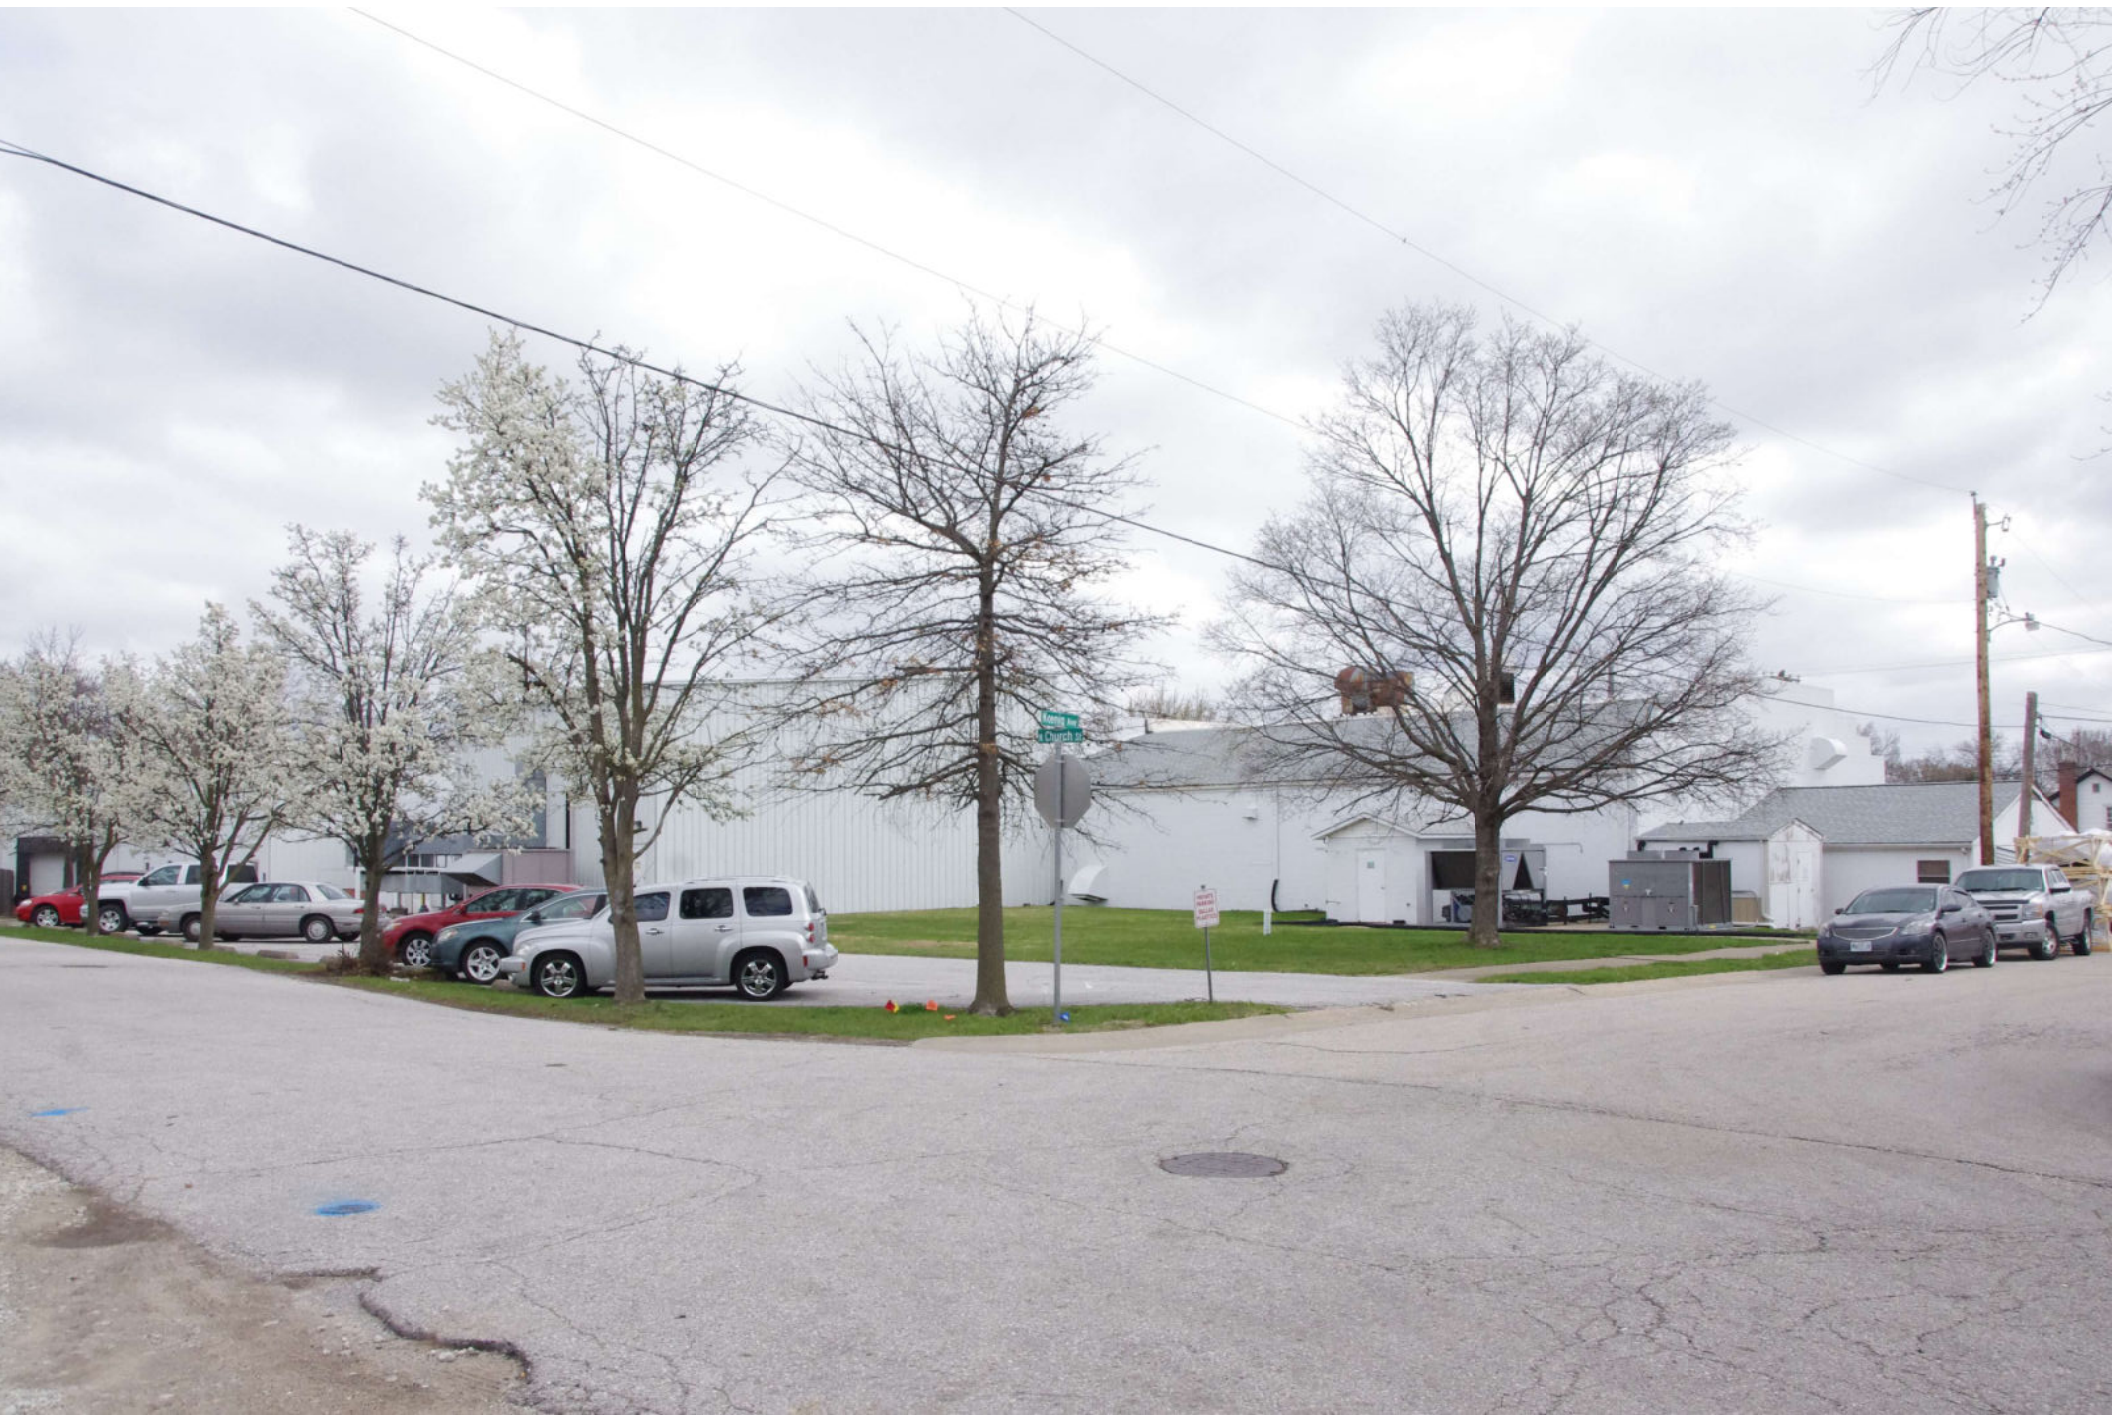
This resource is an industrial complex consisting of a tall (two stories tall on exterior, but interior appears to be one story), painted concrete block, industrial building with a concrete foundation and truncated gabled roof and a stepped parapet on each end of the core building (probably the first building). There have been numerous additions to the complex, all interconnected internally, added to the north and west side of this primary building with the exception of the office wing on the south end, next to Koenig and another gabled one story, vertical wood board office building on the southeast corner of the complex. The five bay, one-story, gabled and vertical wood sided commercial office entrance is located at the street level facing Koenig. Its metal door with metal awning is located in the second bay from the west corner of the south façade and given the period of construction for this industrial complex the door and awning may be original. The remaining bays include what appear to be the original, one-over-one metal sashed windows. A brick parapet wall divides this office wing from the original industrial building behind it. Various metal sided, flat or shed roofed additions have been added behind (north and west) the main block building and appear to date from the 1980s.
