**ARCHITECTURAL/HISTORIC INVENTORY FORM**

1. Survey No. SC-AS-012-0001		2. Survey Name: Reconnaissance Level Survey of Historic Downtown Wentzville	
3. County: St. Charles		4. Address (Street No.) 102	Street (name) East Third Street
5. City: Wentzville	Vicinity: <input type="checkbox"/>	6. UTM:	
8. Historic name (if known):		9. Present/other name (if known):	
10. Ownership: <input type="checkbox"/> Private <input type="checkbox"/> Public		11a. Historic use (if known): DOMESTIC/single dwelling	11b. Current use: DOMESTIC/single dwelling
5. City: Wentzville		7. Township/Range/Section:

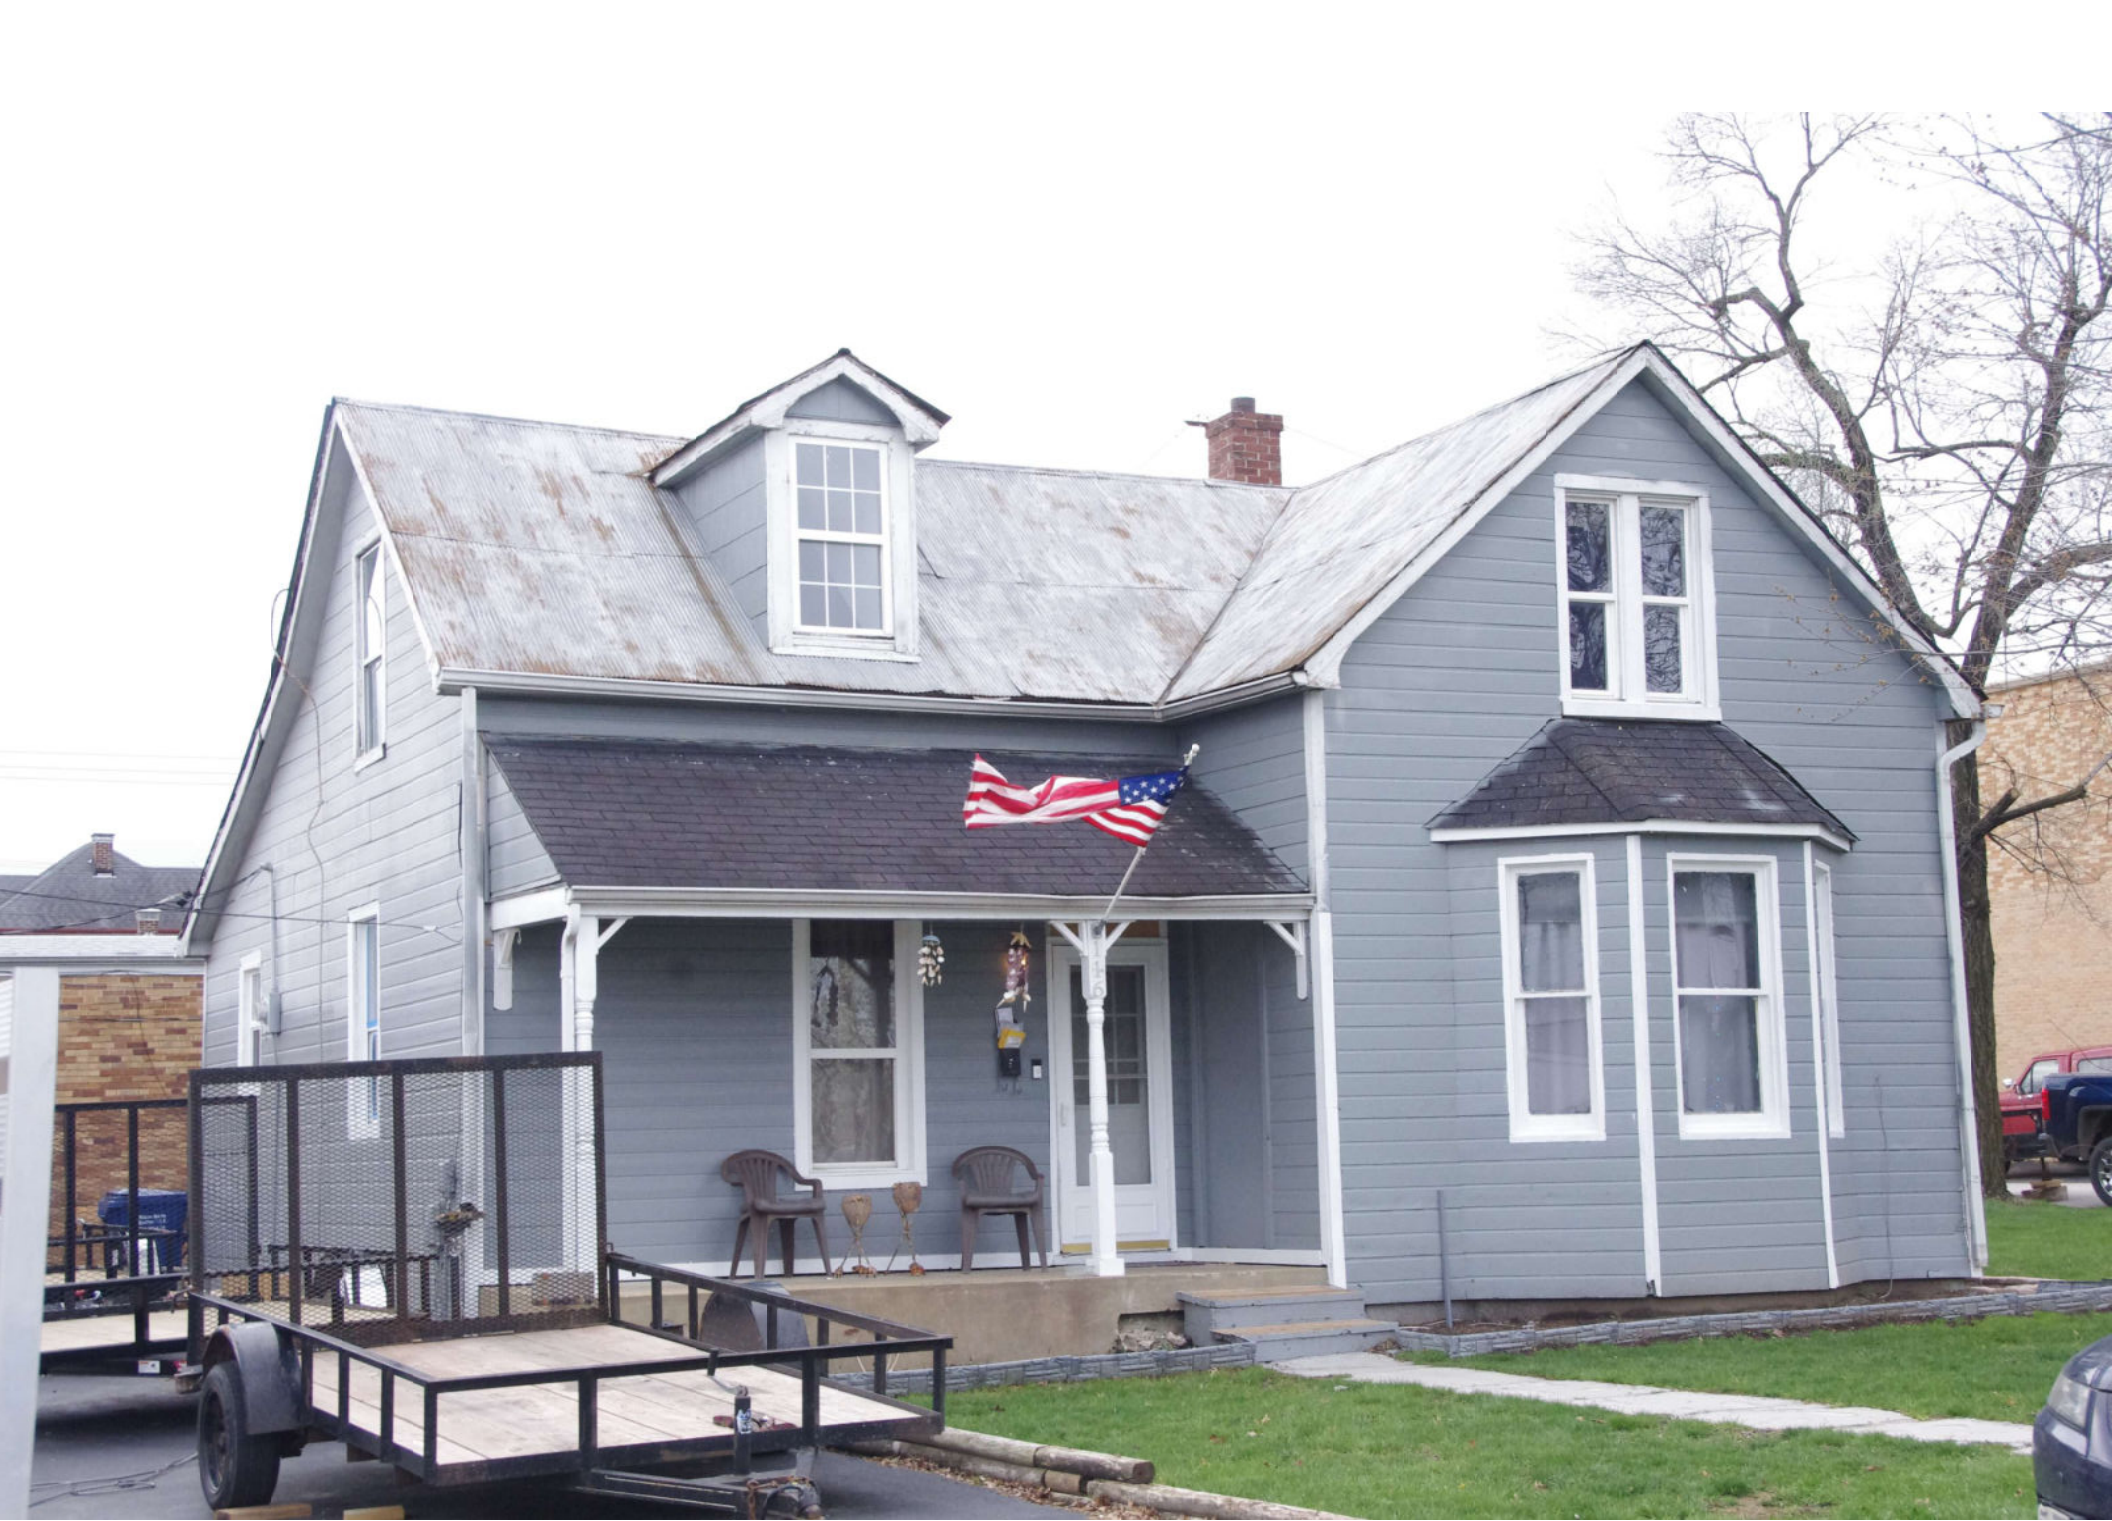
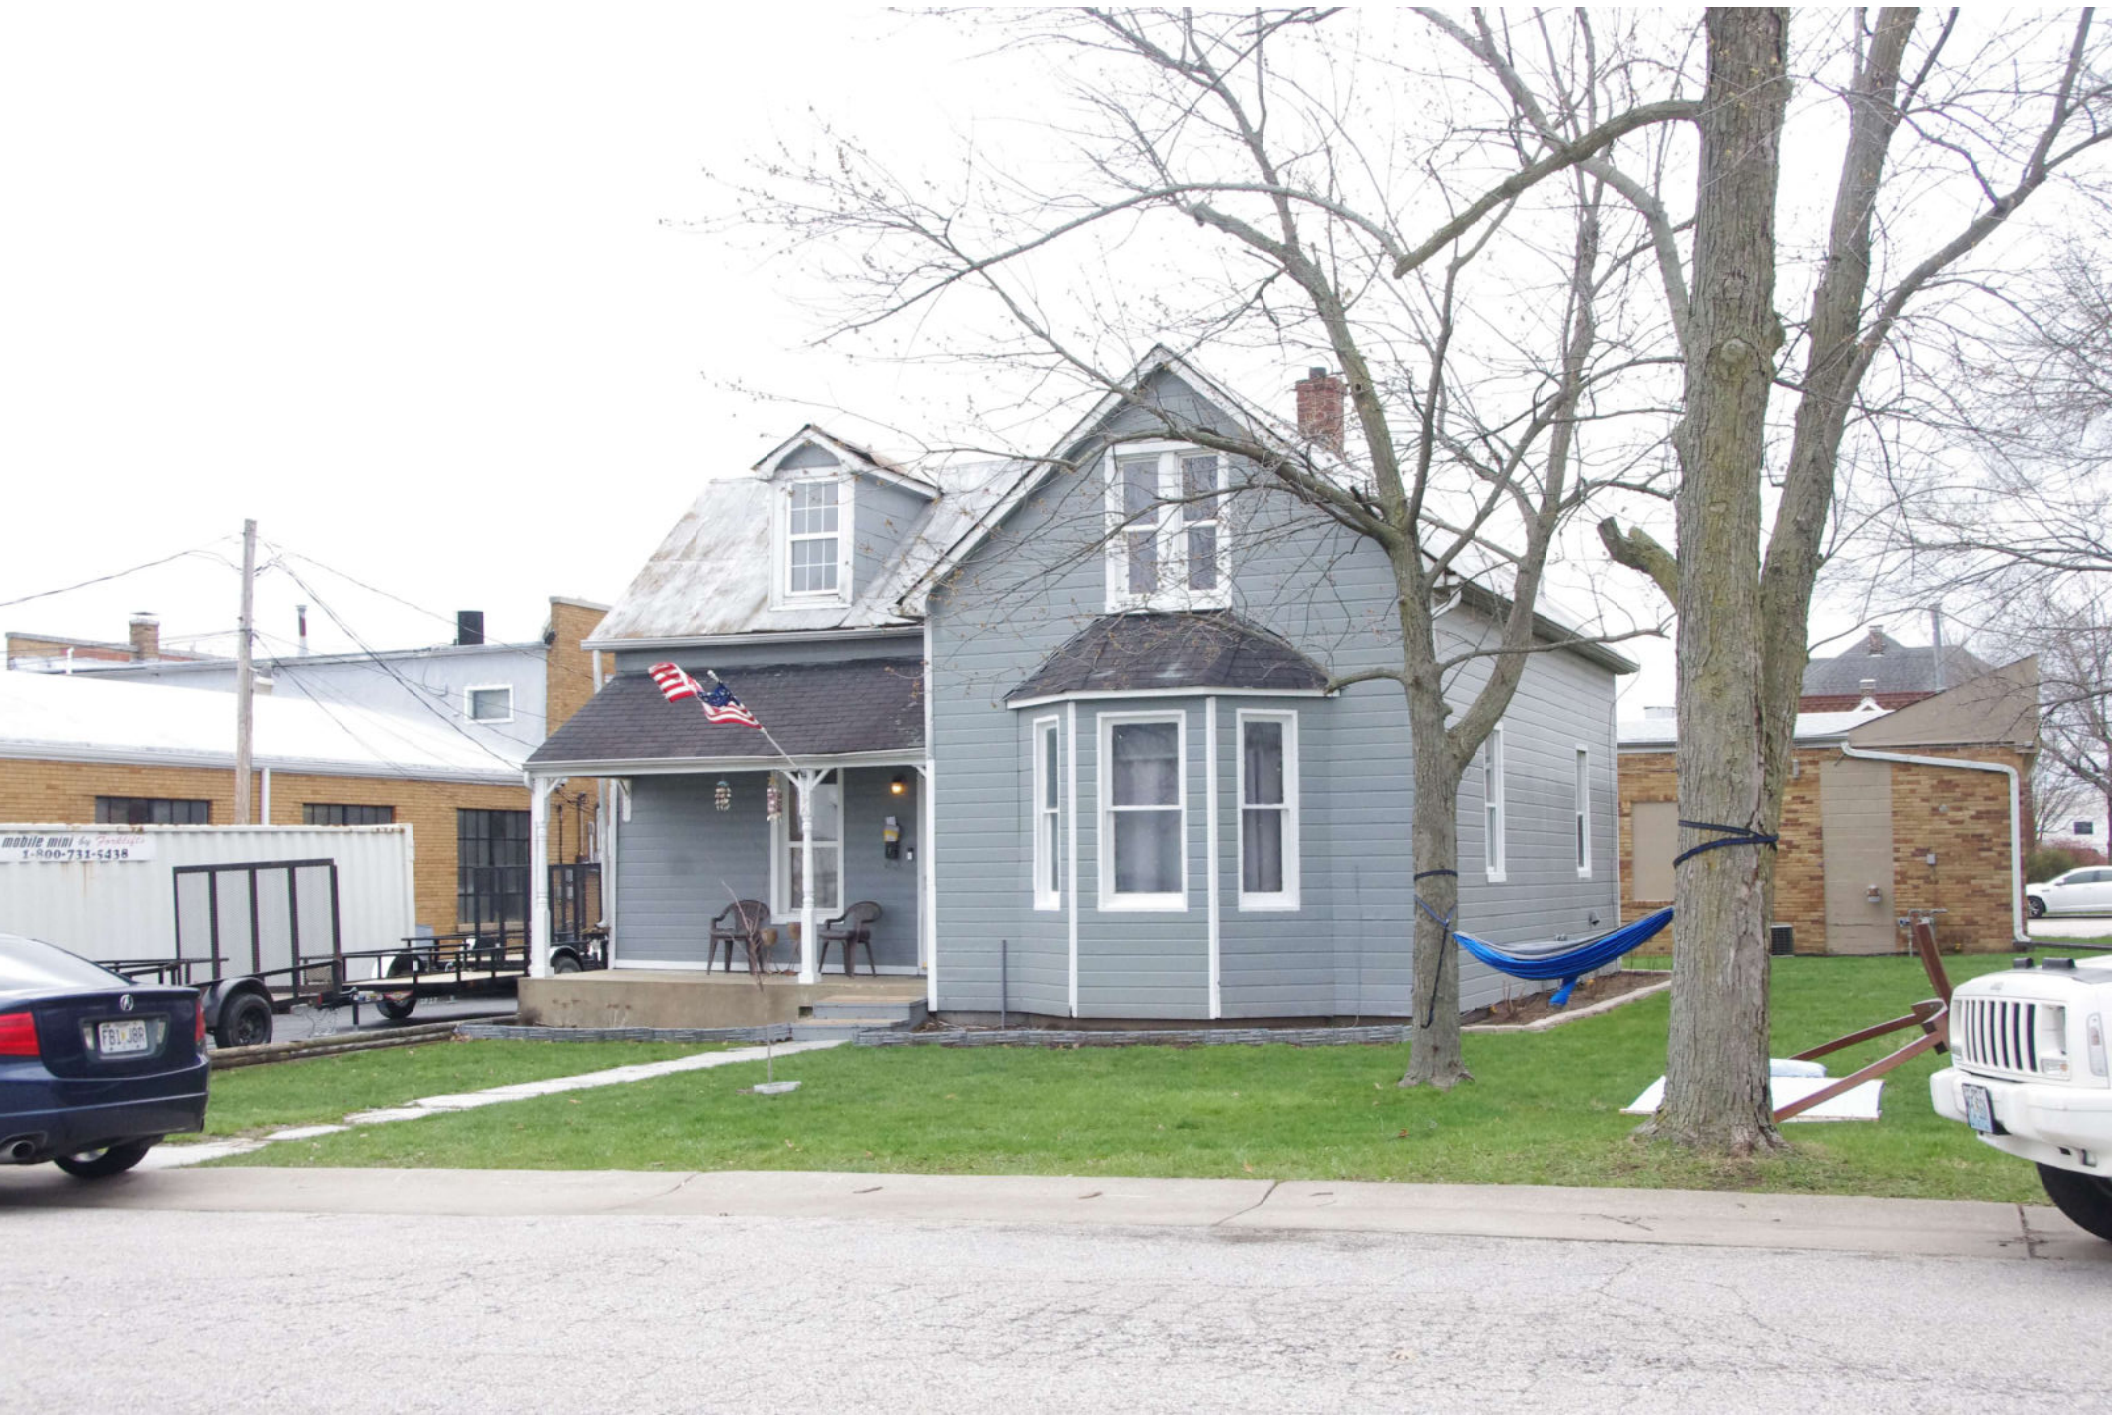
This resource is a 1.5-story gable-and-wing house with a corrugated metal roof and simulated shiplap siding. Apparently the house had previously been re-sided with asbestos shingle siding, some of which remains in the dormer and the new shiplap was added recently to replace the asbestos shingles. The wood door is covered by a storm door on the one-story open porch, with a one-over-one wood sashed window located beside it to the east. In the gable end, there is a canted bay window on the first level with 1/1 wood sashed windows on each face of the bay. There are paired 1/1 wood sashed windows above it in the upper story. A six-over-six vinyl replacement window is located in the gabled dormer above the shed roofed entry porch, which is supported by turned posts with small decorative brackets. The posts may be original but they are now resting a replacement concrete porch floor. An offset chimney is visible above the rear slope.

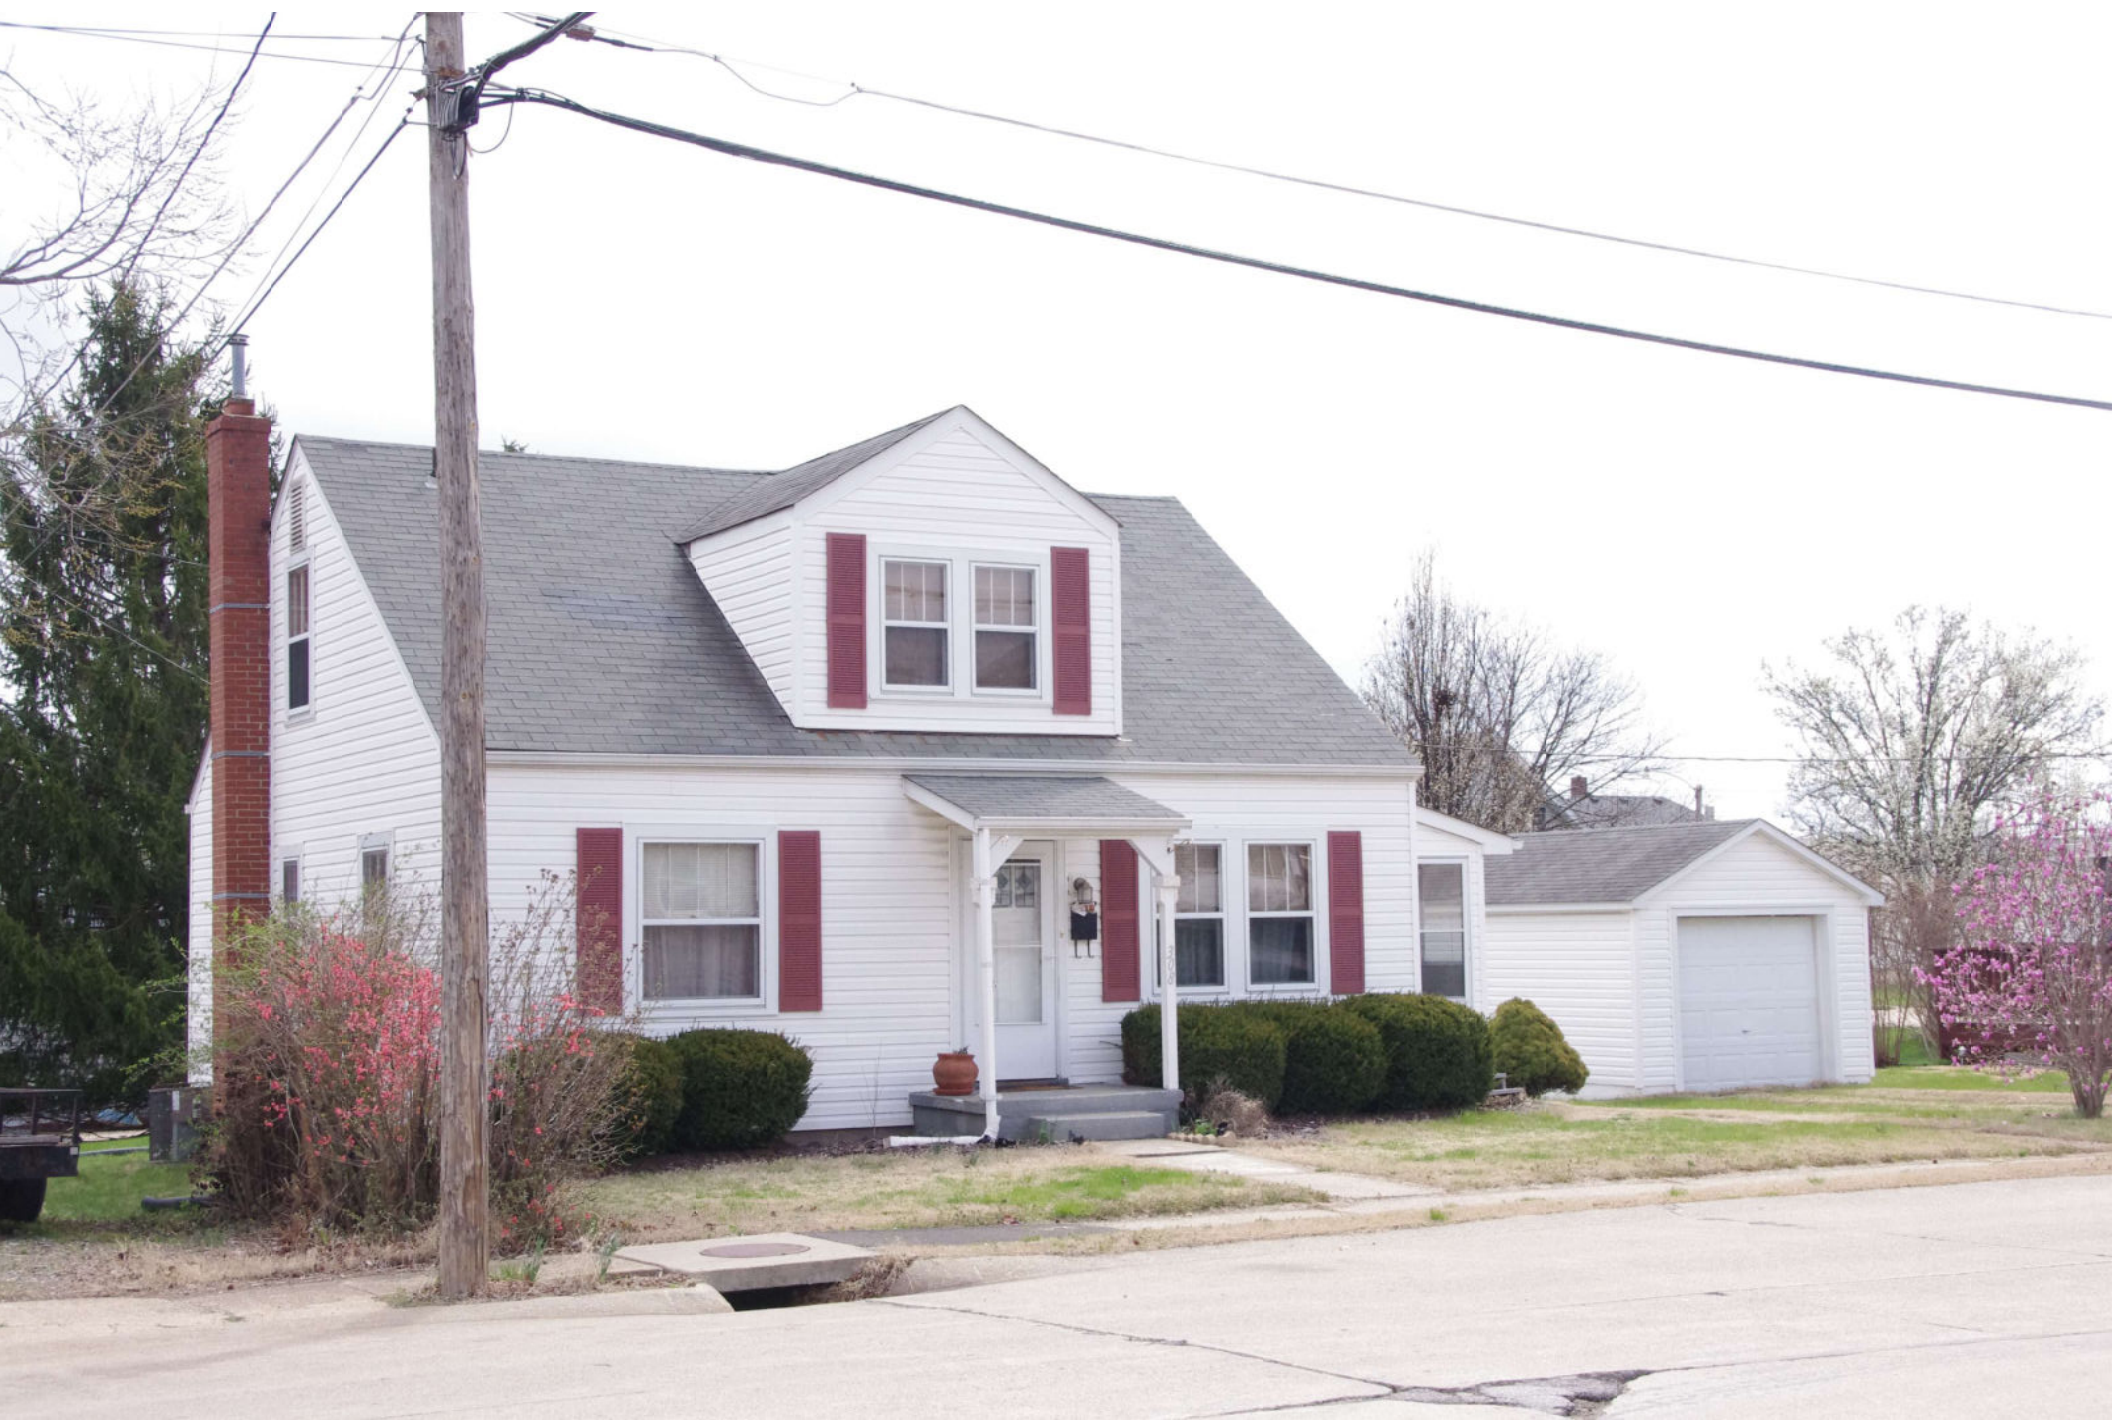
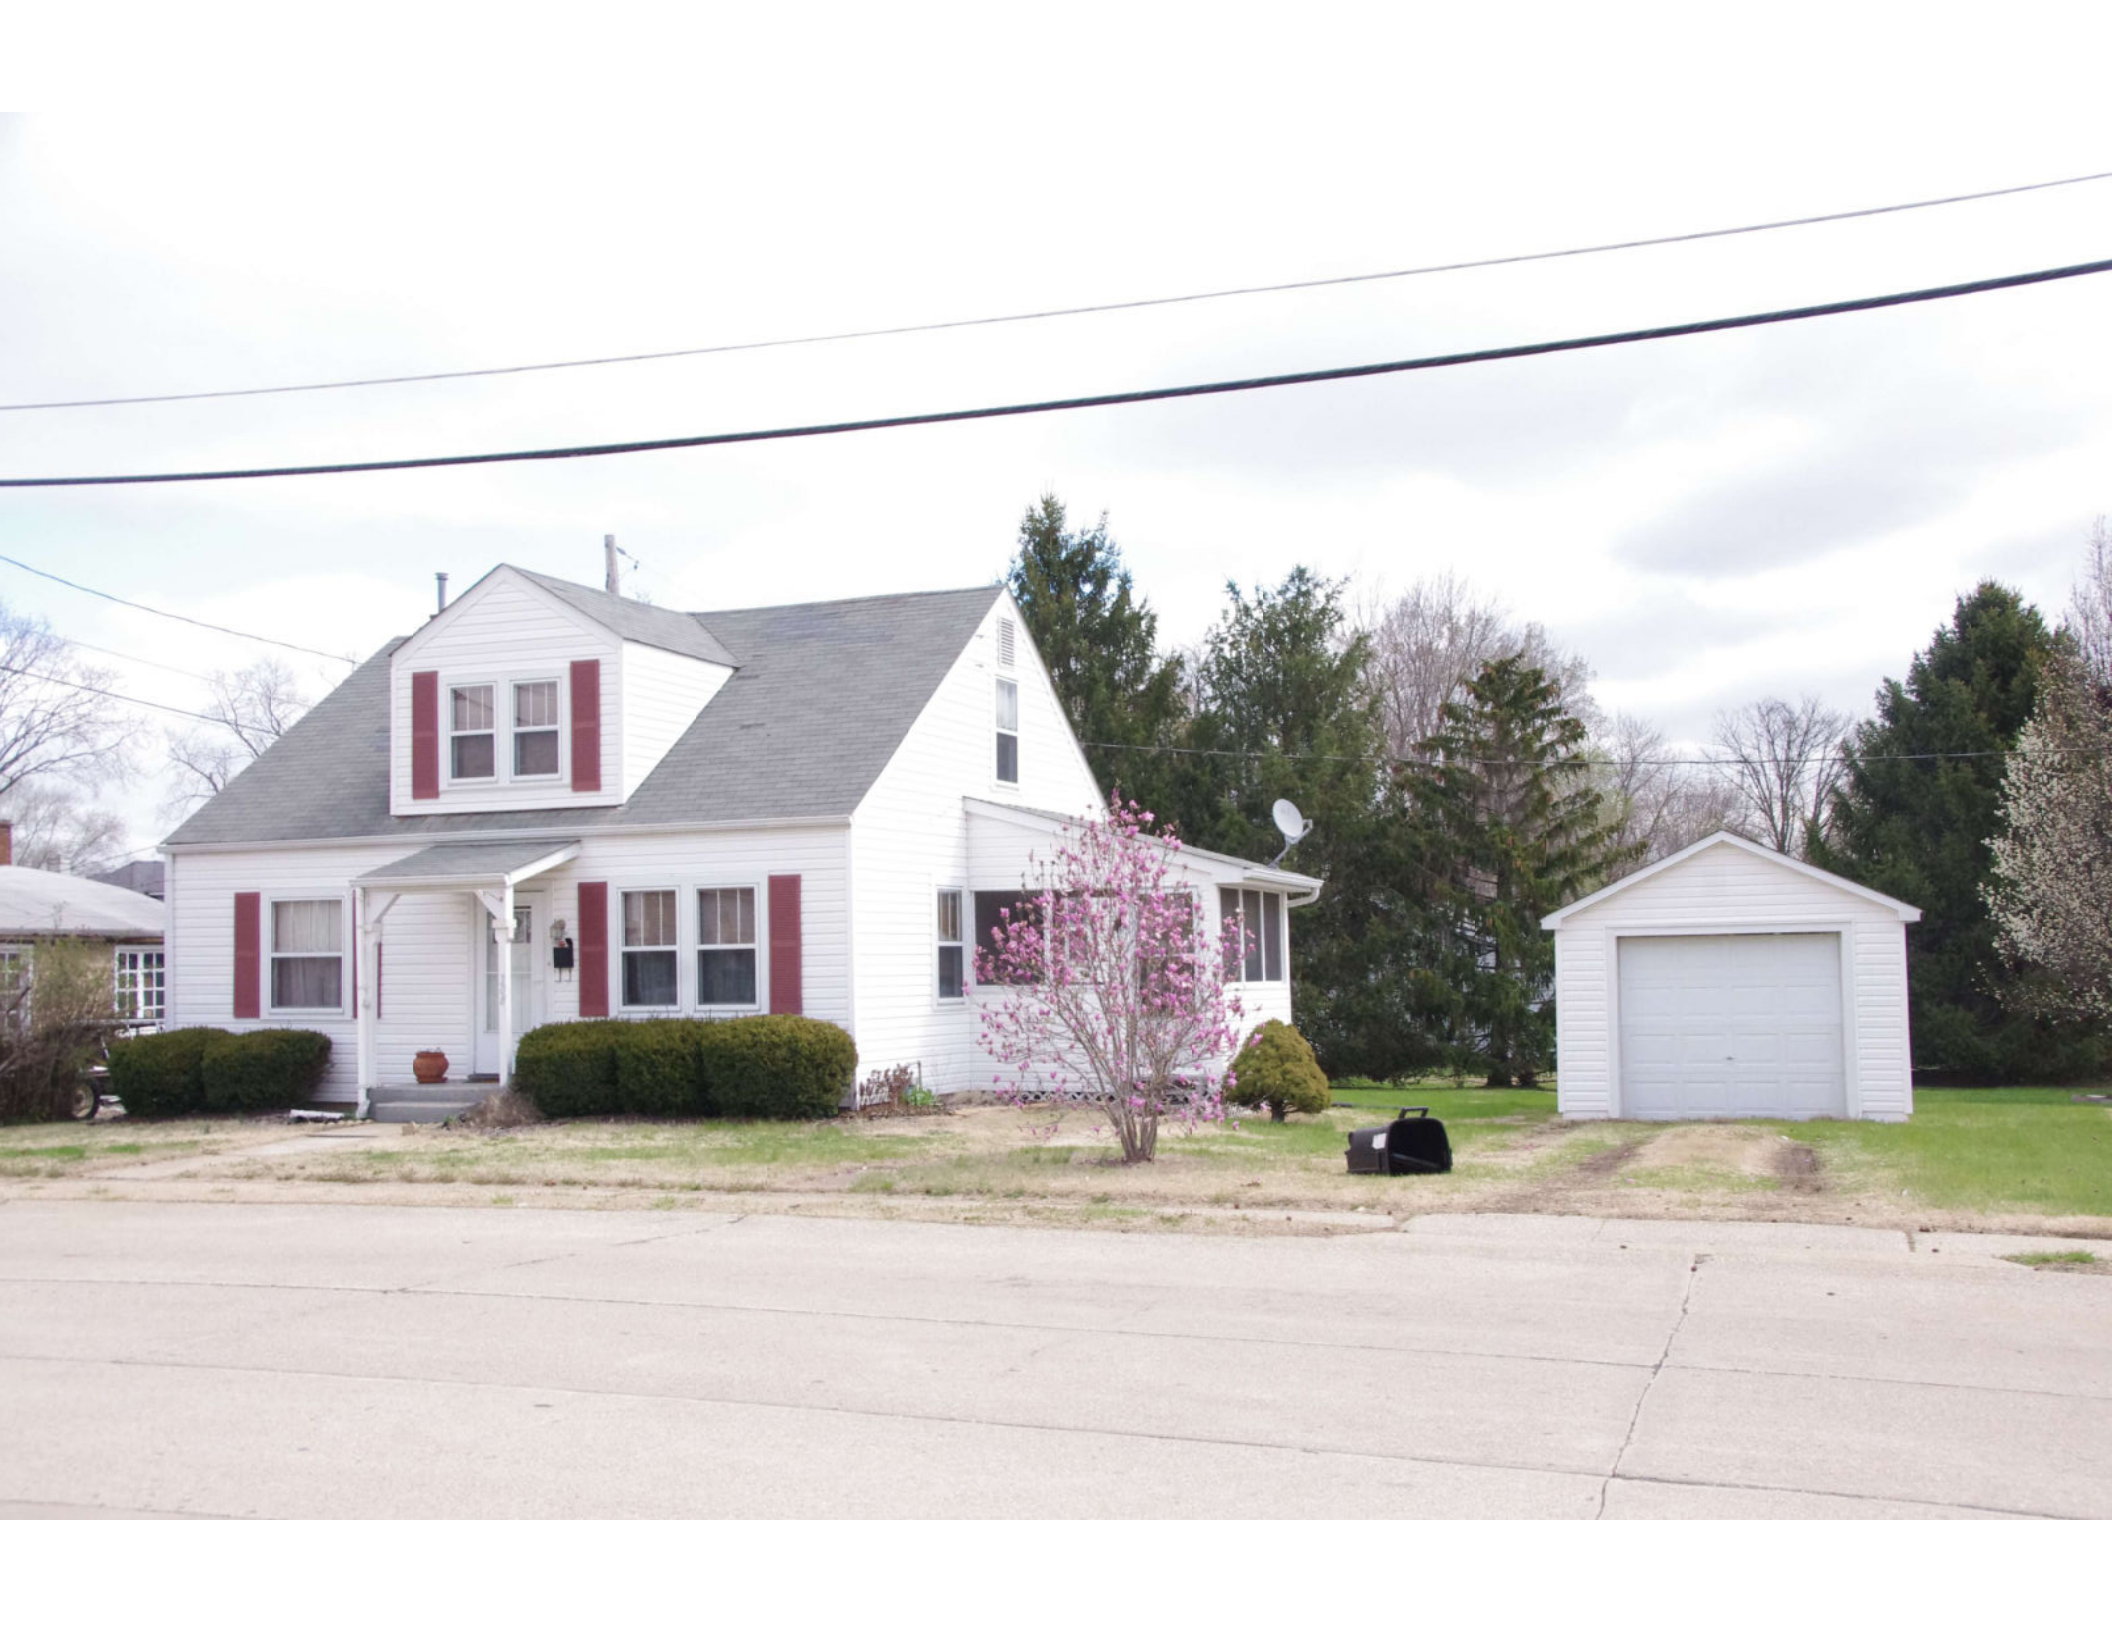
This resource is a one-and-a-half story vinyl sided house with a concrete foundation and a side gabled roof. Paired three-over-one sash windows fill the gabled central dormer. The front entrance is centered below with a shed roof, open porch supported by square, braced, wood posts resting on the concrete porch floor. The entry door has 3 vertical lights in the upper quarter of the door with two, tall, vertical panels below. Paired three-over-one wood windows flank the door to the south, and a single, four-over one window is found in the northern bay, all vertical lights. These vertical light sashed windows and door are original, distinctive features common to many residential buildings of the early twentieth century. The faux shutters were added with the new vinyl siding, but may actually replace original shutters since that is common on these Cape Cod designs. There is a brick, exterior, chimney flue on the north side. On the south side is what appears to have originally been an open side porch that is now enclosed as a sunroom.

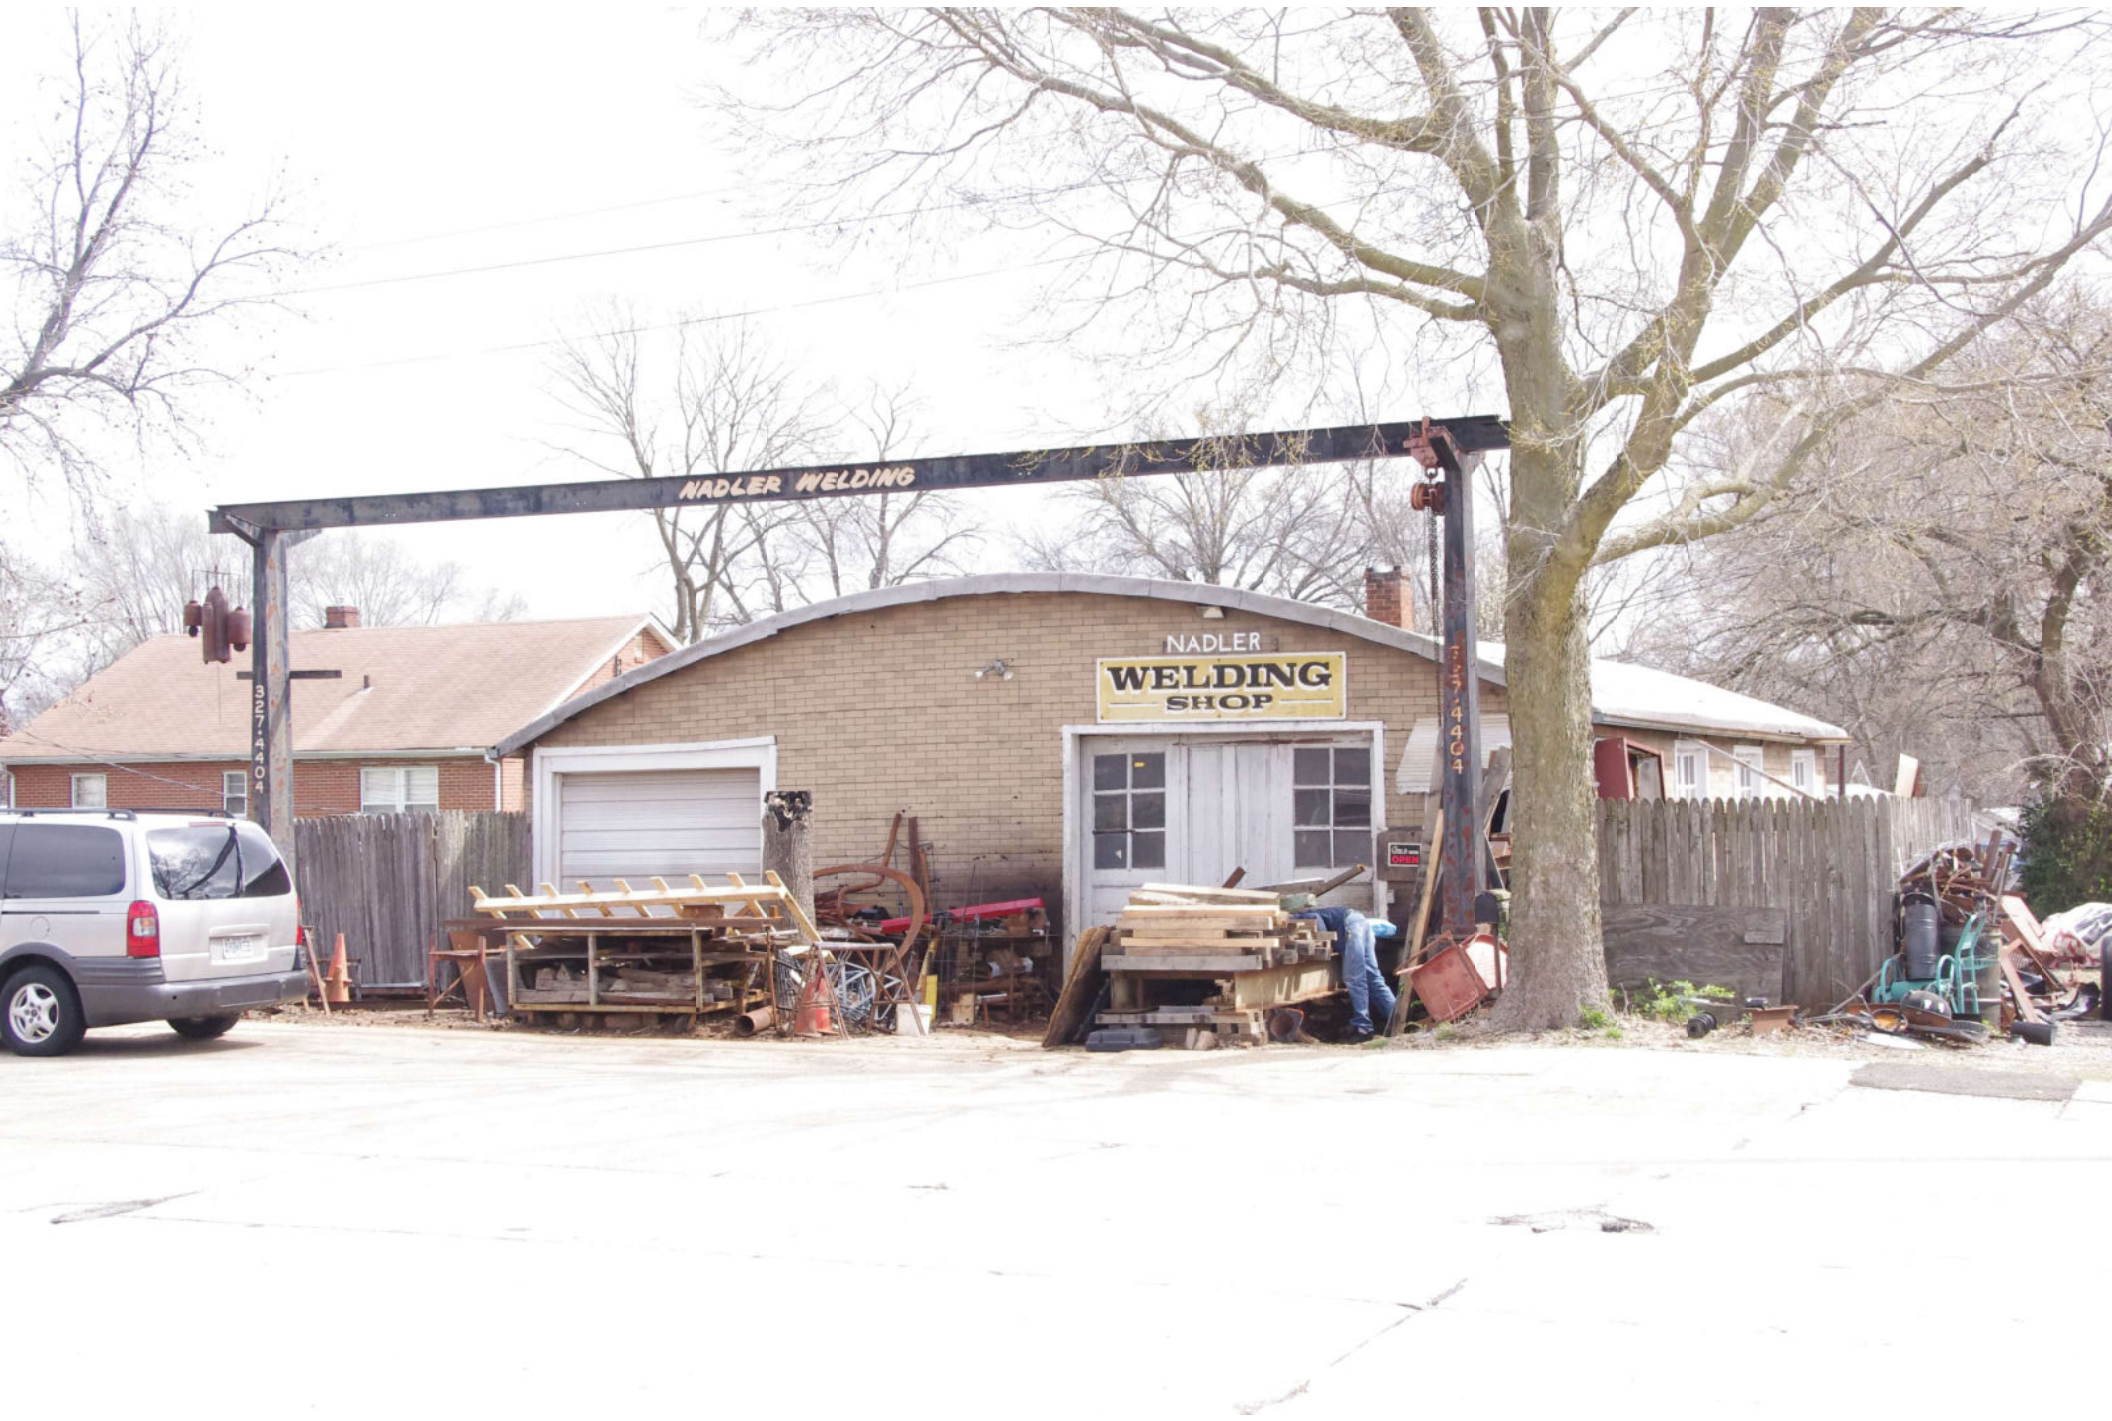
This resource is a one-story commercial garage building with an arched roof. The walls are clad with rolled asphalt siding that has a buff brick pattern. The three bay façade includes a replacement overhead garage door in the northern bay, paired historic six-pane wood doors in the off center bay, and a four light wood entance with a canvas awning. Along the south side of the building there are 3 pairs of multipaned wood casement windows.
